**Pre-Rehabilitation Lead Hazard Paint
Inspection/Risk Assessment Report**

PERFORMED AT:
Private Dwelling
[Redacted]
[Redacted]

Michael Lesser, State of Nebraska Risk Assessor (License #260)
City of Omaha Housing Community & Development Department
1819 Farnam St
Omaha, NE 68183
Date: 6/27/2017

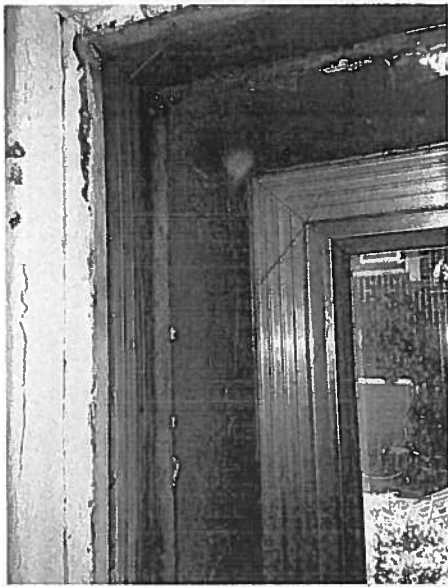
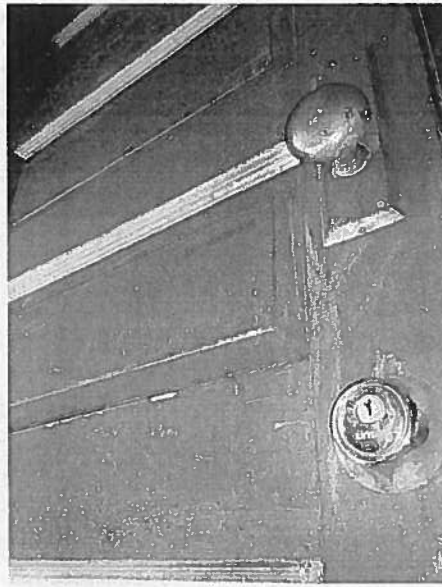
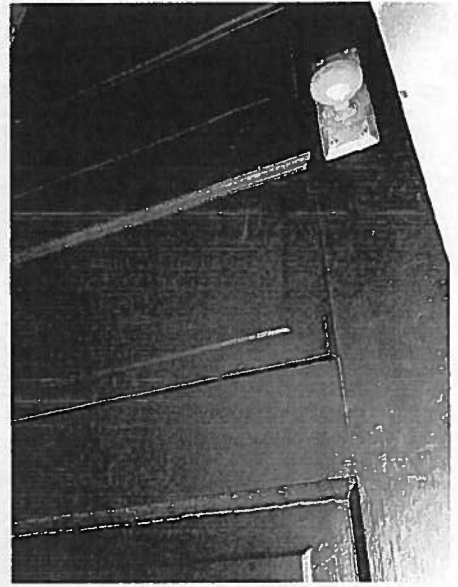
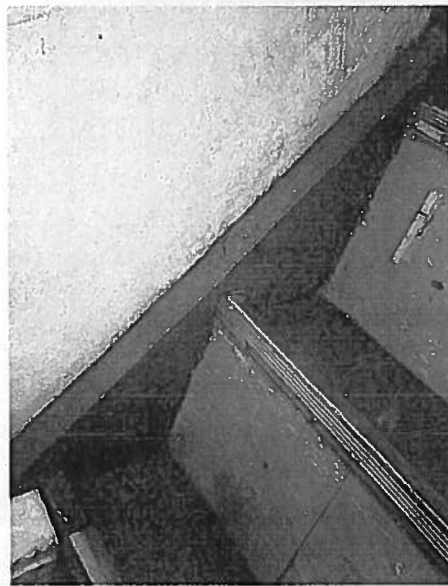
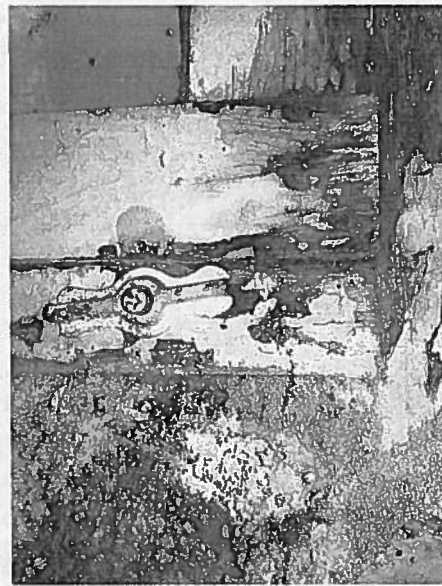
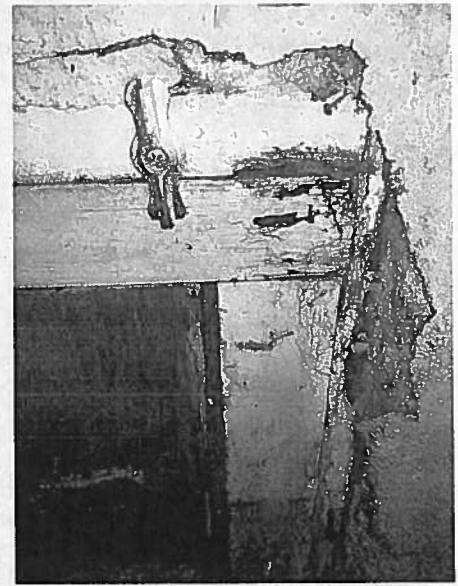
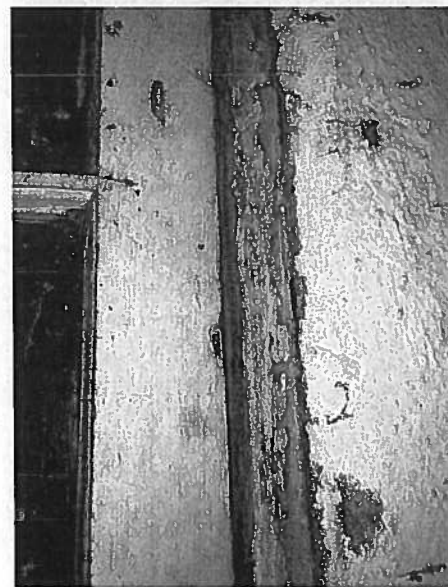
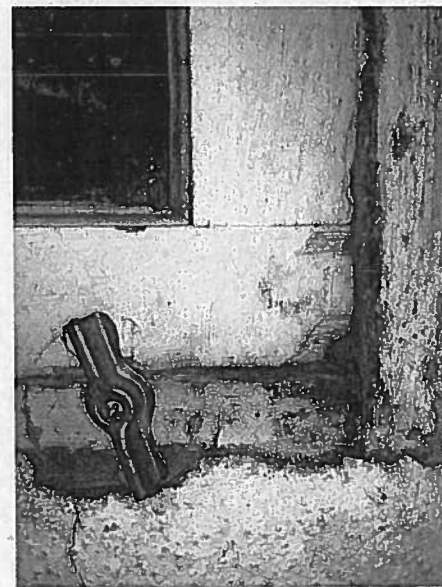
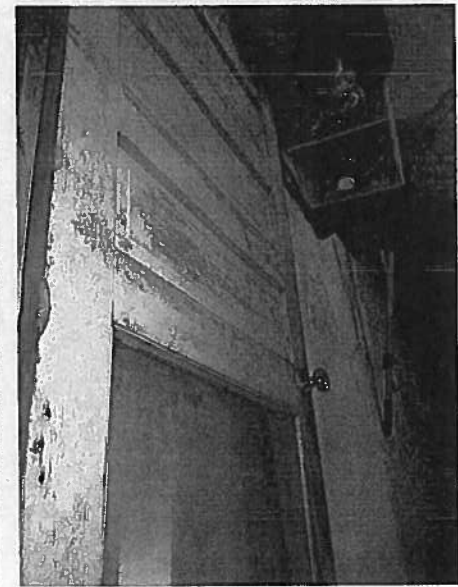
Suspected Lead Hazards				
#	Location	Condition	Comments	Color
1	Dining Room, B wall, Window # 11	Peeling	Inaccessible/A/C *photos	Brown
2	Dining Room, C Wall, Window #13	Peeling	Inaccessible/Caulked Closed *photos	Brown
3	Kitchen, C Wall, Window #14	Peeling	Inaccessible/Caulked Closed *photos	Brown
4	Kitchen, D Wall, Window #15	Peeling	Inaccessible/Caulked Closed *photos	Brown
5	Bed #2, C wall, Window # 23	Peeling	Inaccessible/A/C *photos	Brown
6	Bed #3, D wall, Window # 25	Peeling	Inaccessible/A/C *photos	Brown

1. Dining Room, B wall, Window #11 shows signs of LBP (cracking pattern). (photo)
2. Dining Room, C Wall Window #13 shows signs of LBP (cracking pattern).
3. Kitchen, C wall, Window #14 shows signs of LBP (cracking pattern). (photo)
4. Kitchen, D wall, Window #15 shows signs of LBP (cracking pattern). (photo)
5. Bed #2, C wall, Window #23 shows signs of LBP (cracking pattern). (photo)
6. Bed #3, D wall, Window #25 shows signs of LBP (cracking pattern). (photo)

The following areas are suspected of being coated with LBP that is *deteriorated* and currently present lead hazard. However, the upcoming abatement or interim control plans include work inside the house and scraping and repainting the exterior. If these renovations occur, lead-safe work practices will need to be implemented during the project to ensure that lead hazards are not created.
