# Examples to Support the Housing Health and Safety Rating System

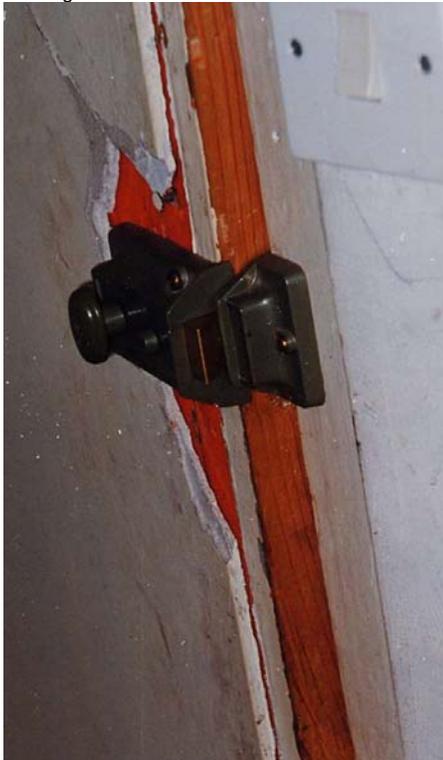
Damaged asbestos sheet around lock .

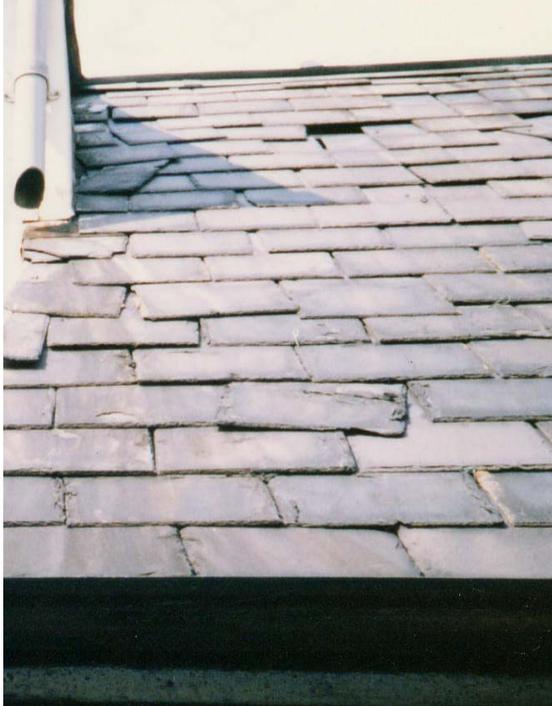
**A) Slipped and missing slates on rear roof**
