OFFICE OF HOUSING

SUBJECT: Electrical Connections Workmanship

This memorandum is being issued in order to bring attention and focus to ensuring electrical connections for manufactured homes are completed in an approved manner. Based on findings from a recent on-site investigation that was conducted in follow-up to an electrical fire in a manufactured home, we recognize the need to reinforce various aspects of good workmanship.

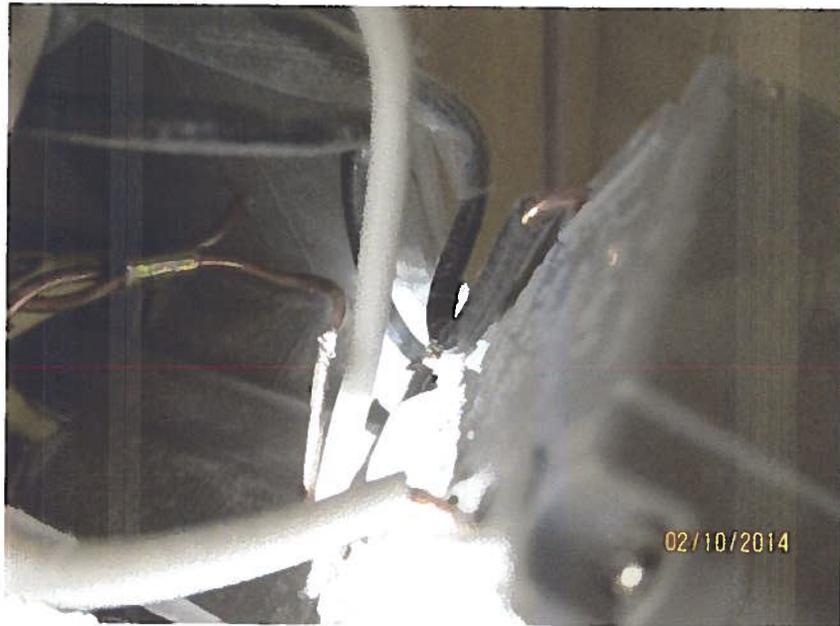
In the photograph below, the ground conductor was in contact with the lower hot conductor (where the insulation has been over stripped) at the push point connection. This has resulted in arcing between the two conductors and therefore, a potential source for over-heating and fire.

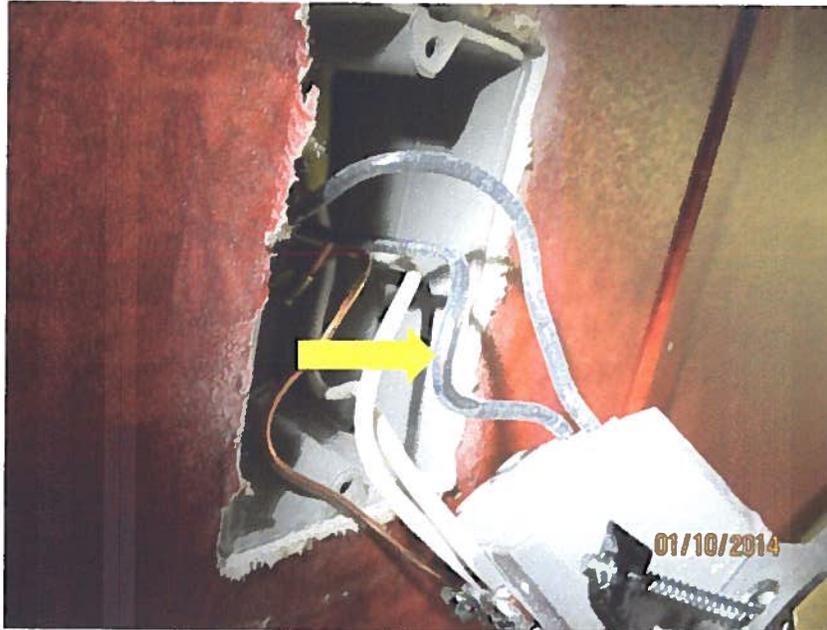
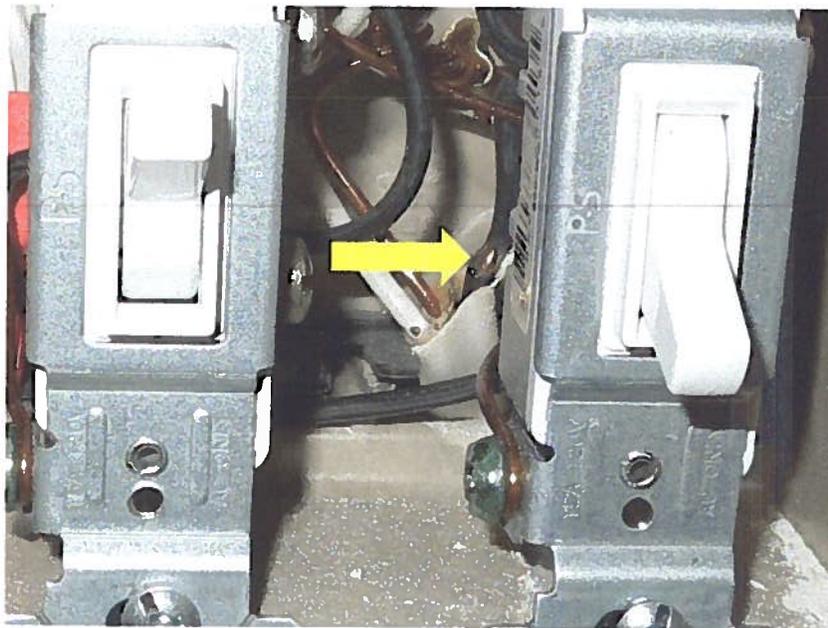
Sample Photographs:

Damaged conductor insulation (nicked and sliced insulation on conductors inside junction boxes) in close proximity of other metal parts

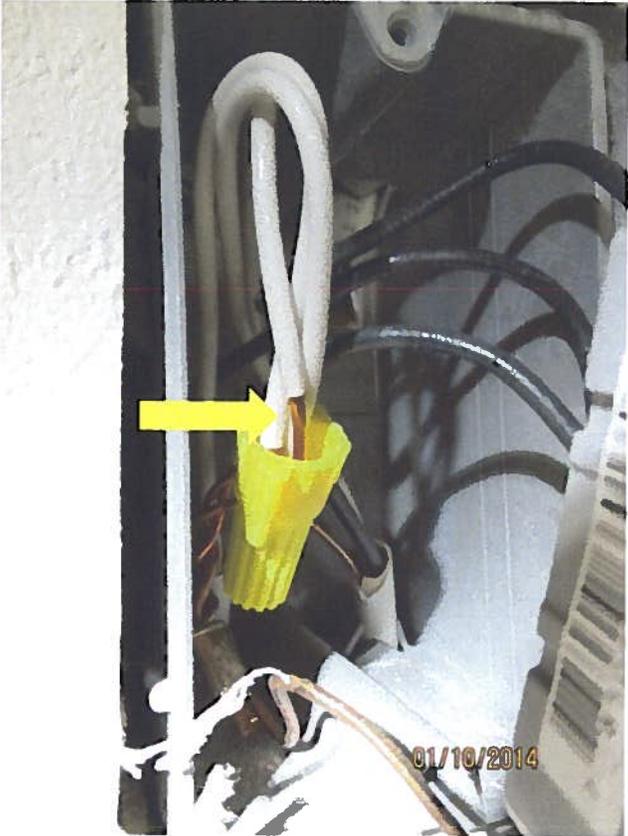
Sample Photograph:

Conductor under wire nuts not fully engaged, loose

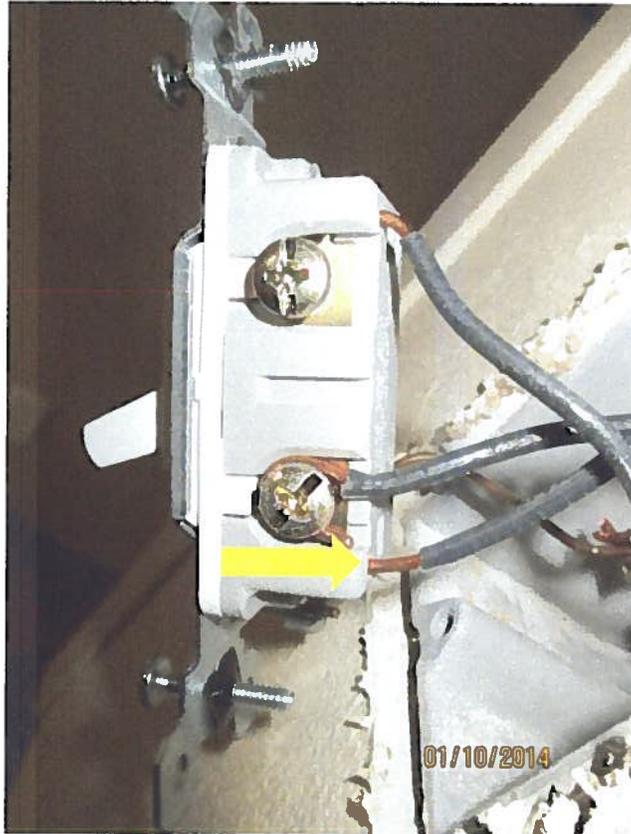
Sample Photograph:

Insulation on conductors at push point connections over stripped

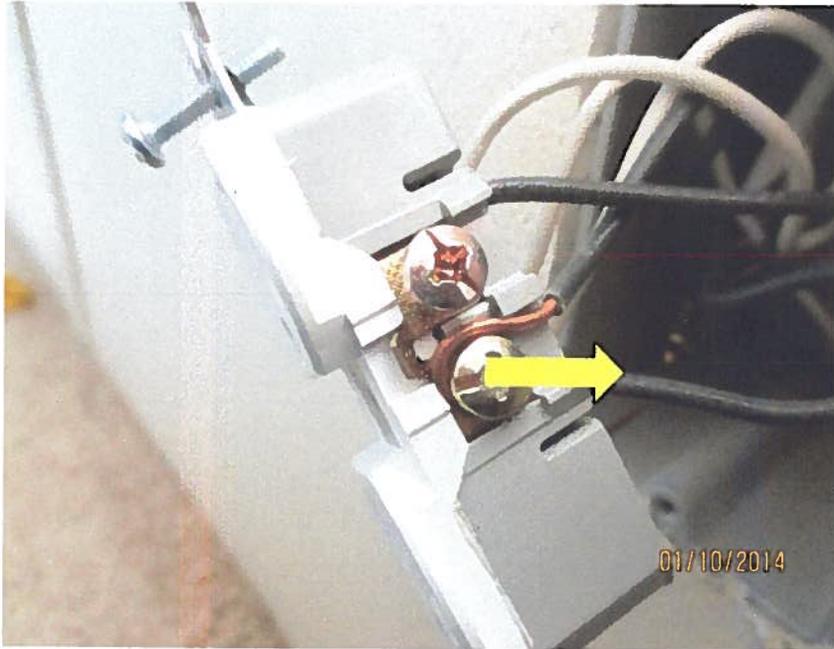
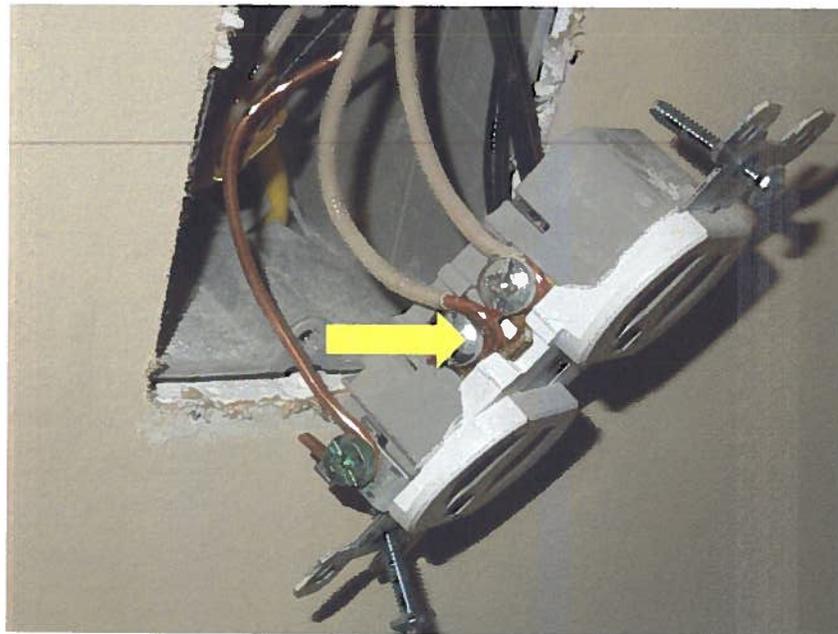
Sample Photographs:

Wire connections around the binding post of a device. - Wire not fully engaged under the head of the binding screw terminal

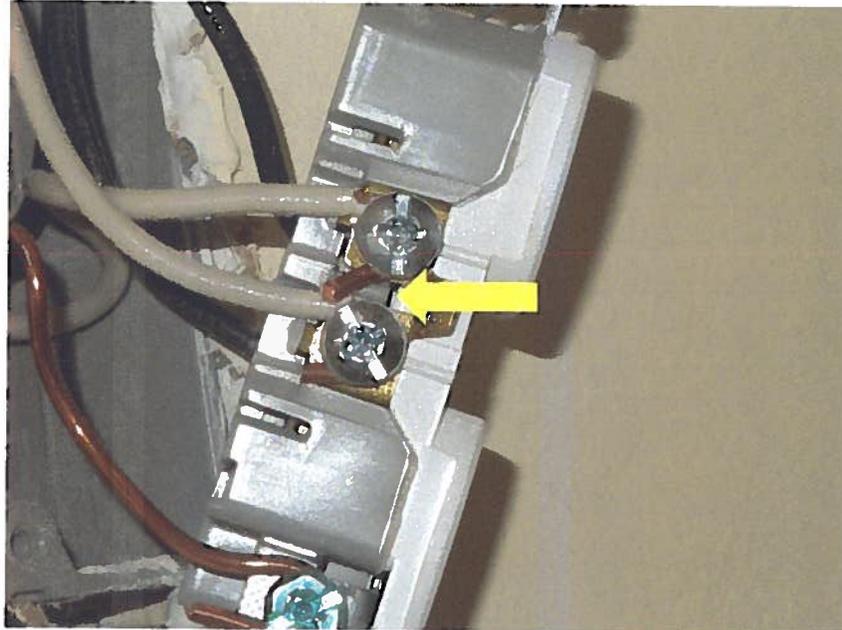
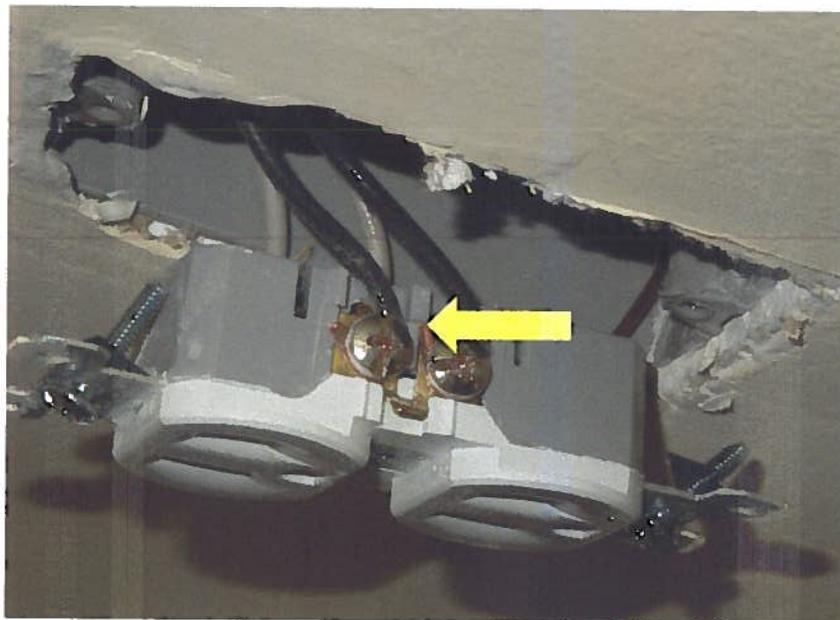
Sample Photographs:

Wire connections around the binding post of a device. - Insulation under the head of the binding screw conductor

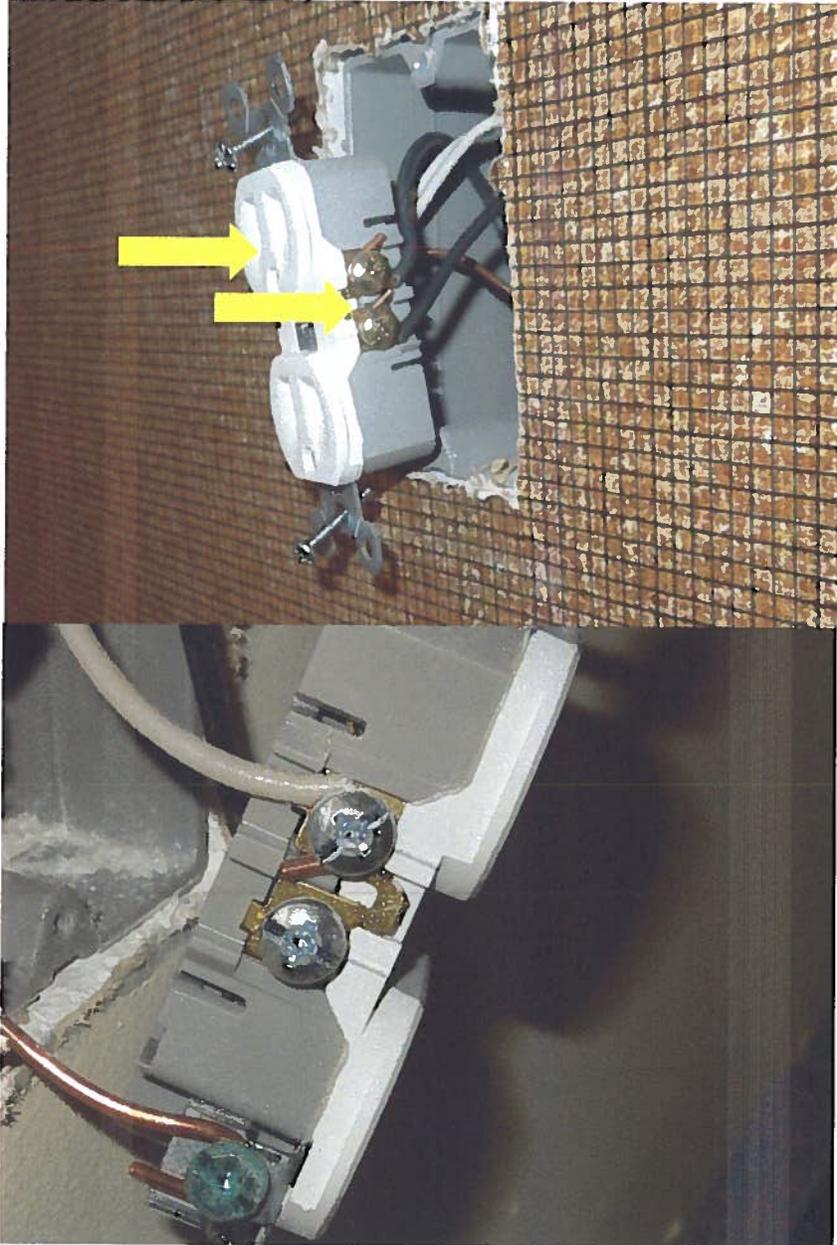
Sample Photographs:

Wire connections around the binding post of a device. Conductor on the shoulder of the terminal.

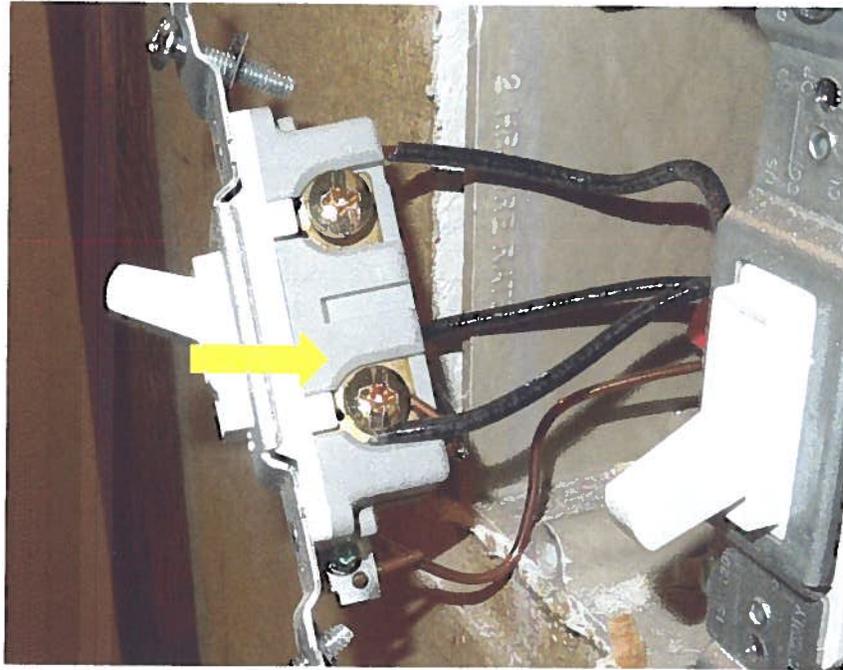
Sample Photograph:

Wire connections around the binding post of a device. - Wire around binding post wrapped over itself.
