# Examples to Support the Housing Health and Safety Rating System

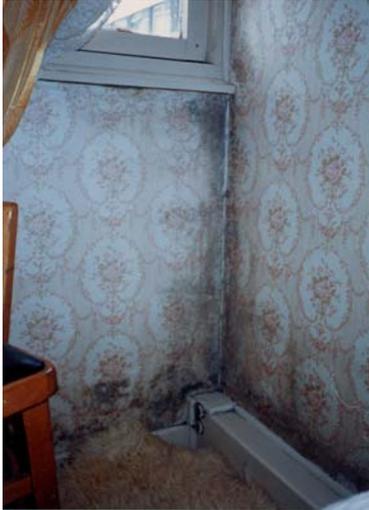
**A) Front end bedroom**

- A) Front bedroom:** The concrete floor to the top floor front bedroom and bathroom projects over the access balcony by approximately 1 metre. There is damp affected plaster and mould growth to the front main walls and to the exterior flank wall to the front bedroom.
- B) Bathroom:** The front wall of the bathroom and adjacent ceiling and internal walls are affected by severe and extensive mould growth, caused mainly by condensation resulting from cold bridging.

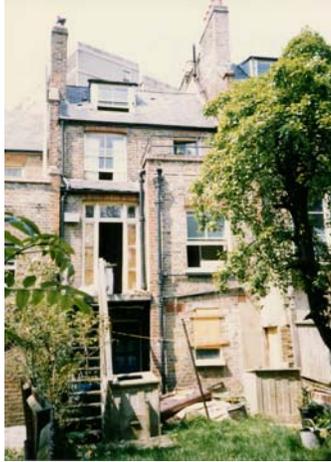
Rear elevation

**A) Rear main wall:** The wall is severely affected by dampness. The roof allows water to soak downwards, and the eavesgutters leak soaking the outside of the wall and allowing water to bounce up from the "patio". The plaster is perished and there is mould growth spreading from the floor.

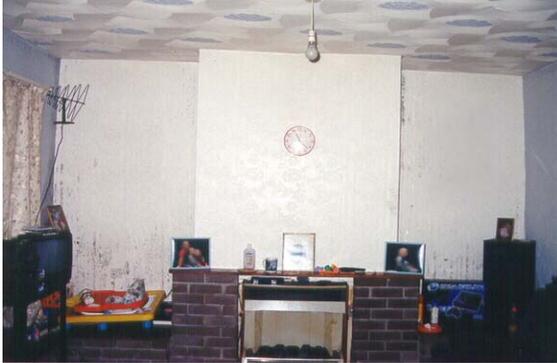
A) Living room

- A) **Living room:** Rising and some penetrating damp with associated mould growth is affecting the external gable wall in both recesses to either side of the fireplace in the living room.
- B) **Kitchen:** Dampness caused mainly by condensation is affecting the whole of the front external wall surrounding the window and adjacent ceiling and party wall in the small kitchen.
- C) **Second bedroom:** Penetrating damp and some associated mould is affecting the end wall.

**Justification** Repairing the dpc, re-rendering the external walls and providing mechanical ventilation in the kitchen would reduce the risk to close to average levels - a score of 15, band I. Improving the thermal efficiency of the walls would reduce the hazard further.

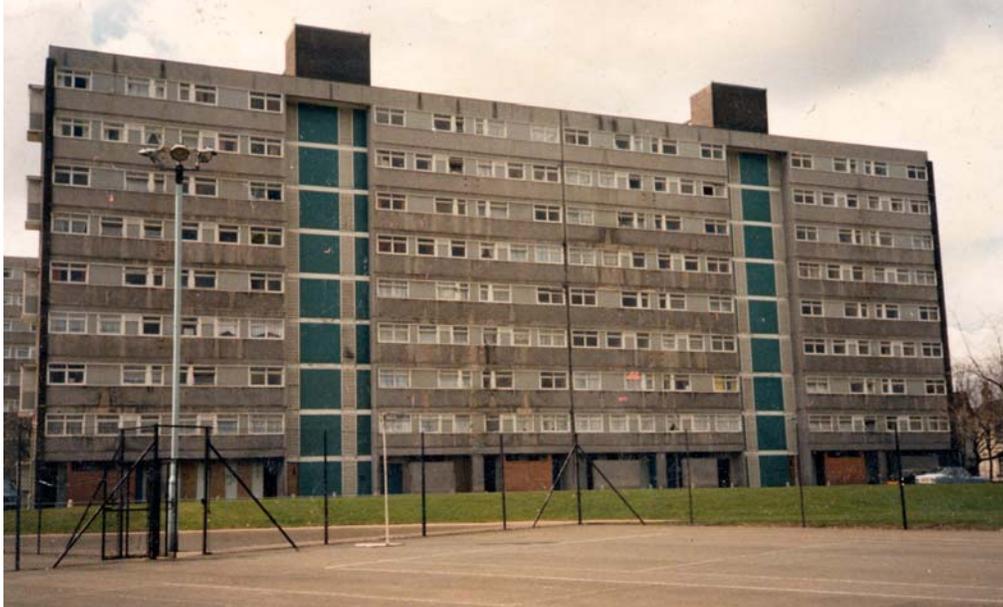
East facing elevation of block

**Dwelling:** End maisonette, on 5th and 6th floors of 1960s nine storey slab block of 32 maisonettes, built of non-traditional concrete construction; orientation East/West.

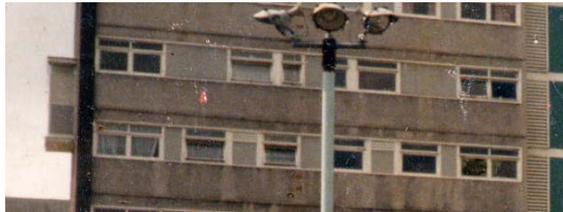
Elevation of maisonette

- A) Heating:** Heating is by electric elements set in the floor slab of the lower floor, with a thermostat control in the living room. The occupier supplements this with portable electric heaters.
- B) Windows and walls:** The windows are single glazed and metal framed. All the windows are centre pivot opening lights, except the bathroom which is a top hung opening light. There is damp and mould growth to the external walls to the upper floor rooms.

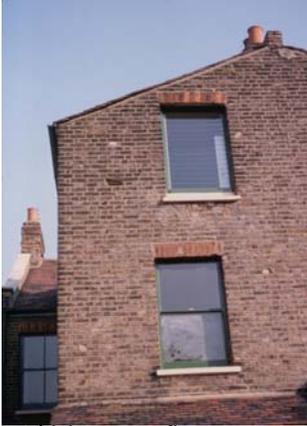
A) Rear windows

- A) **Windows:** Windows to the back addition kitchen, bathroom and w.c. compartment have been replaced with louvred windows. All other windows are single glazed, double hung sashes.
- B) **Heating:** The open fireplaces throughout the flat have been sealed. Radiant bar heaters fitted in the front living/dining room, rear bedroom and in the dining area in the back addition.

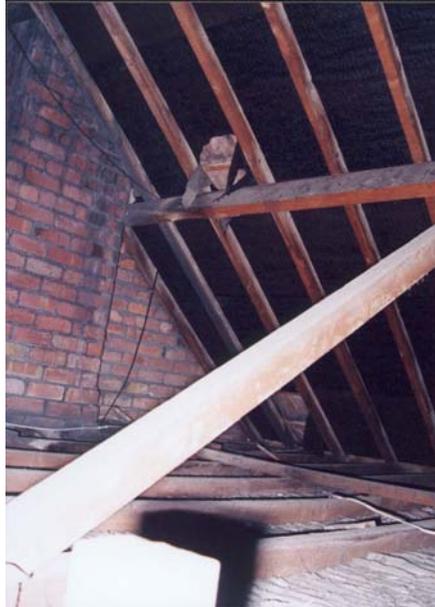
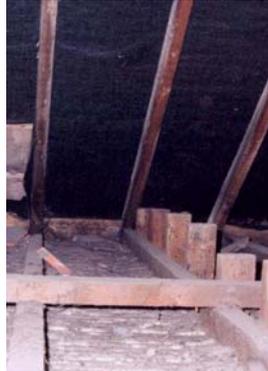
Loft space

**Heating and insulation:** Around 15 years ago, full central heating was installed in the dwelling run from a gas-fired boiler located against the boundary wall in the kitchen extension. The windows, which are mainly sash, are in good condition but single glazed. However, the roof space (where some of the sarking is torn) lacks any form of thermal insulation above the thick lath and plaster ceilings.

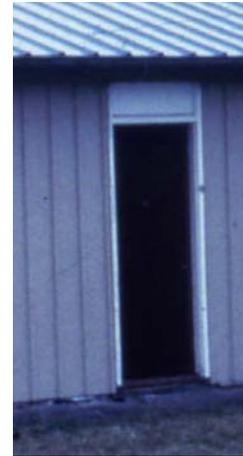
A) Front door

**Justification** The extent of the breakdown of the asbestos insulation sheets and the accumulation of fibres on the ground close to the front door means that the likelihood of a hazardous event occurring within a 12 month period is relatively high, particularly if one includes the psychological effects caused by the fear of asbestos in and around the home. However, the problem is confined to outside of the dwelling where the fibres are widely dispersed by the air, producing a substantially smaller risk than the same problem indoors.

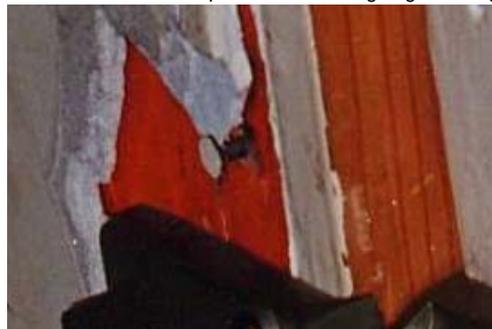
Close up of break showing original fixing

**Doors:** As part of the upgrading, the wooden front doors to each flat were lined internally with 8mm 'chrysotile' (white) asbestos cement sheeting. In the flat under consideration, some of the sheeting has broken away around the point where it has been shaped to accommodate the door locks. This has resulted in some fraying and the exposure of the asbestos fibres. Above and below the locks, a cover strip running around the sides of the door, designed to protect the edge of the asbestos sheeting, is also missing.

**Justification** The asbestos sheets have been damaged too badly to be sealed and their careful removal, under controlled conditions, is required to eliminate the health and safety risk. Once cleansed of any residual fibres resulting from the removal, the likelihood would reduce to that for the minimum exposure background level. For fire safety, the front door to the flat also needs to be replaced with a modern fire doors satisfying current regulations.

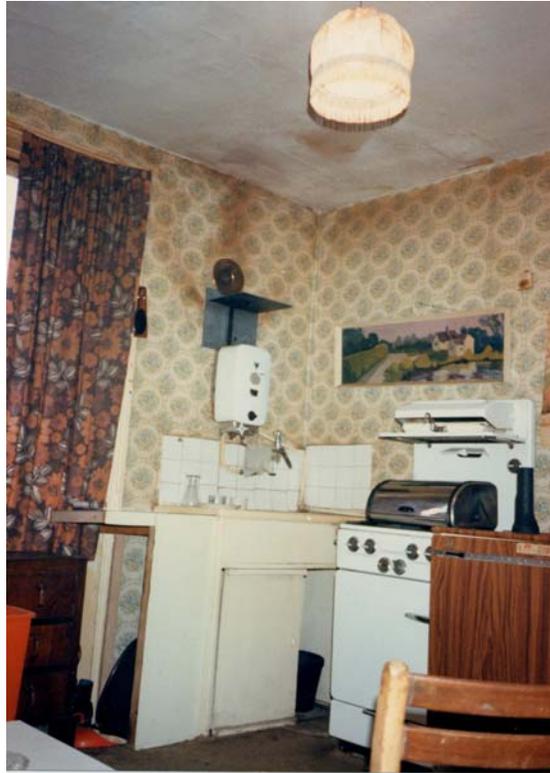
A) Location in kitchen/diner

**A) Water heater:** The photographs are of the 1st floor rear kitchen/diner, which connects directly with the bedroom, and show the sink with a gas instantaneous water heater over and the adjacent gas cooker. A crude metal plate and horizontal cowl have been fixed on the wall above the unflued water heater but this has not prevented the wall and ceiling above becoming stained by the hot gasses emitted. The window is a double hung sash and there is no other means of ventilation. There are no carbon monoxide detectors in the dwelling.

From the extent of the staining of the walls and ceiling and its pattern around the metal cowl and decorative plate, this unflued water heater is clearly emitting a substantial volume of hot and potentially dangerous gases. With no permanent fixed ventilation, the build up of carbon monoxide and other toxic gases in the room and adjacent bedroom from both the gas cooker and water heater is likely to be considerable. Consequently, the likelihood of the occupants suffering some harm will be high.

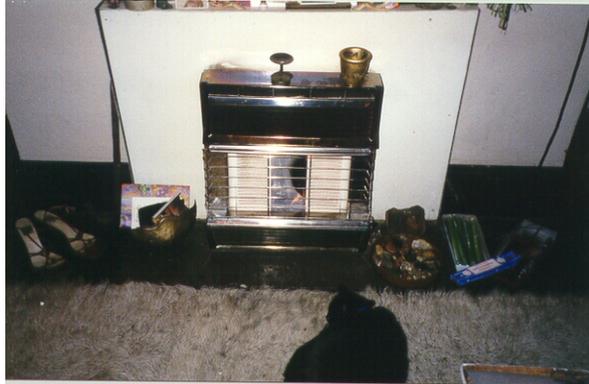
A) Gas fire in living room

- A) Gas fire:** The sole source of heating in the principal rear living room is by a fixed gas fire, which has a back boiler serving radiators in three other rooms. The central radiant has burnt through and the fire burns with a reddish flame. (The cooker in the kitchen is electric)
- B) DIY built Conservatory:** The part of the rear yard alongside the back addition has been enclosed, with a corrugated plastic roof and timber studding supporting single fixed glazing. There is no direct ventilation to the rear ground floor living room and the only opening light in the casement window is at high level, the bottom two and one of the upper opening lights having been sealed up. The only external opening to the conservatory is the door.

**Justification** There is no provision for permanent ventilation to the back boiler in the rear room and the gas fire shows signs of incomplete combustion. In practice, although the DIY conservatory is not particularly air tight, the rate of air change is likely to fall well below currently recommended standards when the windows and kitchen and conservatory doors are closed. Consequently, with the incomplete combustion, the risk is much higher than average.

**Justification** The evidence of incomplete combustion indicates that there is likely be elevated levels of carbon monoxide and other gases in the rear room after the fire has been on for prolonged periods of time. This will increase the risk of fatal, severe and serious outcomes from these gases and, with the high likelihood, would give a high score of 1,405 and a hazard rating of C.

**Justification** Providing permanent ventilation to the back boiler and gas fire and repairing the installation such that the appliance satisfied the relevant Gas Safety (Installation and Use) Regulations would reduce the likelihood and health outcomes to average or below. This would reduce the rating to Band J.

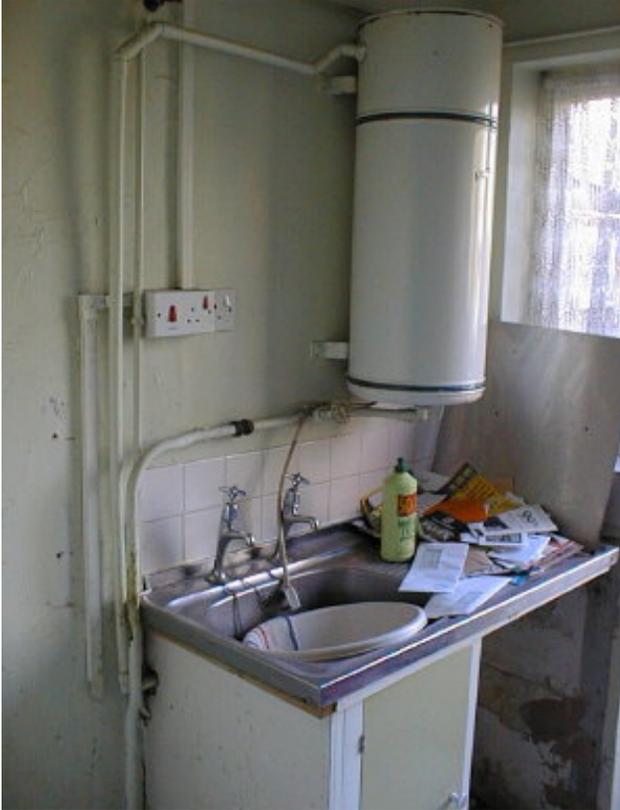
Rear kitchen

- A) Lead paint:** There have been a few improvements and alterations to the house. However, repainting of internal woodwork has not included removal of the original paint and the main lead water supply pipe has not been changed. Much of the internal decoration is worn and peeling, the paint to internal woodwork is chipped in parts and repainting is needed.
- B) Lead pipes:** The water supply pipe serves the cold water tap over the sink and the electric water heater. The dwelling is in a rural area, and water supplies are known to be plumbo-solvent.

**Justification** The internal woodwork is in need of repainting, which, in view of its condition, would involve removal of the old paint down to the bare wood. Without appropriate precautions being taken, this could release old lead-based paint dust and fumes into the dwelling. This combined with the contamination of the water supply would dramatically increase the likelihood of an occurrence. (Without the old paint, the likelihood would be around 1 in 56.)

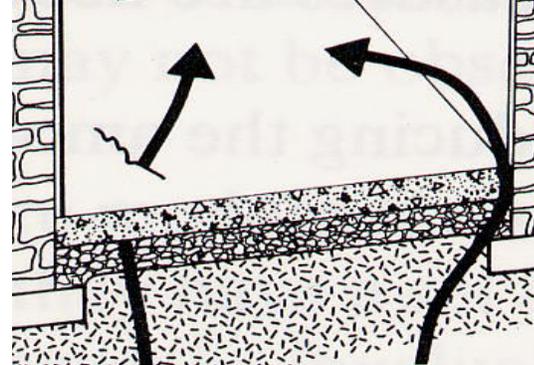
B) Rear dining room floor

**Justification** There is sufficient evidence to suggest a radon problem and subsequent measurements show a level of over 2,000 Bqm<sup>-3</sup>, way above both the average for radon affected areas and the recommended action level of 200 Bqm<sup>-3</sup>. Information from NRPB and other sources (see table overleaf) indicates that this would give an annual risk of cancer of around 1 in 100.

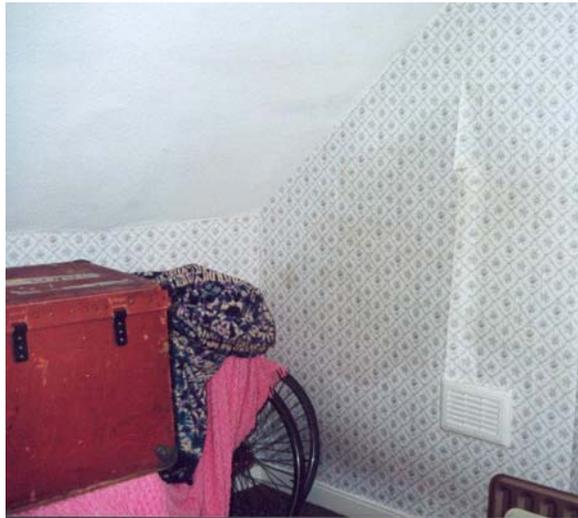
Corner of bedroom prior to redecoration

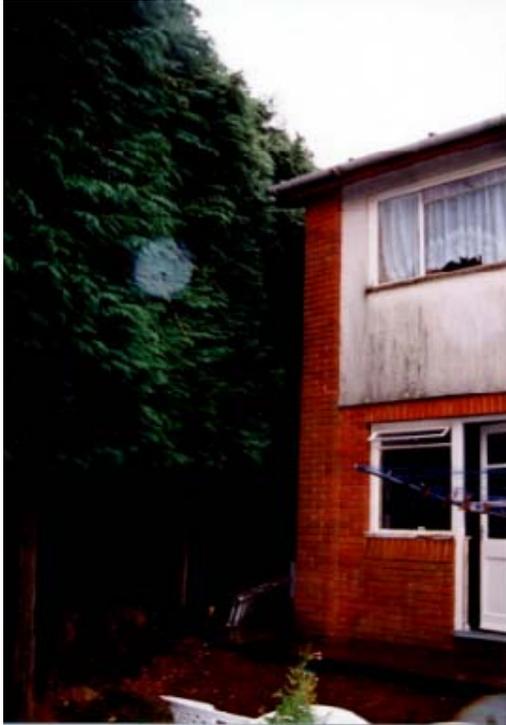
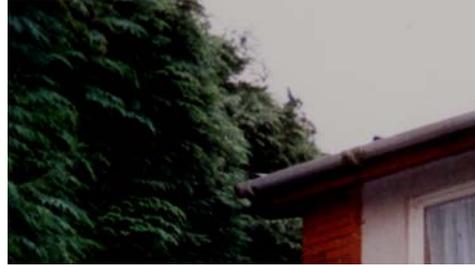
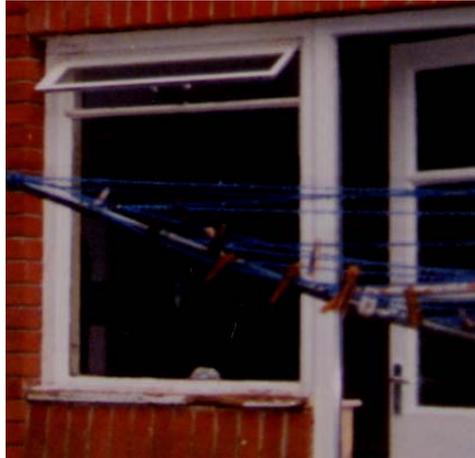
Ground floor rear kitchen/diner

**Justification** The windows to the rear elevation are of adequate size and are well located so that, if unobstructed, the dwelling there would be adequate natural lighting. However, the position and height of the Leylandii hedge obstructs daylight with the result that there is inadequate daylight penetration into the rear rooms. As one of these is the kitchen/diner, the likelihood of a harmful occurrence, is significantly increased. Concerns about getting the hedged removed/lopped may also add to the psychological harm.

**Justification** The hedge should be cut down to a height of less than 2 metres or removed and replaced with a fence. Either of these would remove the obstruction and allow adequate daylight penetration.

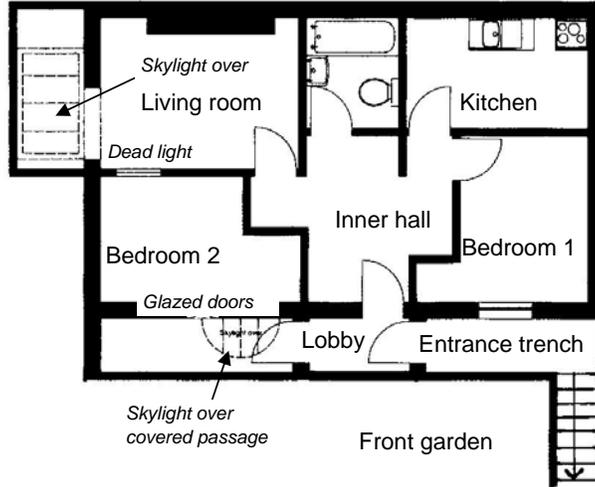
Plan of basement flat

**Justification** Wherever you are in this dwelling, you would be aware that it was built underground. Only the first bedroom provides anything near the natural lighting conditions and outlook that one would expect from a dwelling. The living room has barely adequate light but no outlook, while all the remaining rooms are clearly devoid of both natural light and any outlook whatsoever. Apart from the difficulty of reading without artificial light, it is likely that most people would also suffer some psychological harm from living in the dwelling for a year or more.

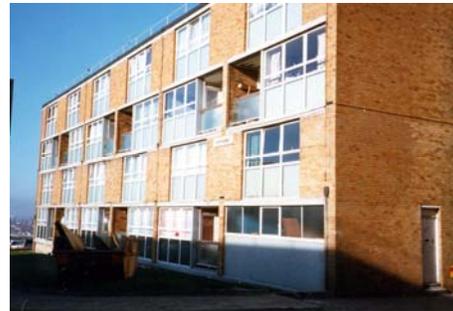
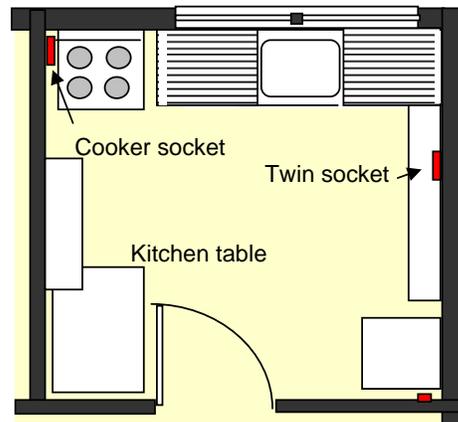
**Rear elevation**

The only impervious work surface at normal worktop height is given by the narrow shelf along the right hand wall of the kitchen. Given the inconvenience of preparing food on this shelf or on the low kitchen table, it is likely that one of the large worn wooden drainers will be used for this purpose and, with its badly worn surface, this could lead to the cross-contamination of cooked and uncooked foods. The lack of proper worktops is further exacerbated by the general lack of storage space in this kitchen.

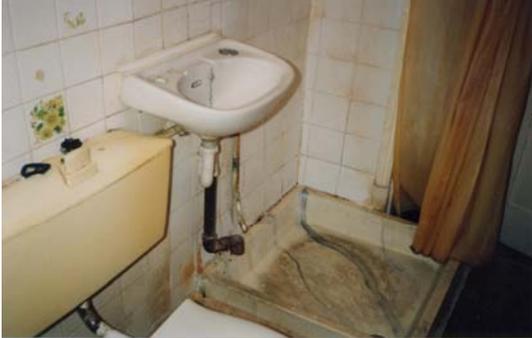
A) Shower room with w.c.

**Justification** The lack of taps to the whb, the location of the basin largely over the shower tray, and the state of the basin all discourage hand washing after using the wc, so significantly increasing the risk of infection. The state of the shower also discourages maintenance of personal hygiene. The room is inconvenient for the ground floor bedsits who may thus use the sink for washing. As all amenities are shared, the risk of spreading infection is increased. Overall, the likelihood of an occurrence is increased substantially for each of the dwellings.

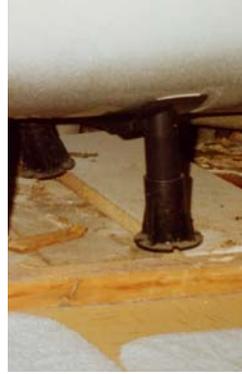
Bath legs at foot

**Bath:** To provide a level footing for the four feet of the bath, old white shelving has been placed over the old uneven floor boards. However, no fixing has been provided and with the use of the bath, the boards have now shifted and the feet become dislodged, causing the bath to be unstable and liable to rock. The bath itself has a narrow rim, no grab rails and a rounded bottom with no patterning to increase friction. Elsewhere on the bathroom floor, plywood has been laid over the uneven boards and varnished, and now covered with loose rugs.

**Justification** The risk of a fall associated with the bath is substantially increased by the fact that it is no longer stable and liable to rock significantly as a person gets in and out of the bath. The risk is further exacerbated by the old fashioned design of the bath, with its deep rounded bottom and lack of surface friction, narrow rim and lack of any grab handles. There is also a danger of slipping on the varnished floor, even discounting the loose rugs, when getting in or out of the bath.

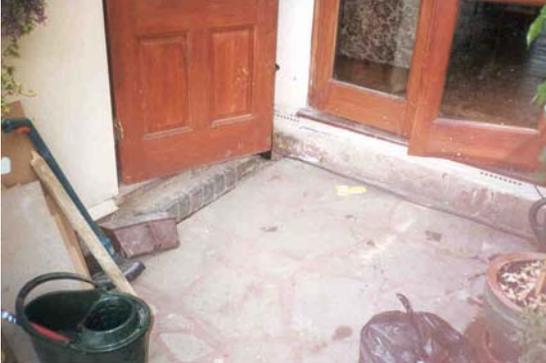
A) Steps to patio and back door

- A) **Rear steps:** The kitchen door in the back addition and patio doors to the main rear room both open outwards onto the concrete yard. They open awkwardly over respectively a single grey brick and concrete step/threshold. The patio door is fitted with safety glass.
- B) **Floor surfaces:** The floor surfaces in the main rooms on the ground floor, including the area at the foot of the stairs, comprise highly varnished stripped wooden floor boards. There are also some loose boards. The rest of the flooring in the house is typical of the dwelling age and type.
- C) **Rear garden:** The rear garden beyond the patio/yard has a surface of rough cast and broken concrete.

**Justification** The way the rear doors open over the threshold and the poor differentiation between the colour of this step and patio surface increase the risk of a fall when exiting to the rear. The loose boards also increase the risk and are a matter for the HHSRS. Although the floors were originally designed to be carpeted, the work to expose and varnish the floors represents a material change to the dwelling and their consequent slippiness an added hazard. The rear garden surface presents another small risk.

**Justification** Providing a wide level platform outside the kitchen and patio doors, repairing and re-carpeting or re-finishing the floor boards to give a less highly glazed, slippery finish and grassing the rear garden would reduce the likelihood of a fall to the average for this age of dwelling.

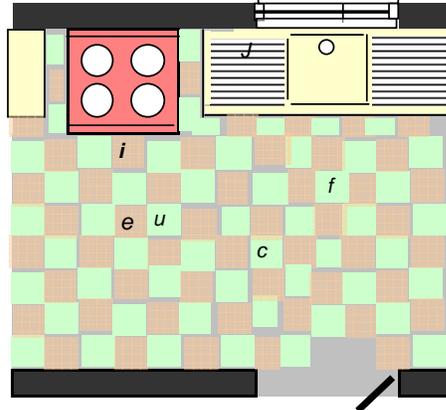
A) Plan

**A) Kitchen floor:** The main photograph shows the kitchen floor looking through the main door leading from the other rooms in the dwelling. Throughout the kitchen, the original thermoplastic plastic tiles have become unstuck due to rising damp through the concrete sub-floor and have also become brittle and broken with age. The remaining floors in the dwelling, although similarly damp on the ground floor, do not present any additional risk with respect to falls on the level and the front access and rear paths are also in reasonable condition. (This floor would also need to be separately rated with respect to provision for food safety)

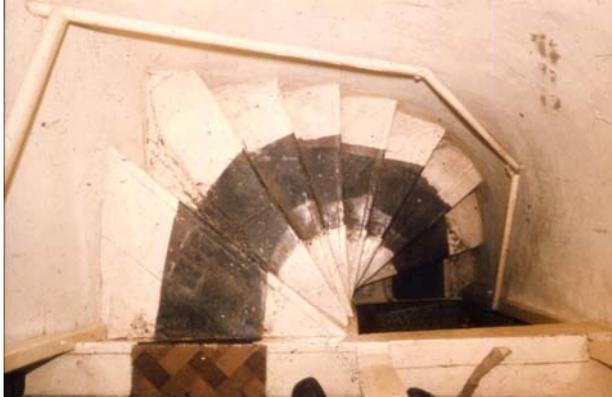
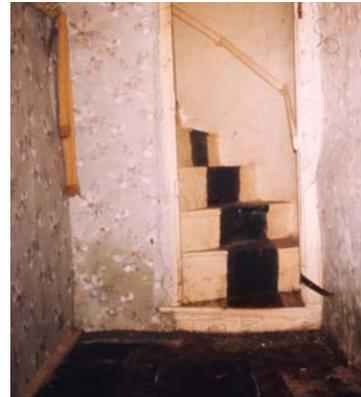
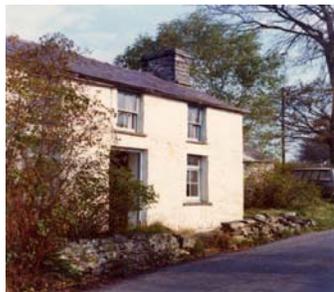
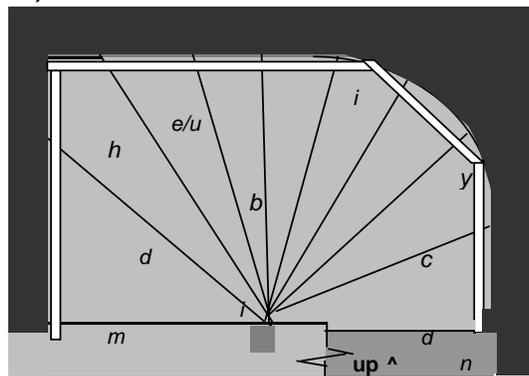
**Justification** The extreme steepness of the stairs, the uneven angles, tread and riser dimensions and poor handrail, particularly the lack of any handrail or grab rail on the inside of the stairs, together with the lack of natural lighting and inconvenient location of the switches to the artificial lighting, all add to the likelihood of a major accident occurring on these stairs.

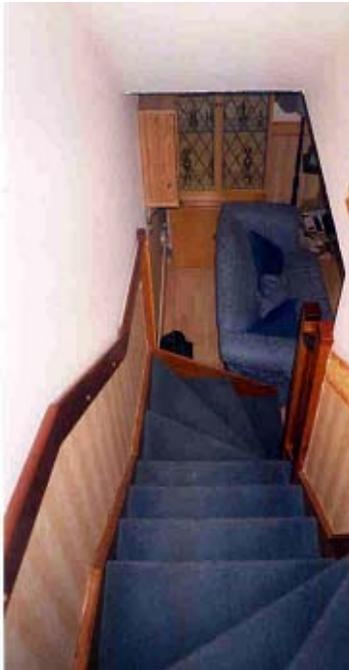
A) Main stairs

**Justification** The stairs are designed to be carpeted and there are no secondary hazards. However, the lack of guarding near the foot of the stairs and the consequent possibility of a small vertical fall over the end slightly increases the risk of a fatal or severe health outcome from that for the average for the stock.

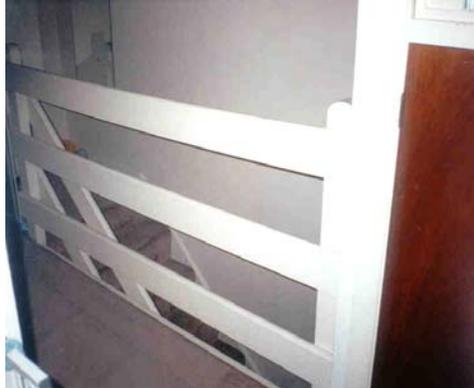
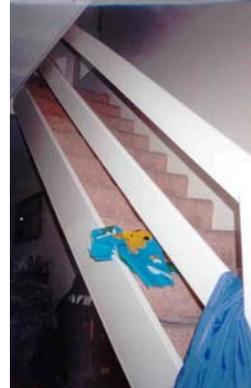
A) Landing balustrade

**Justification** The harm outcome of an indoor fall may be reduced by the fact that the stairs and floors are designed to be carpeted, but the stair and balustrade constitutes serious secondary hazards for a fall from the landing. Although much less likely, a fall from the front or rear bedroom window will result in a higher % of fatal and severe outcomes, due to the longer drop and concrete paving below, thereby further worsening the overall spread.

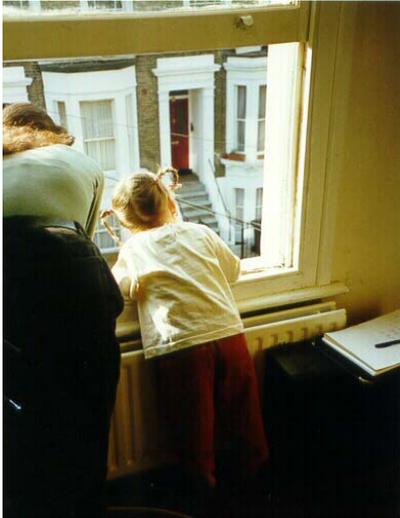
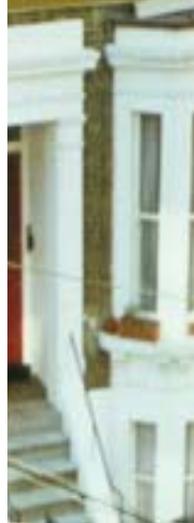
A) Front bedroom window

<i>1</i>	Type of opening light	<b>A</b>	3
<i>a</i>	Ease of window operation	<b>A</b>	2
<i>b</i>	Safety catches	<b>A</b>	2
<i>c</i>	Opening limiters	<b>A</b>	3
<i>d</i>	Sill heights	<b>A</b>	1
<i>e</i>	Disrepair of window	<b>A</b>	-
<i>f</i>	Ease of cleaning	<b>A</b>	2
<i>g</i>	Height of guarding	<b>A</b>	-
<i>h</i>	Easily climbed guarding etc	<b>A</b>	2
<i>i</i>	Openings in guarding	<b>A</b>	-
<i>j</i>	Constr./repair of guarding	<b>A</b>	-

<i>a</i>	Height above ground/ level #	<b>A</b>	2
<i>b</i>	Nature of ground/ surface #	<b>A</b>	3
<i>c</i>	Non-safety glass	<b>A</b>	2
<b>#</b>	<b>Secondary hazards</b>	<b>A</b>	
<i>1</i>	Stone front door steps	<b>A</b>	2

**Justification** A direct fall of over 6 metres is possible from this window and one rear window. The harm outcomes from this particular window are likely to be substantially more severe than from most first floor windows, due to the formidable secondary hazards. These are the concreted basement well, the stone front door steps and, particularly, the iron railings to the stairs and basement which are positioned directly below the centre of the window.

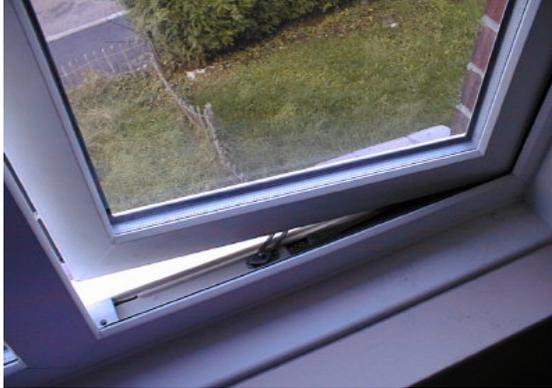
A) First floor front bedroom window

1	Type of opening light	A
a	Ease of window operation	-
b	Safety catches	3
c	Opening limiters	-
d	Sill heights	-
e	Disrepair of window	2
f	Ease of cleaning	-
g	Height of guarding	-
h	Easily climbed guarding etc	2
i	Openings in guarding	-
j	Constn./ repair of guarding	-

a	Height above window/ level	2
b	Nature of ground/ surface #	2
c	Non-safety glass	-
<b># Secondary hazards</b>		<b>A</b>
i	Concrete kerb	2
<b>Key</b>		
3	Seriously defective	2 Defective
1	Not satisfactory	- Satisfactory/NA

**Justification** Although the sill is at a normal height, it would be possible for a child to use the radiator to climb onto the sill and disengage the safety catch, if the window was left ajar, or for an adult to fall while using the fully open side window to clean the fixed pane. However, with only one such window in the house and this being in the main bedroom, the likelihood of a fall would be no more than average for the stock - that is around 1 in 1,800

**Justification** Depending on how the person falls, he or she will land wholly on the concrete path or kerb, partly on the path or kerb, wholly on the grass, or on the wooden fence. The latter is unlikely given the way the window opens. The first two possibilities appear the most likely and, with the added height due to the sloping site, the chance of a fatal, severe or serious fall is increased to figures above those for the average spread of harms.

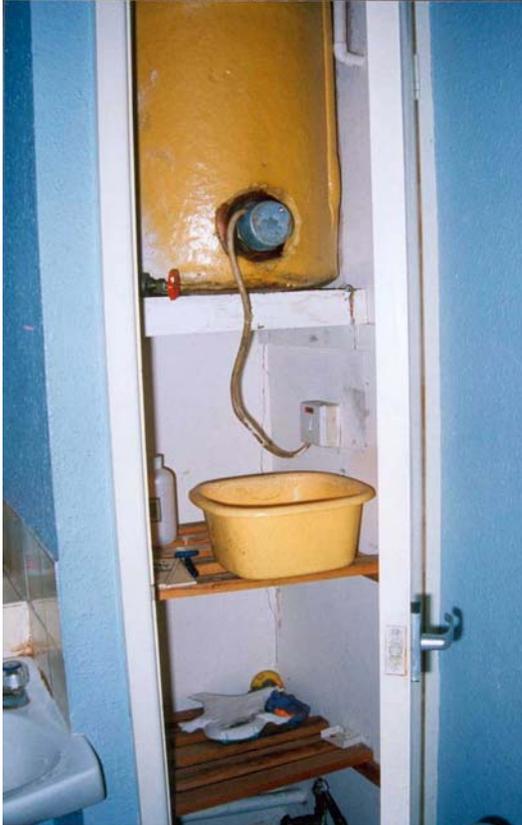
**A) Supply, meter and fuses**

**A) Immersion Heater:-** The gasket around the hole where the immersion heater enters the cylinder has perished resulting in a small but continuous leak. Water is not only running down the loose electric lead to the heater, but also onto the timber shelf holding the cylinder and down the side wall of the airing cupboard on which the switch to the immersion heater is located. The plaster skim and plasterboard above and behind the switch box is now thoroughly soaked. The householder has placed a bowl to catch any directly dripping water.

**Justification** The water seeping into the switch box could give rise to an electrical accident, particularly for adults. However, the greatest risk is to children. To reach the affected area, young children would need to find the cupboard door open and climb the shelving, although the presence of bathroom toys in the cupboard might encourage this. There is a further danger that the loose lead could be used to assist such a climb and pulled away from the heater while switched on.

**Justification** There is a possibility that the water collected in the bowl could be spilt over the child during the climb. This could increase the harm outcomes by, for example, conducting the electricity through the child's clothing. This increased spread of health outcomes on top of the above average likelihood would give a hazard score of 334 and a band E rating.

**Justification** Although the main hazard comes from the switch, this does not appear defective. The immersion heater needs replacing and rewiring to current standards, ensuring that the cable is securely fixed. With no other major electrical installation faults in the house, this would reduce the hazard score to the average for the stock.

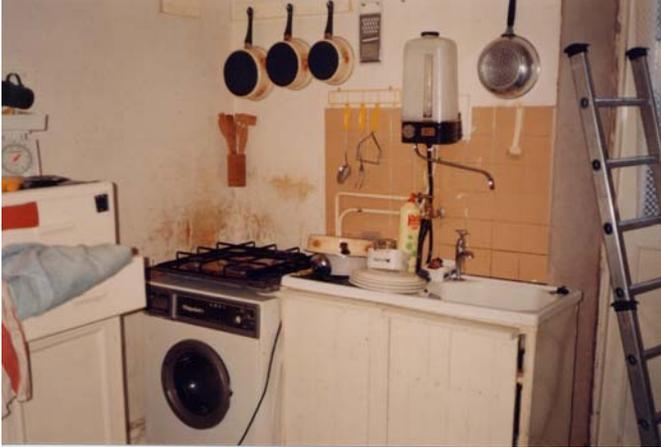
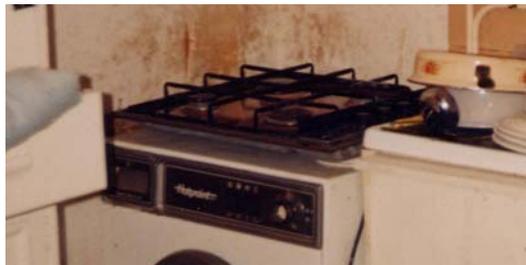
A) Kitchen area of main room

LIKELIHOOD	A	OUTCOMES	A
a Heater/cooker position	3	a Smoke/heat detectors	2
b Space heating	-	b Combustible furnishings	-
c Defects to heating	3	c Means of escape	-
d Clothes drying facilities	-	d Fire fighting equipment	3
e Number/siting of sockets	-	e Lighting protection system	-
f Electrical installation	-		
g Non-fire resistant fabric	-	<b># Secondary hazards</b>	<b>A</b>
h Smoke permeable fabric	-	- None	-
i Fire stops to cavities	-		
j Disrepair to fabric	-		
k Internal doors	-		
l Self-closers	-		
m Smoke/heat detectors	2	<b>Key</b>	3 Seriously defective
n Fire fighting equipment	1		2 Defective
o Lightning protection system	-		1 Not satisfactory
			- Satisfactory/NA

**Justification** **Ground floor rear dwelling:** The siting of the gas hob directly on the washing machine, without any fixing or intervening heat insulation, the loose gas pipe and its position in the extreme corner of the room, close to wooden kitchen fittings, presents a fire risk substantially above the average for pre 1920 flats .

**Justification** The flat has good means of escape; the kitchen/diner has direct access to the front door via the hall, while the bedroom contains a door to the garden. Consequently, notwithstanding the lack of a smoke/heat detector in the flat (there is a battery operated one in the hall), the spread of harms is judged to be very only a little greater than average.

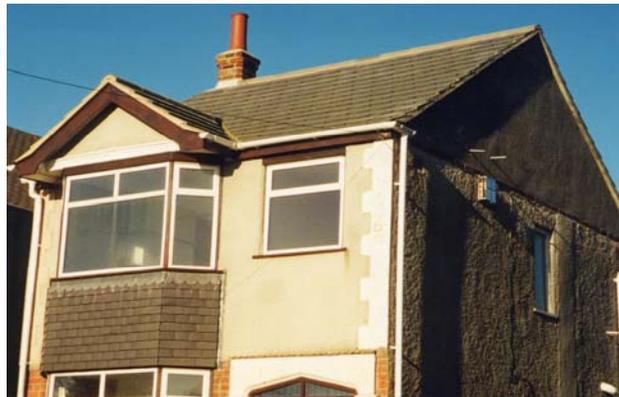
Closer view of main windows

**A) Means of escape:** During the 1950's, the timber framed casement windows to all elevations were replaced with aluminum framed, double glazed units with fixed lights and small top hung opening casements. The main form of heating is open coal fire with back boiler serving radiators to the ground floor only, but this is supplemented by portable electric radiant fires and a paraffin heater. There is an electric cooker. There are no smoke/heat detectors or alarms.

**Justification** The use of open coal fires and, particularly, the supplementary use of portable electric radiant and paraffin heaters which is a direct consequence of the inadequate fixed heating, significantly increases the risk of fire over and above that average for this age of dwelling.

**Justification** The lack of fire detectors and the limited means of escape resulting from the use of fixed glazing in all windows, substantially increases the risk of fatal, severe and serious outcomes occurring as a result of a fire.

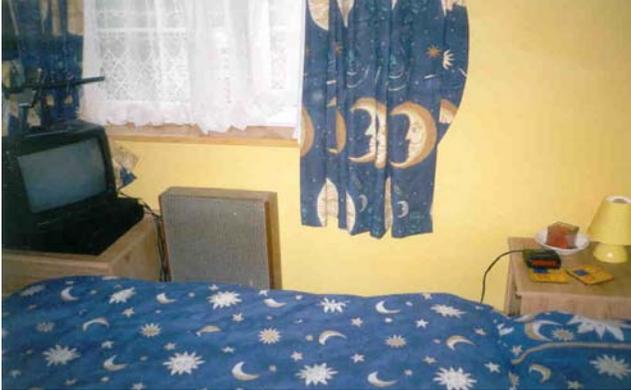
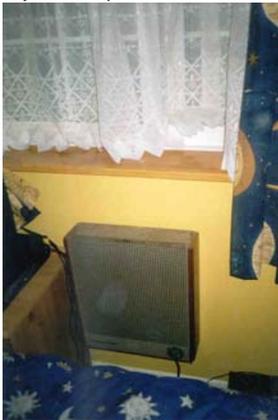
A) Gas heater in bedroom

LIKELIHOOD	A	OUTCOMES	A
a Heater/cooker position	3	a Smoke/heat detectors	1
b Space heating	2	b Means of escape	-
c Defects to heating	-	c Combustible furnishings	-
d Clothes drying facilities	-	d Fire fighting equipment	1
e Number/siting of sockets	-	e Lighting protection system	-
f Electrical installation	-		
g Non-fire resistant fabric	-	<b># Secondary hazards</b>	<b>A</b>
h Smoke permeable fabric	-	- None	
i Fire stops to cavities	-		
j Defects to fabric	-	<b>Key</b>	
k-l Internal doors/self-closers	-	3 Seriously defective	
m Smoke/heat detectors	-	2 Defective	
n Fire fighting equipment	-	1 Not satisfactory	
		- Satisfactory/NA

**Justification** The dwelling has one smoke alarm (albeit battery operated) and generally provides a relatively straightforward and easy means of escape, both through the doors and via the windows. Consequently, in the event of a fire in the bedroom, there is nothing to indicate that the likely spread of harms would be either significantly more or less than average (67% of all occupied dwellings now have smoke alarms).

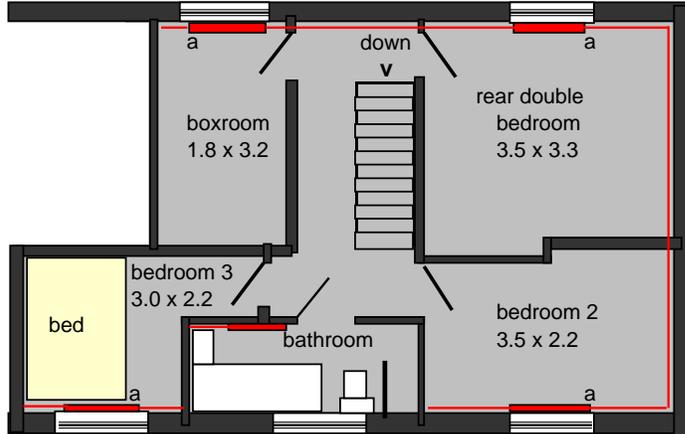
A) Plan of maisonette

**Justification** As a small child could easily become trapped between the pipes and the bed in the third bedroom, the probability of severe harm is increased.

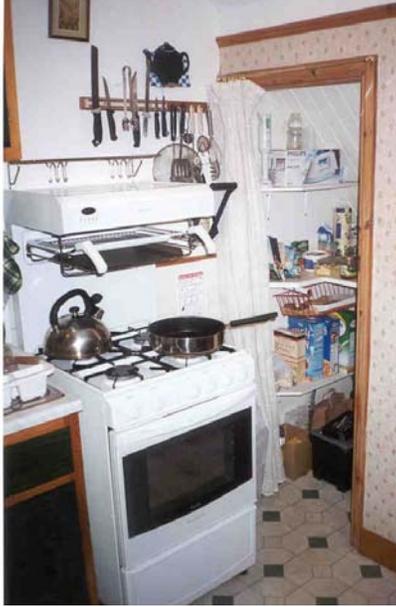
A) Cooker position

**Justification** Although the cooker is away from the main thorough fare between the kitchen and living room, there is likely to be a need to enter the food cupboard to retrieve ingredients during the process of cooking. Although the risk is generally apparent, the need to squeeze past the cooker to get to the food cupboard is bound to increase significantly the risk of an accident occurring. The lack of a worktop at either side of the cooker will also further increase the likelihood slightly.

**Justification** This hazard could be largely eliminated by resiting the door to the larder next to the living room door. However, if possible, a better solution would be to resite the cooker in the kitchen, such that that there is a worktop either side of the appliance. This would reduce the likelihood and spread of outcomes for this hazard to near the average for the stock and reduce the rating to Band G-.

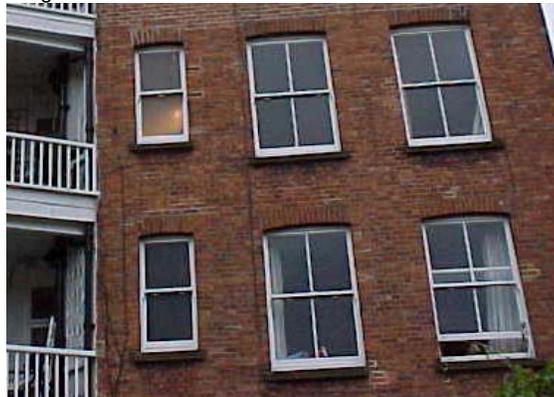
Original sash windows

The threadbare condition of the sash cords, particularly those of the most frequently opened lower frames, suggests that the remaining cords and particularly that on the sash where there is already a broken cord, could break during the following 12 months. As this is most likely to snap while the window is being opened or closed, the likelihood of harm is increased.

The major proportion of collision and entrapment accidents involve trapping limbs or fingers in doors and casement windows. The vertical motion of this sash window and heavy weight due to the large panes of glass and the fact that the latter could shatter if the frame slipped down without the retention of the counter weights, increase the possibility of the health outcomes being more severe than average.

Replacing all the sash cords with new sash cord and adjusting and balancing the sash weights would reduce the likelihood towards the average for this hazard. However, other work is advisable to reduce the risk of falls between levels, such as safety catches, guards, or raising the window sills, and perhaps the installation of safety glass.

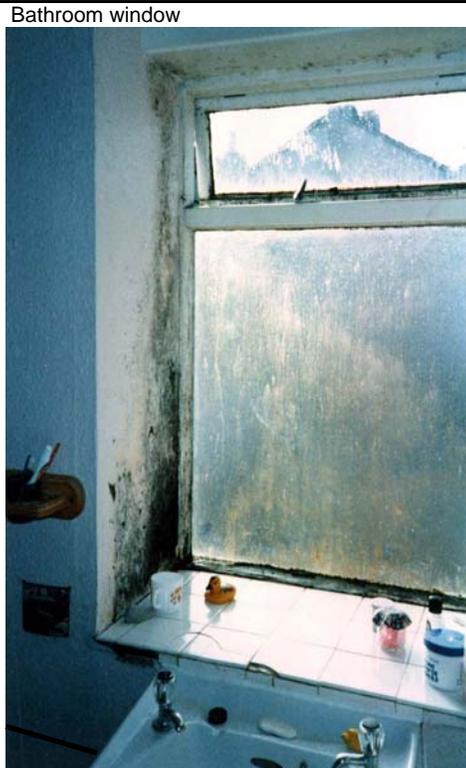
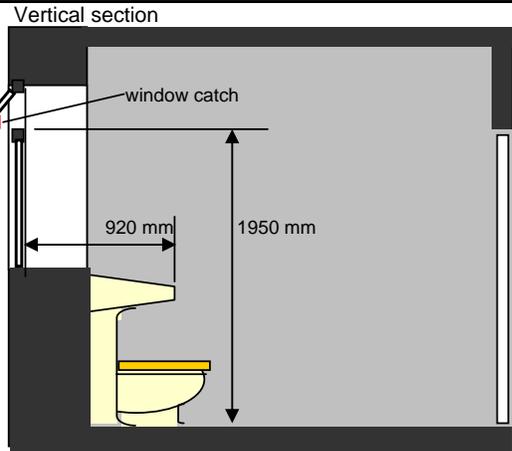
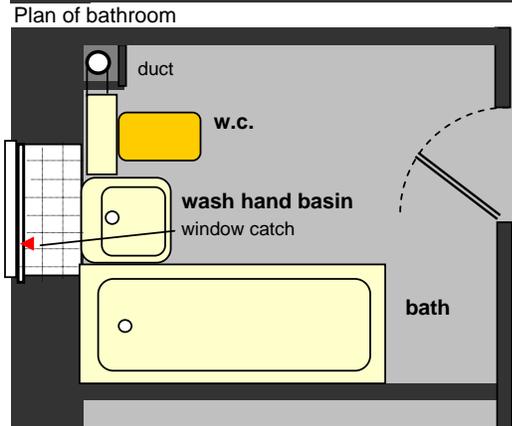
The catch to the top opening light is positioned just under 2 metres above the bathroom floor. This height would be just acceptable, except that to reach the catch in this case also entails stretching over both the full sized wash hand basin and the deep window sill, this being a total horizontal distance of some 920 mm. Without standing on or in the bath, this makes the window catch very awkward to reach and the full opening of the top-hung window virtually impossible for anyone of average height or below.

Although the likelihood is higher than average, the spread of harms is not changed. In terms of poor ergonomics, therefore, the overall risk would be relatively low, the rating score being 52 or Band G-. In practice, a greater risk from this deficiency is likely to arise from the window being consequently left unopened, not just because of its inaccessibility but for reasons of security. This is likely to lead to a further increases in condensation and mould growth.

Resiting the wash hand basin on the internal wall, on the opposite side of the soil pipe and duct, would allow easier access to the window. However, ideally the window should also be replaced with one having a larger opening light and lower catch or, alternatively, to improve security, mechanical ventilation should be installed. This would reduce the HHSRS score to average.

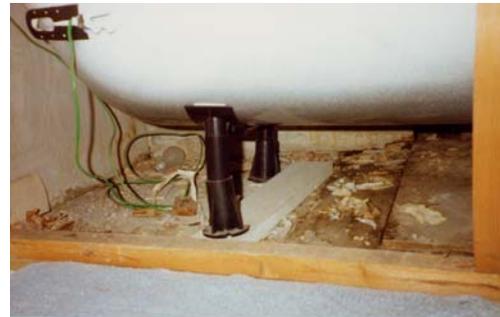
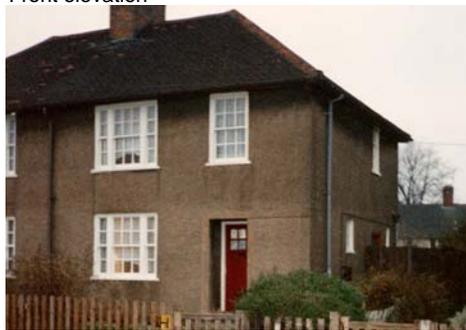
A) Floor below bath

**A) Floor below bath:** The bathroom is on the first floor at the rear of the house above the kitchen. Wet rot in the floor below the bath has caused the boards to rot and some of the end of the floor joists to lose their bearing. The edge of the bath adjacent to the external wall has already dropped by up to 3 cm, resulting in cracks and bulging to the kitchen ceiling below. Immediately below the bath are the kitchen units, which include an electric cooker.
