PASS TRAINING - DINE & LEARN

How to Inspect a Unit – Part 2

UNIT INSPECTION PART II

DEFICIENCY DEFINITIONS

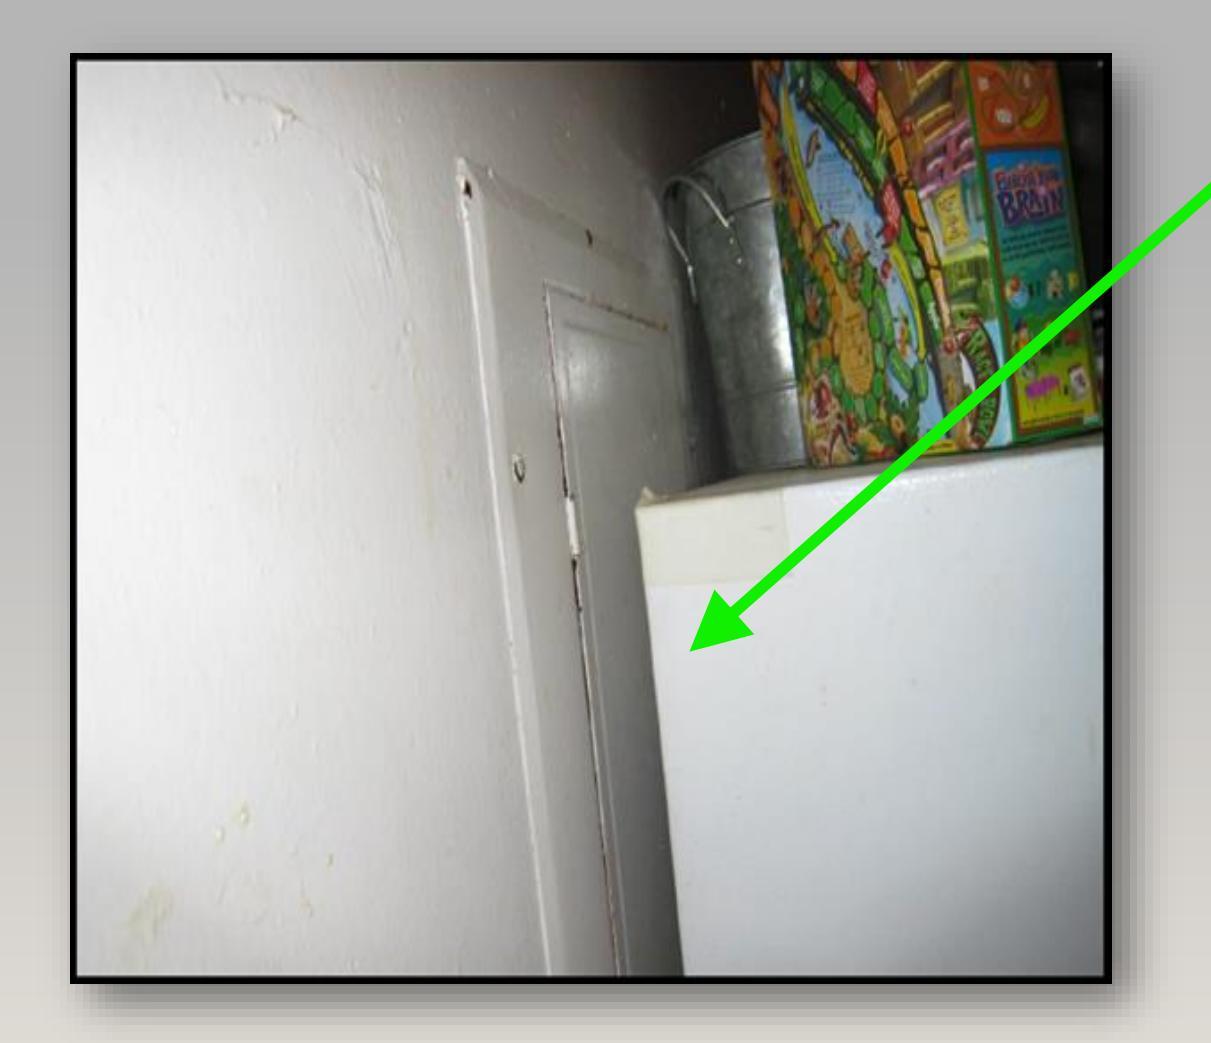
BLOCKED ACCESS TO ELECTRIC PANEL PHOTOS

Deficiency: A fixed obstruction or item of sufficient size and weight can delay or prevent access to any panel board switch in an emergency.

Level 1: N/A Level 2: N/A Level 3: One or more fixed item(s) of sufficient size and weight can impede access to the unit's electrical panel during an emergency.

Blocked Electrical Panel, not readily accessible

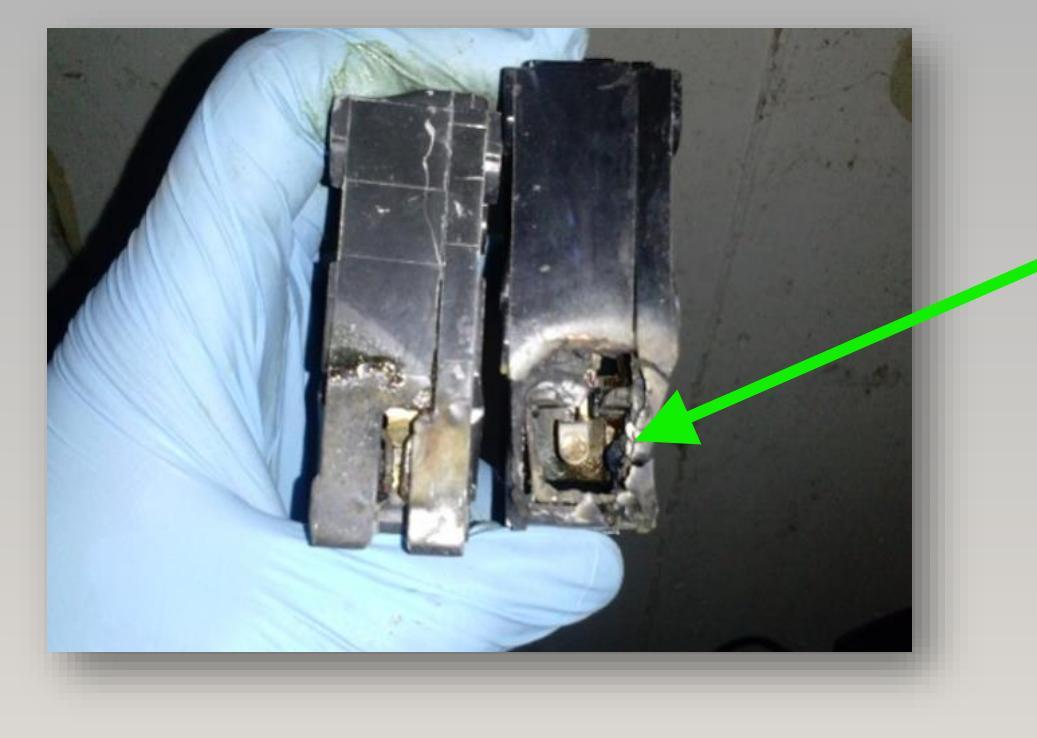
BURNT BREAKERS PHOTOS

Deficiency: Breakers have carbon on the plastic body, or the plastic body is melted and scarred.

Level 1: N/A Level 2: N/A Level 3: You see any carbon residue, melted breakers, or arcing scars.

Burnt Breaker in Electrical Panel

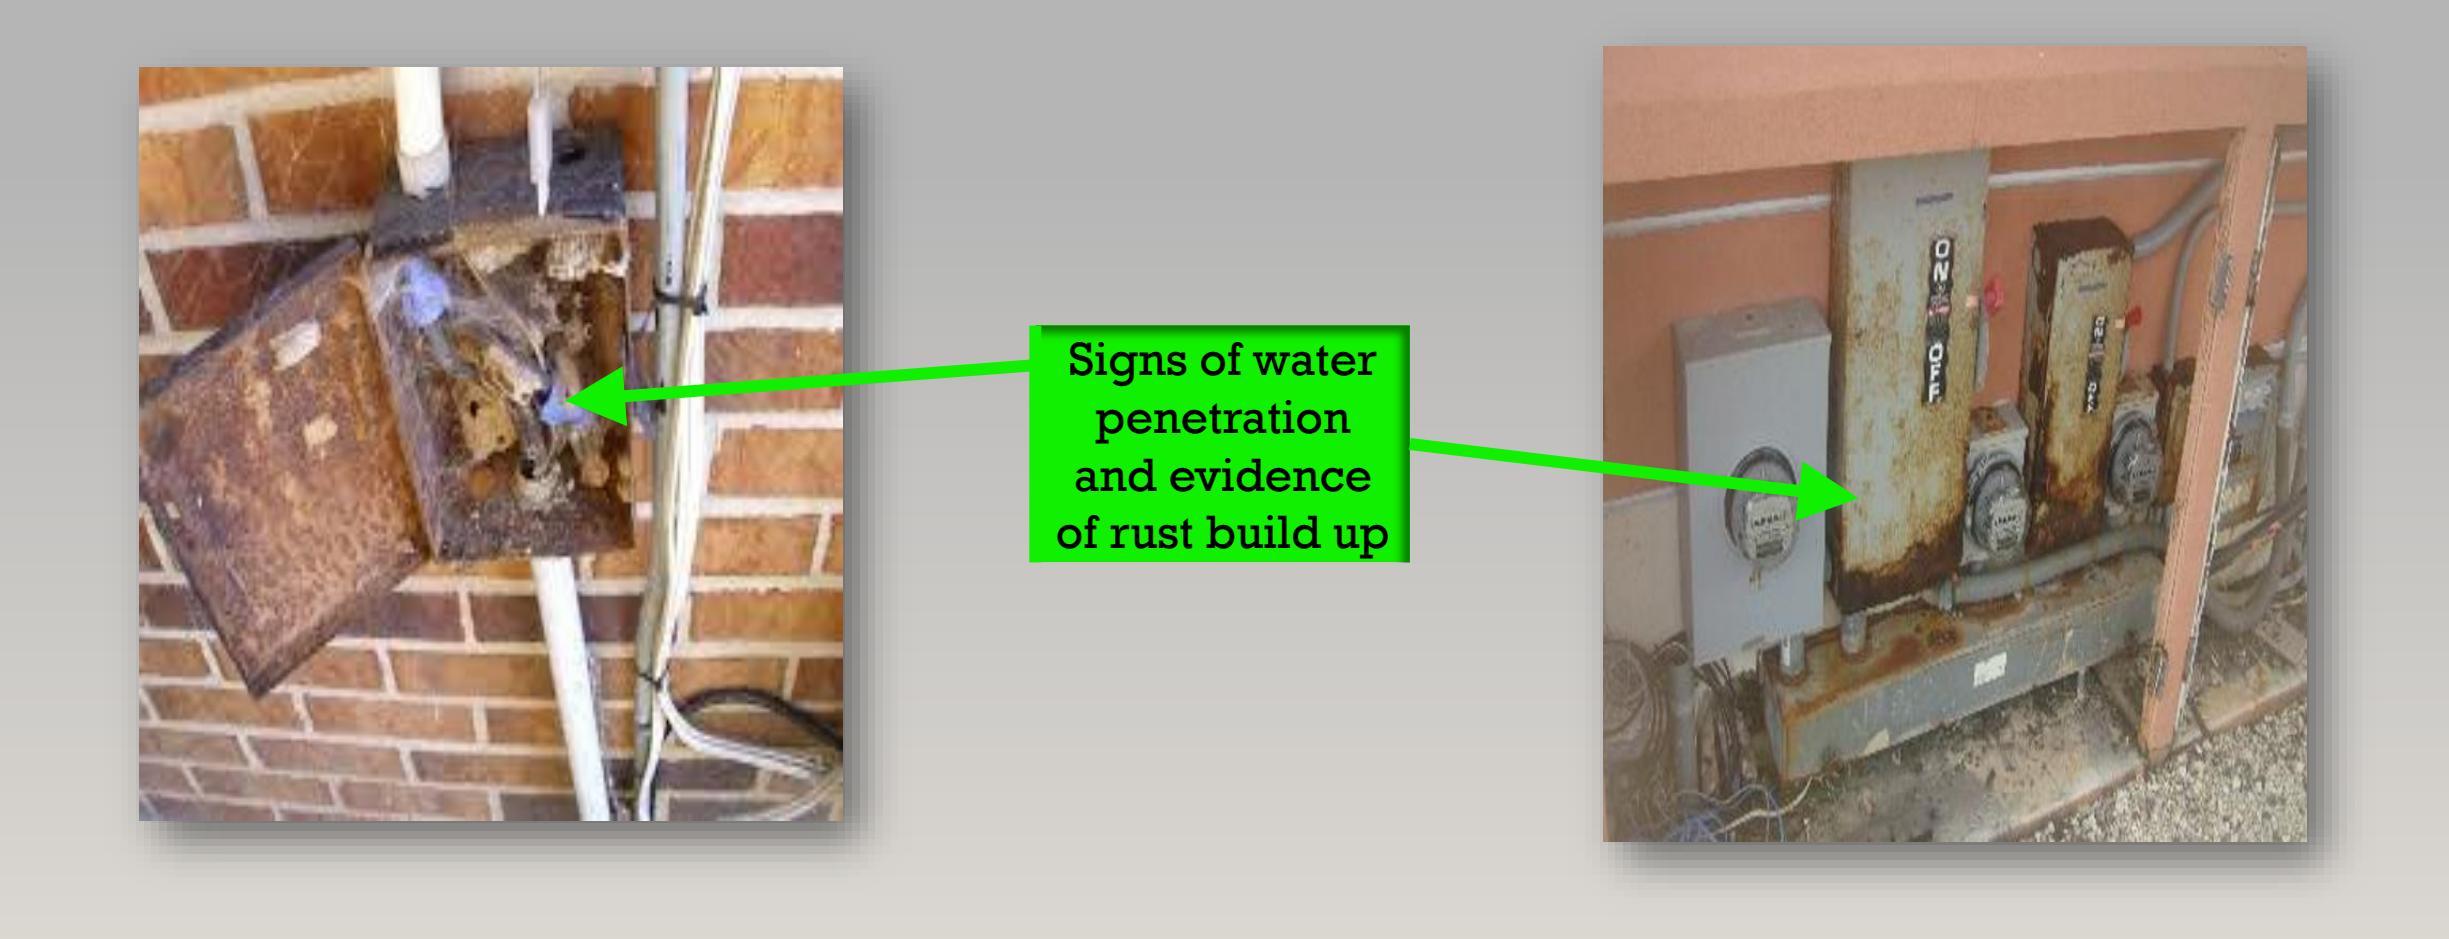
EVIDENCE OF LEAKS CORROSION PHOTOS

Deficiency: You see liquid stains, rust marks, or other signs of corrosion on electrical enclosures or hardware.

Level 3: Any corrosion that affects the condition of the components that carry electrical current.

-OR Any stains or rust on the interior of electrical enclosures.

-OR Any evidence of water leaks in the enclosure or hardware.

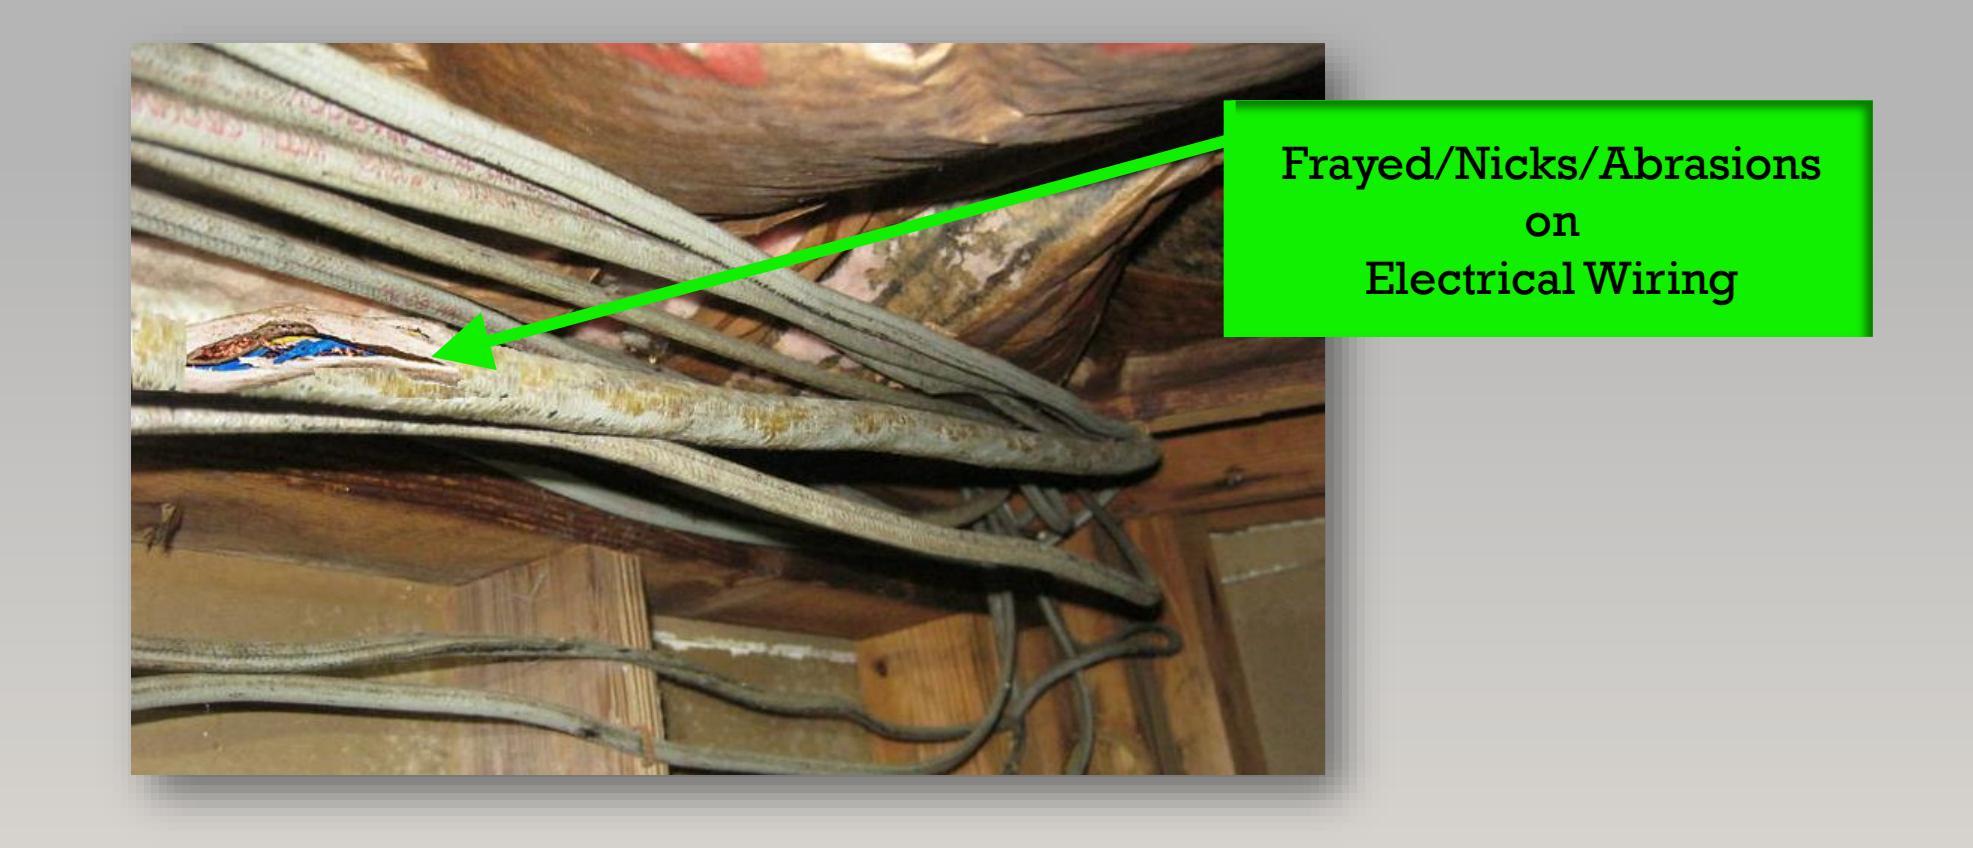
FRAYED WIRING PHOTOS

Deficiency: You see nicks, abrasions, or fraying of the insulation that expose wires that conduct current.

Level 1: N/A Level 2: N/A Level 3: You see any nicks, abrasions, or fraying of the insulation that expose any conducting wire.

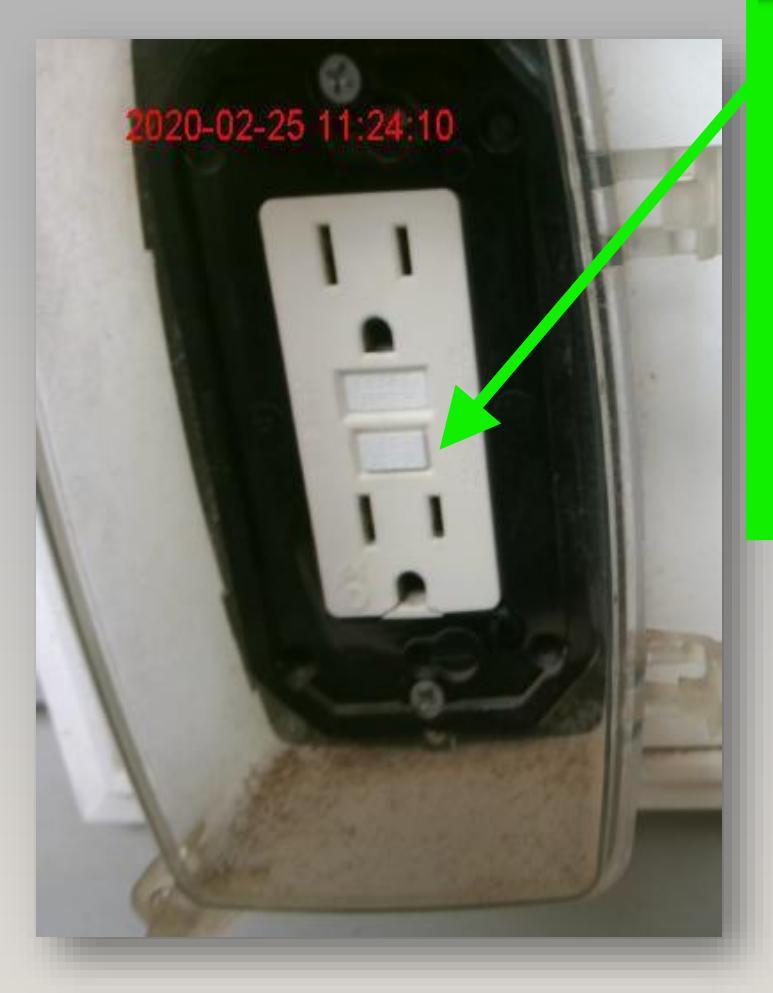
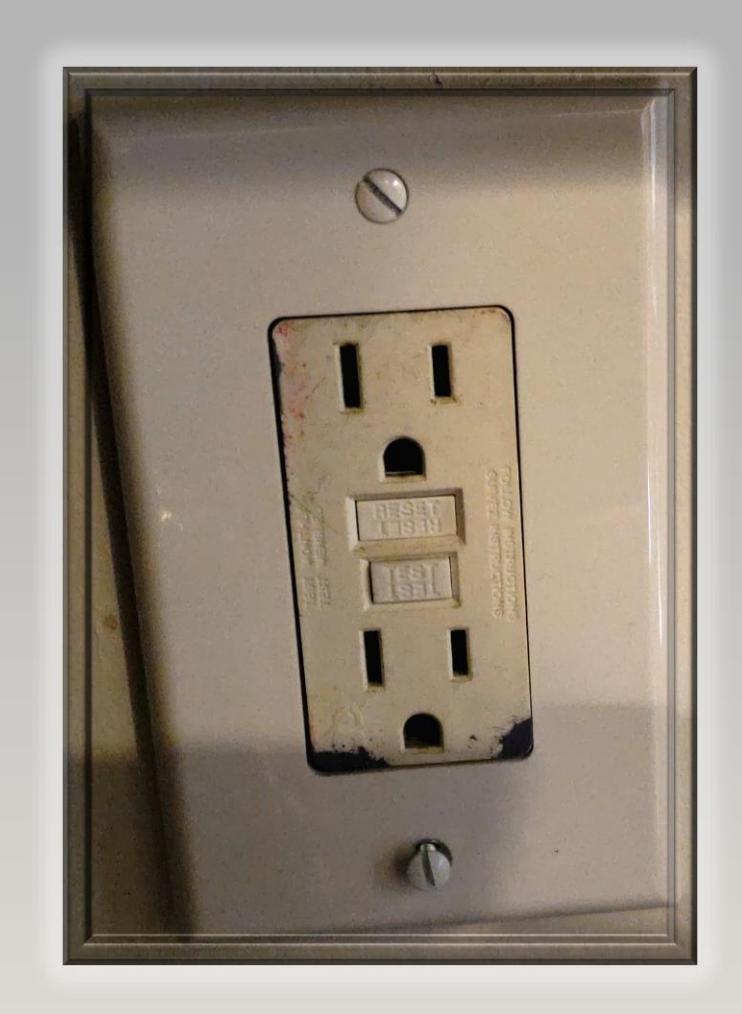
INOPERABLE GFI RECEPTACEL PHOTOS

Deficiency: The GFI does not function.

Note: To determine whether the GFI is functioning, you must press the self-test button in the GFI unit.

If trip button does not reset after testing of GFI outlet, it is inoperable, or trip button will not trip, it is inoperable

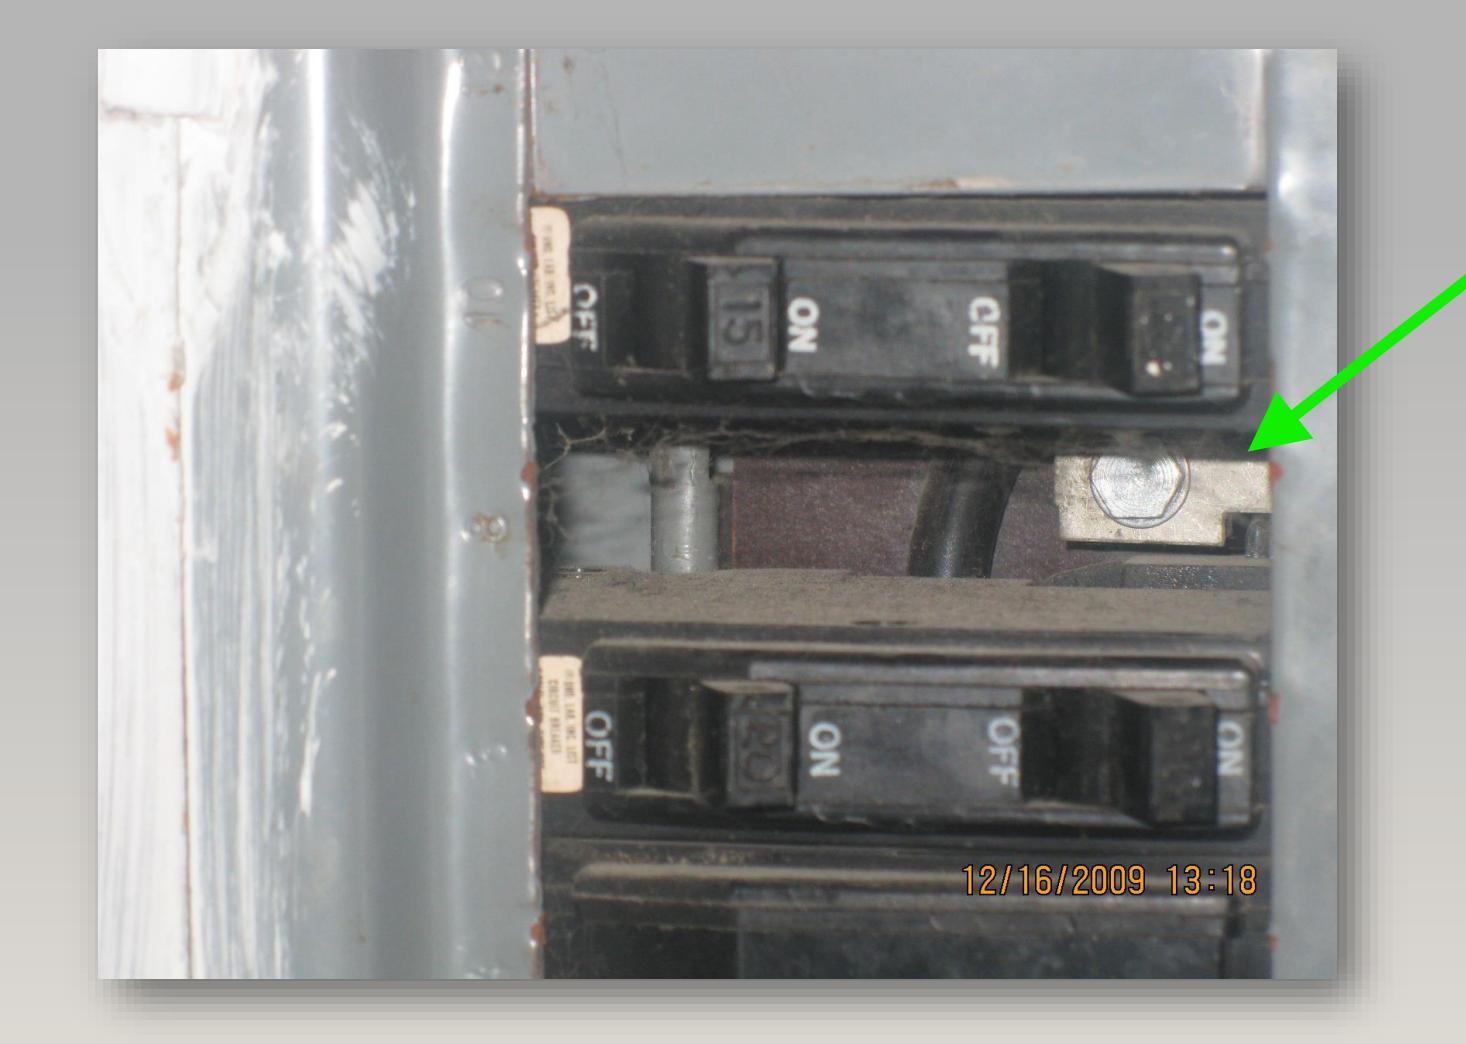
Missing Breakers/Fuses (Electrical System – Unit)

Deficiency: In a panel board, main panel board, or other electrical box that contains circuit breakers/fuses, you see an open circuit breaker position that is not appropriately blanked-off.

Level 1: N/A Level 2: N/A Level 3: You see an open breaker port.

Missing Breaker or Open Port, exposing live electrical connections

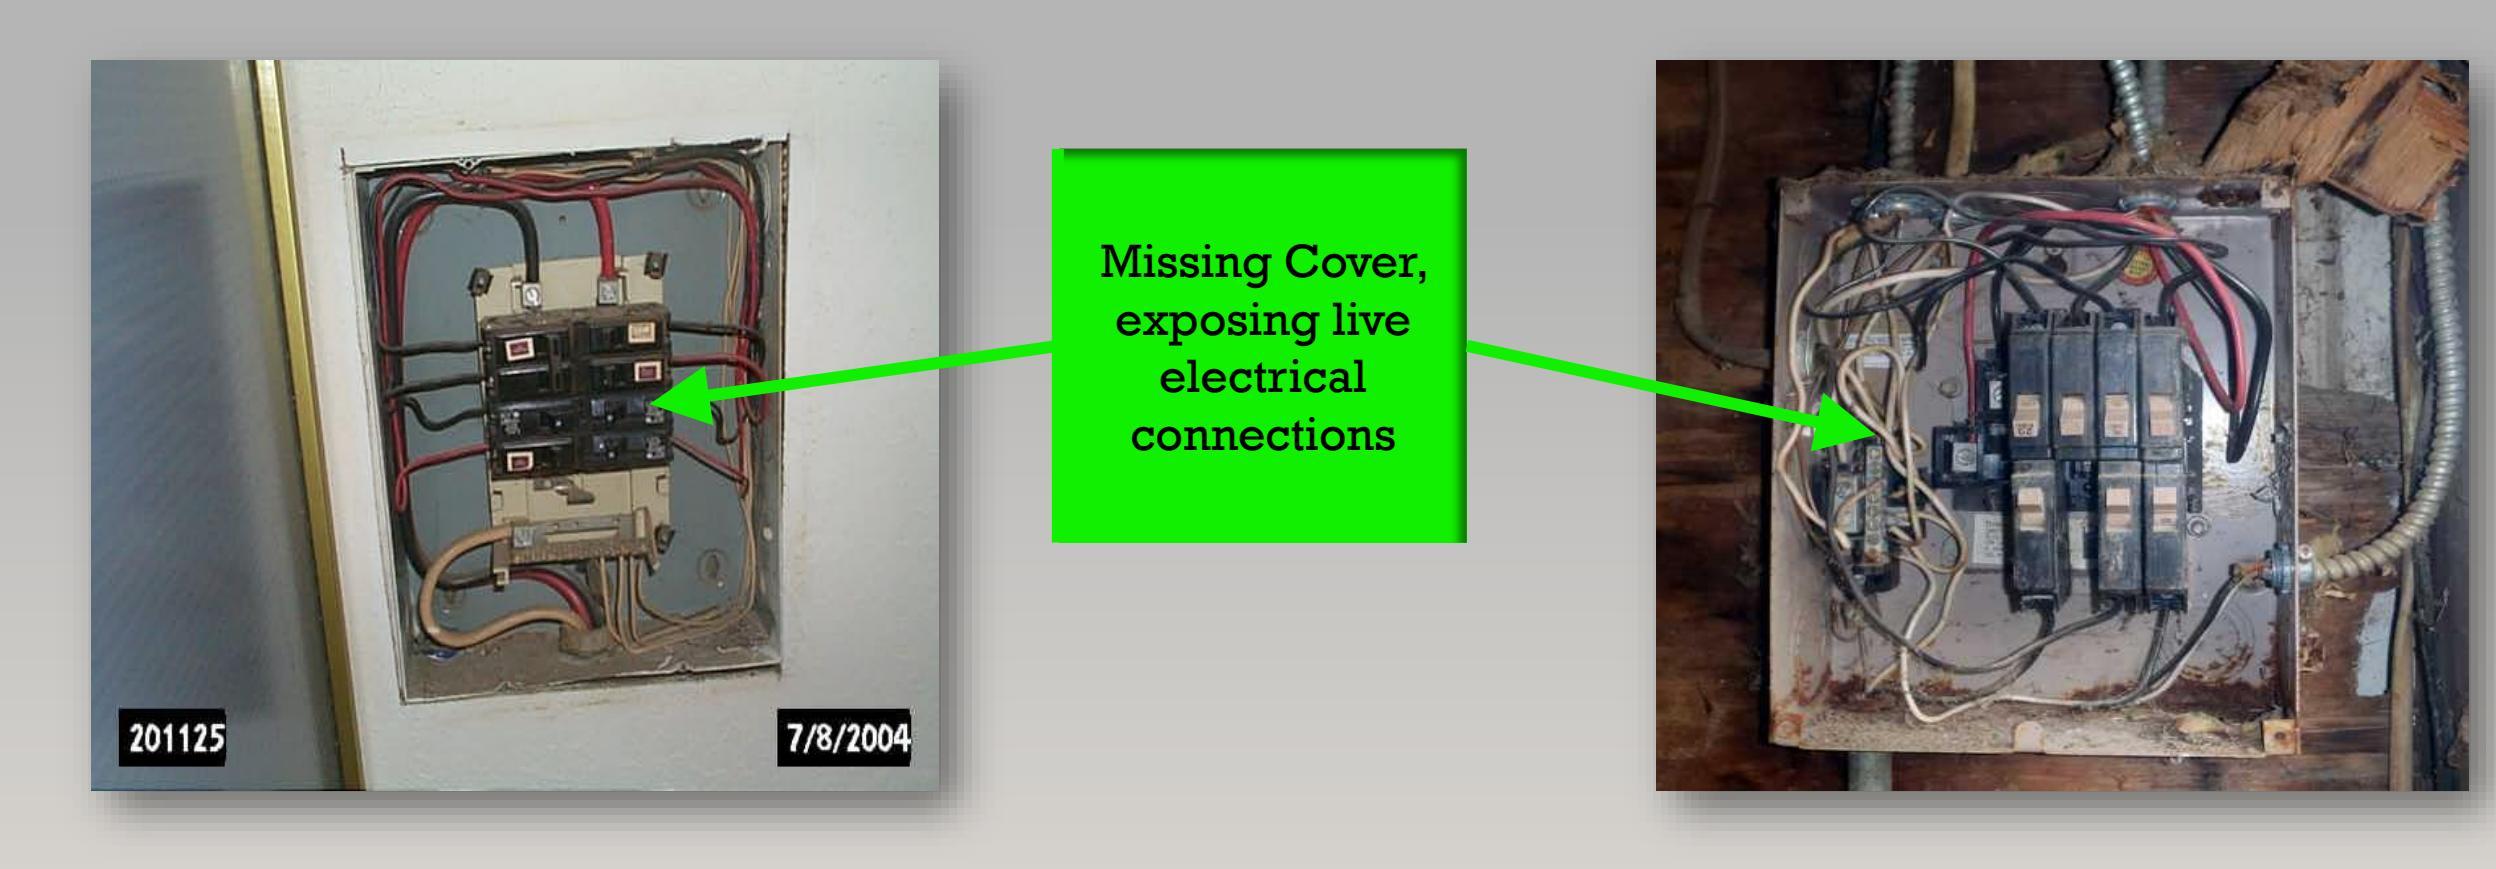
MISSING COVERS PHOTOS

Deficiency: The cover is missing from any electrical device box, panel box, switch gearbox, control panel, etc., with exposed electrical connections.

Level 1: N/A Level 2: N/A Level 3: A cover is missing, and you see exposed electrical connections.

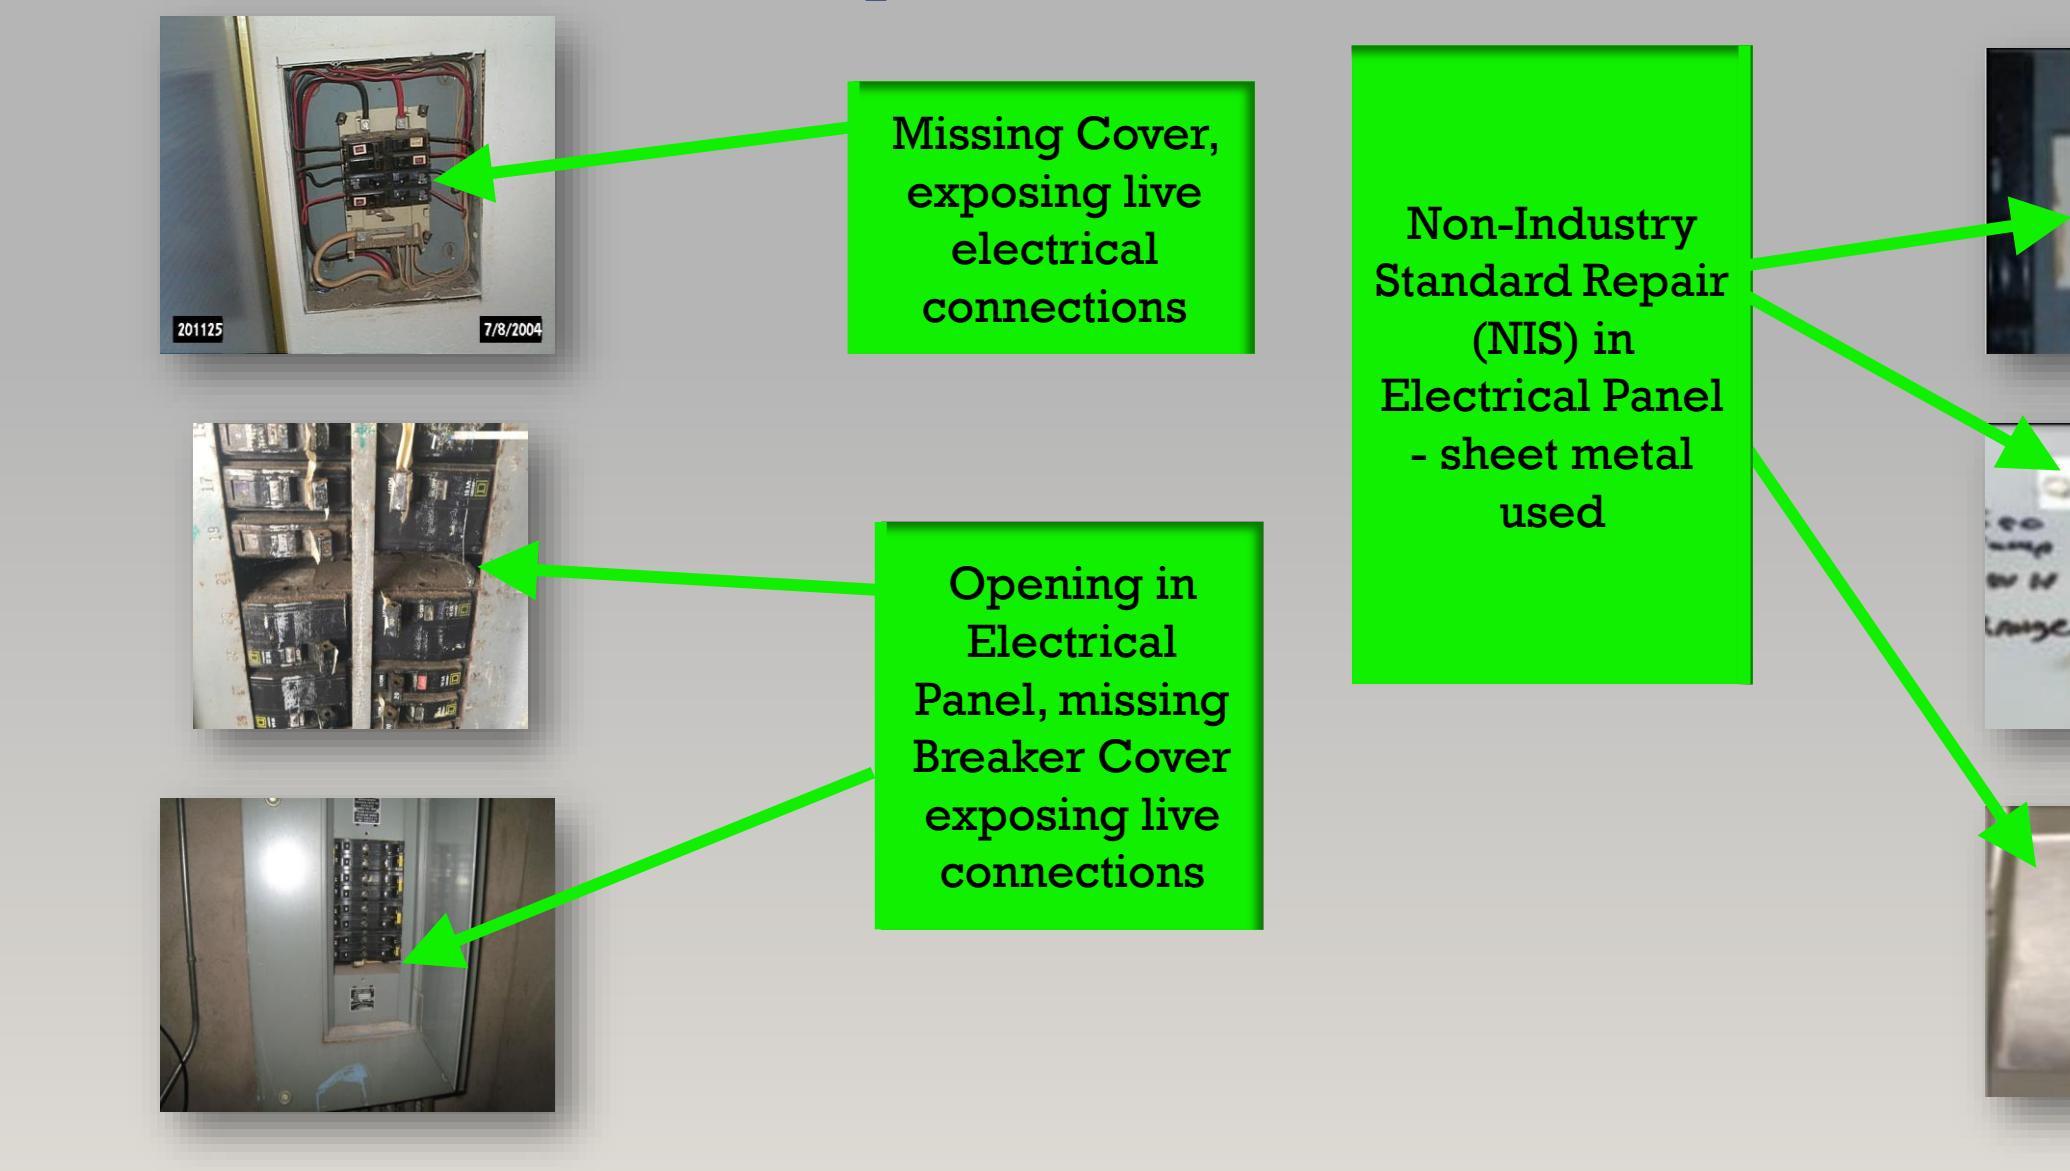
Examples Of Electrical Panel Defects

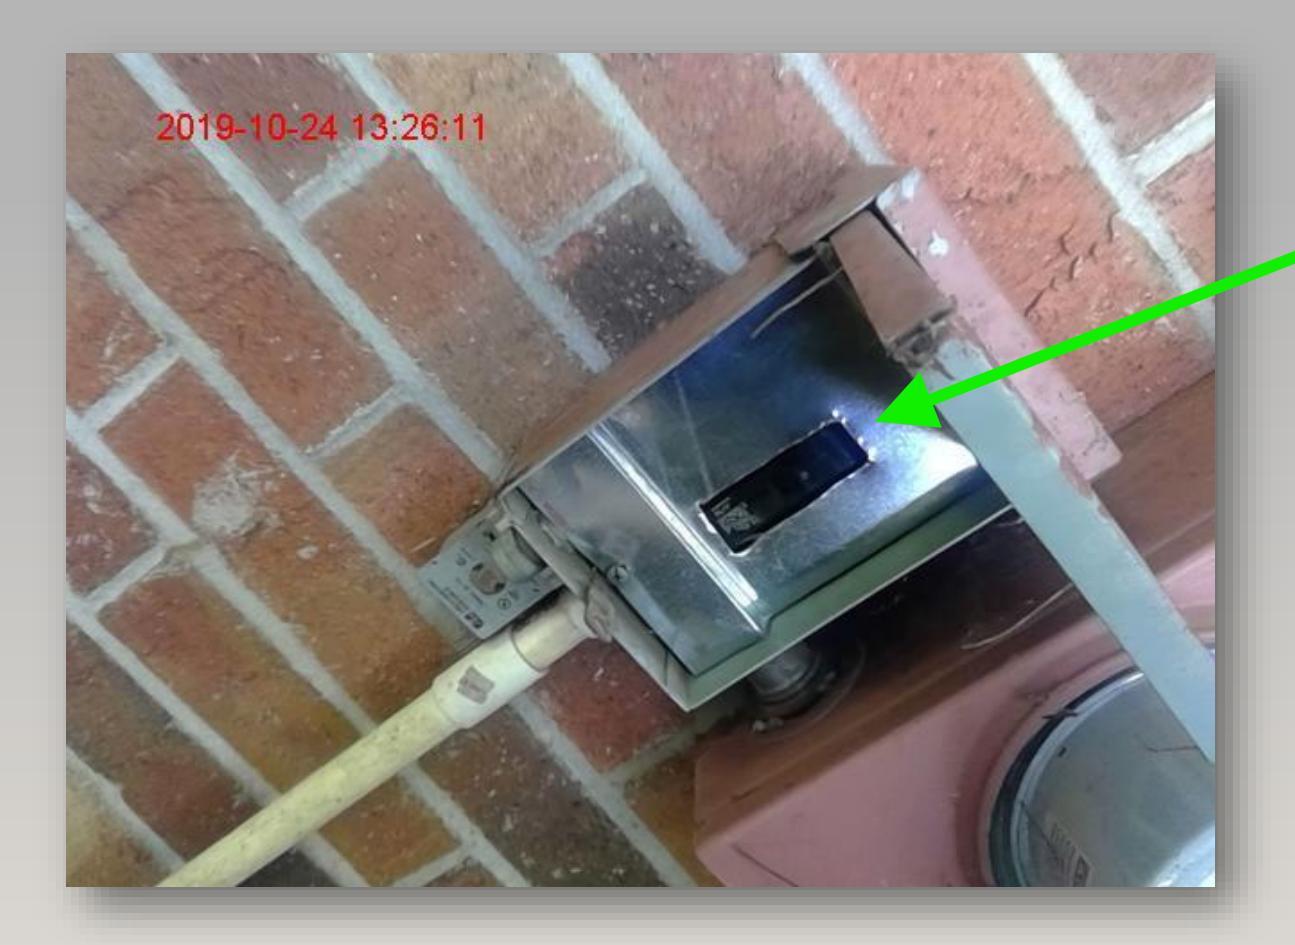
NIS REPAIR PHOTO

NIS Repair - sheet metal prefabricated cover.

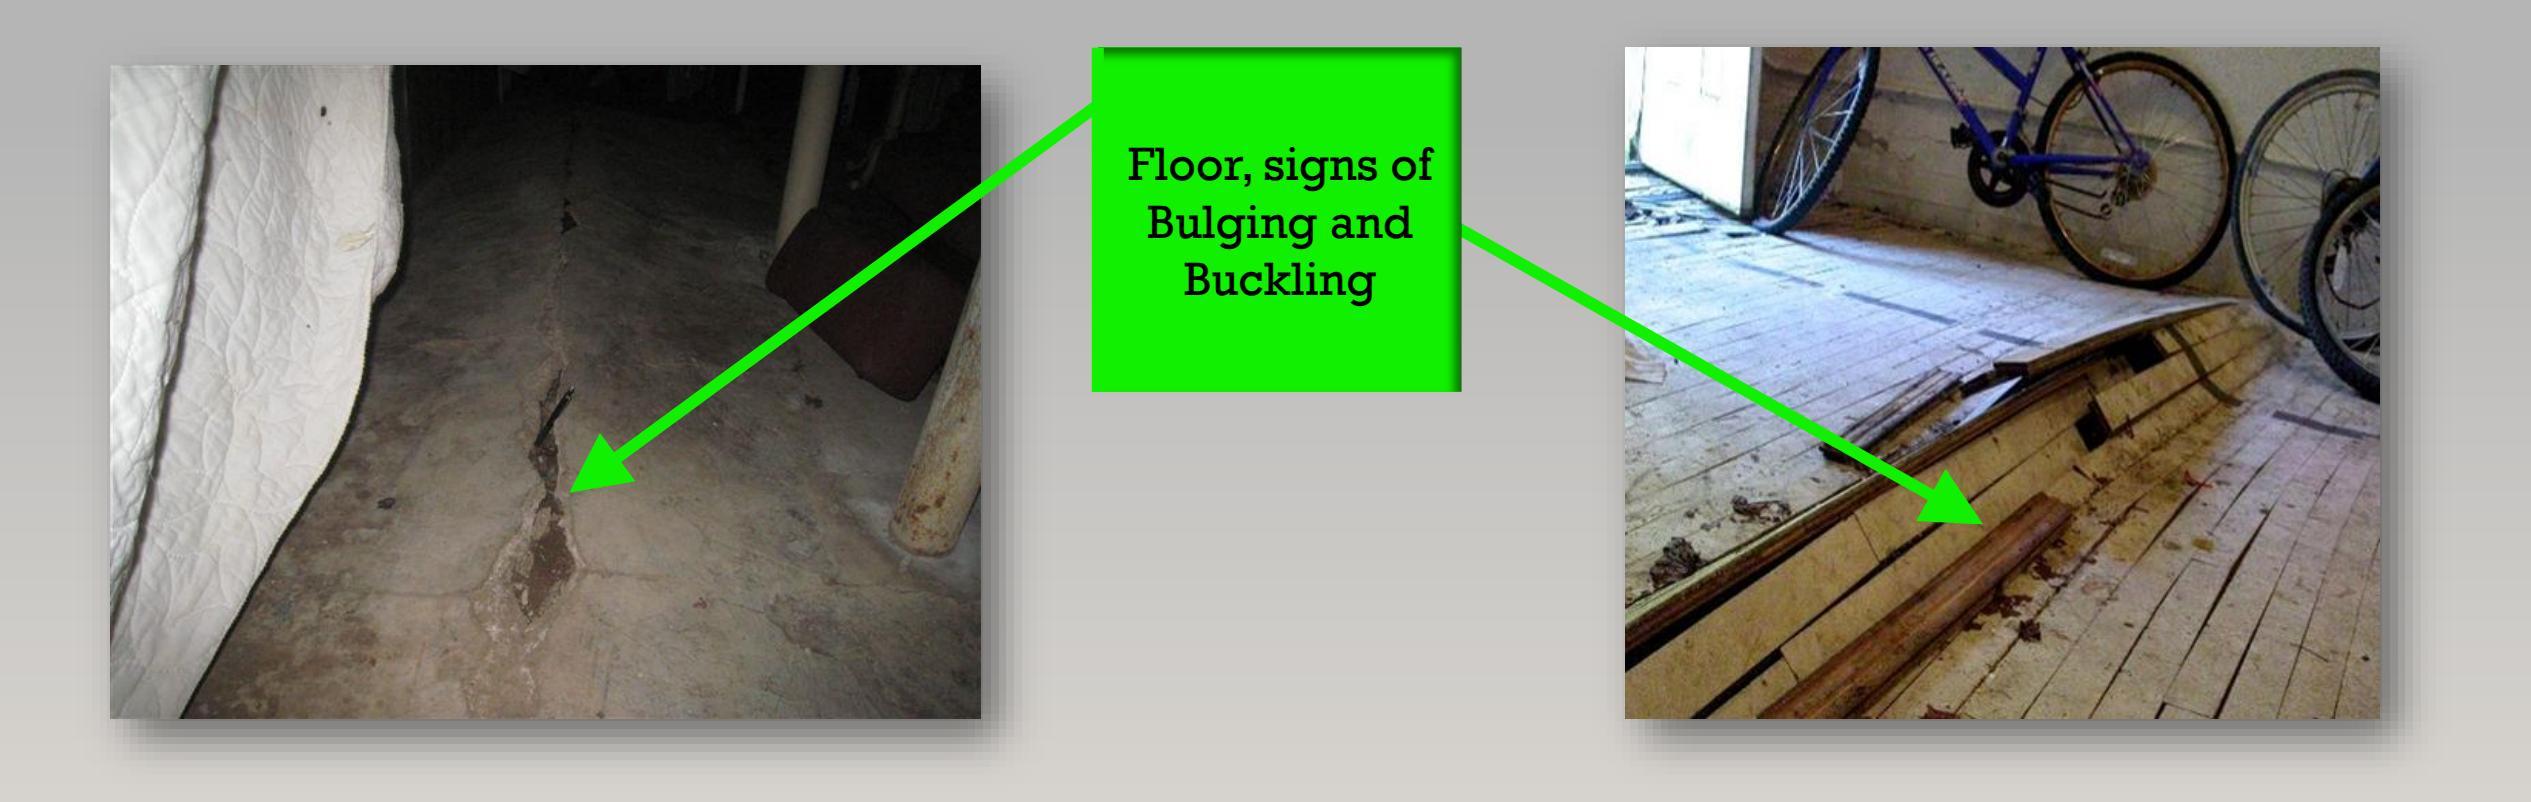
BULGING/BUCKLING (FLOORS – UNIT) PHOTOS

Deficiency: A floor is bowed, deflected, sagging, or is no longer aligned horizontally.

Level 1: N/A Level 2: N/A Level 3: You see bulging, buckling, sagging, or a lack of horizontal alignment.

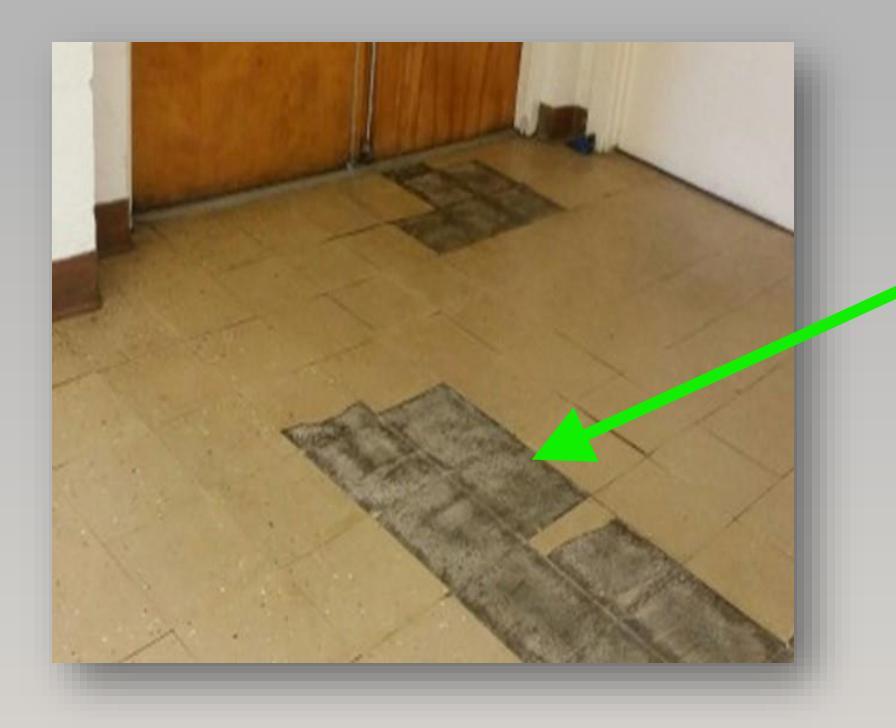
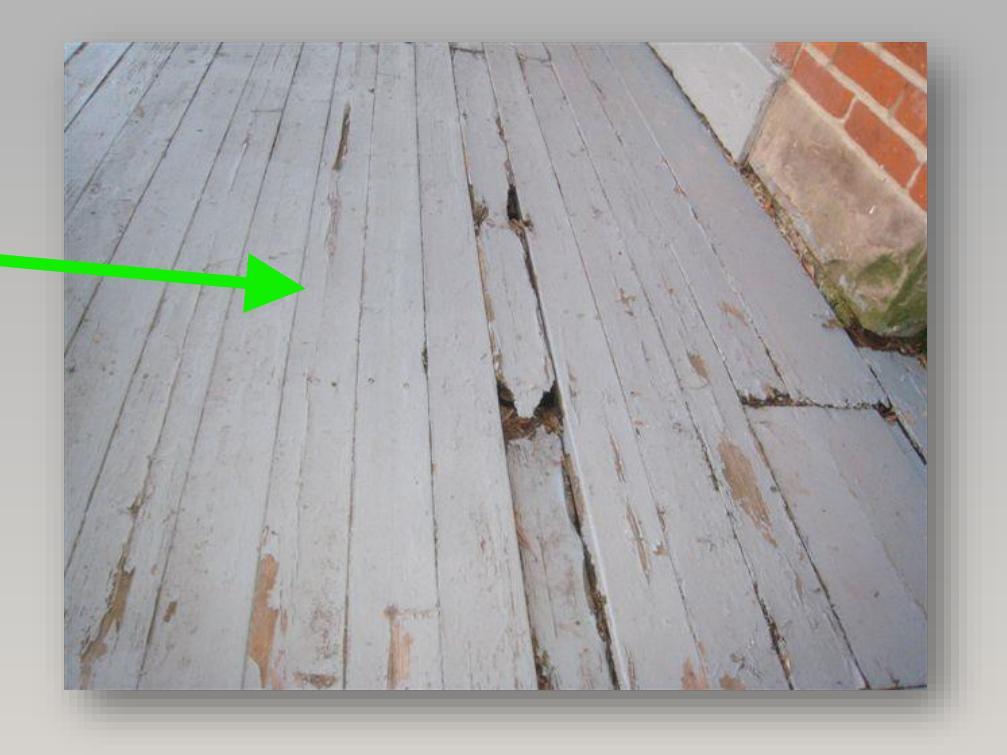
Hard Floor Covering Missing/Damaged Flooring/Tiles (Floors – Unit) Photos

Deficiency: You see that hard flooring, terrazzo, hardwood, ceramic tile, sheet vinyl, vinyl tiles, or other similar flooring material, is missing section(s), or presents a tripping or cutting hazard, associated with but not limited to holes or delamination.

Hardwood floor covering missing and damaged. Left 1s missing tile, right is damaged flooring

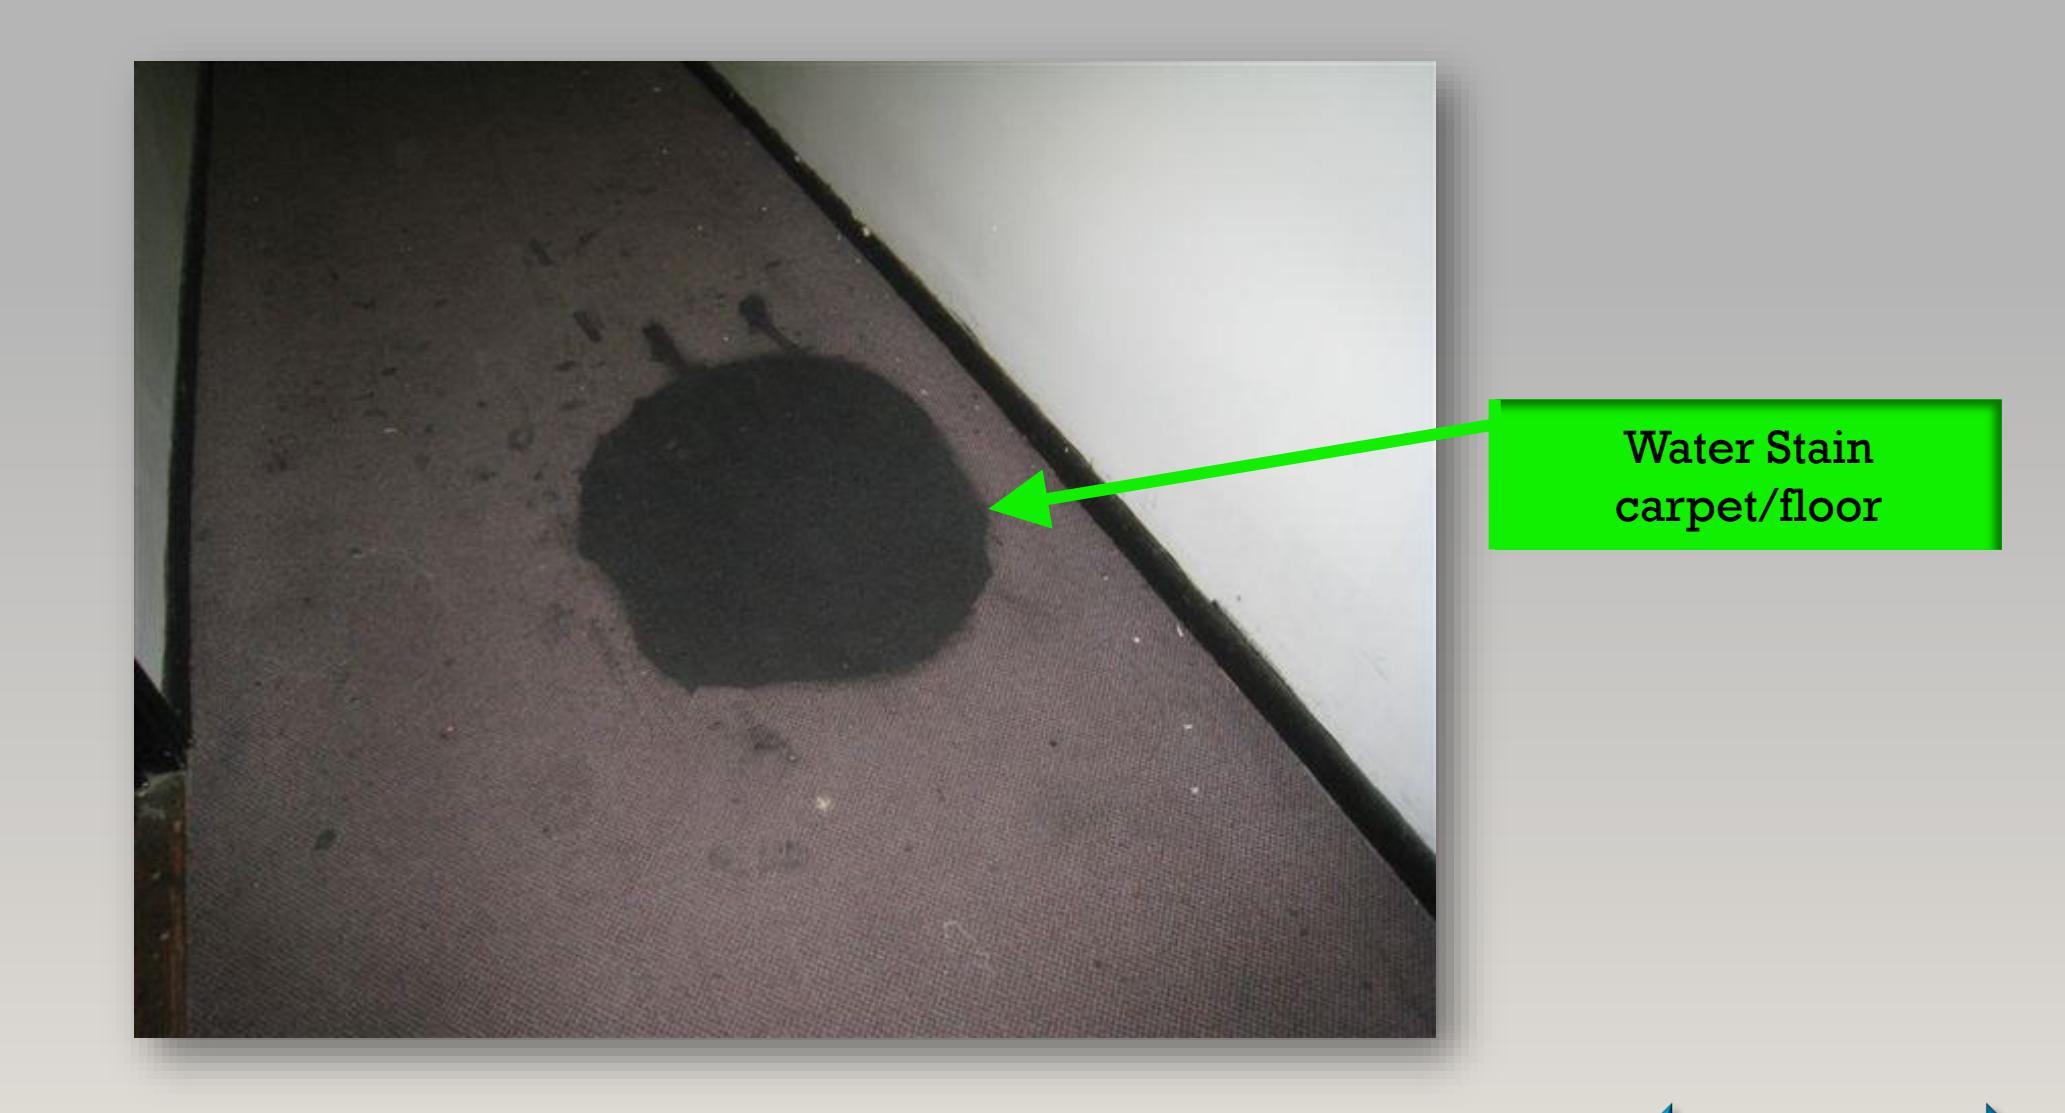
Mold/Mildew/Water Stains/Water Damage (Floors – Unit) Photos

Deficiency: You see mold or mildew that may have been caused by saturation or surface failure or evidence of water infiltration or other moisture producing conditions.

Level 2: On 1 floor, you see evidence of mold, mildew, water stains, or water damage, such as a darkened area, over a large area (4 square inches to 1 square foot). You may or may not see water.

Level 3: On 1 floor, you estimate that a very large area (more than 1 square foot) of its surface has been substantially saturated or damaged by mold, mildew, water stains, or water damage. The floor surface may have failed.
