PASS TRAINING - DINE & LEARN

How to Inspect a Unit – Part 2

UNIT INSPECTION PART II

DEFICIENCY DEFINITIONS

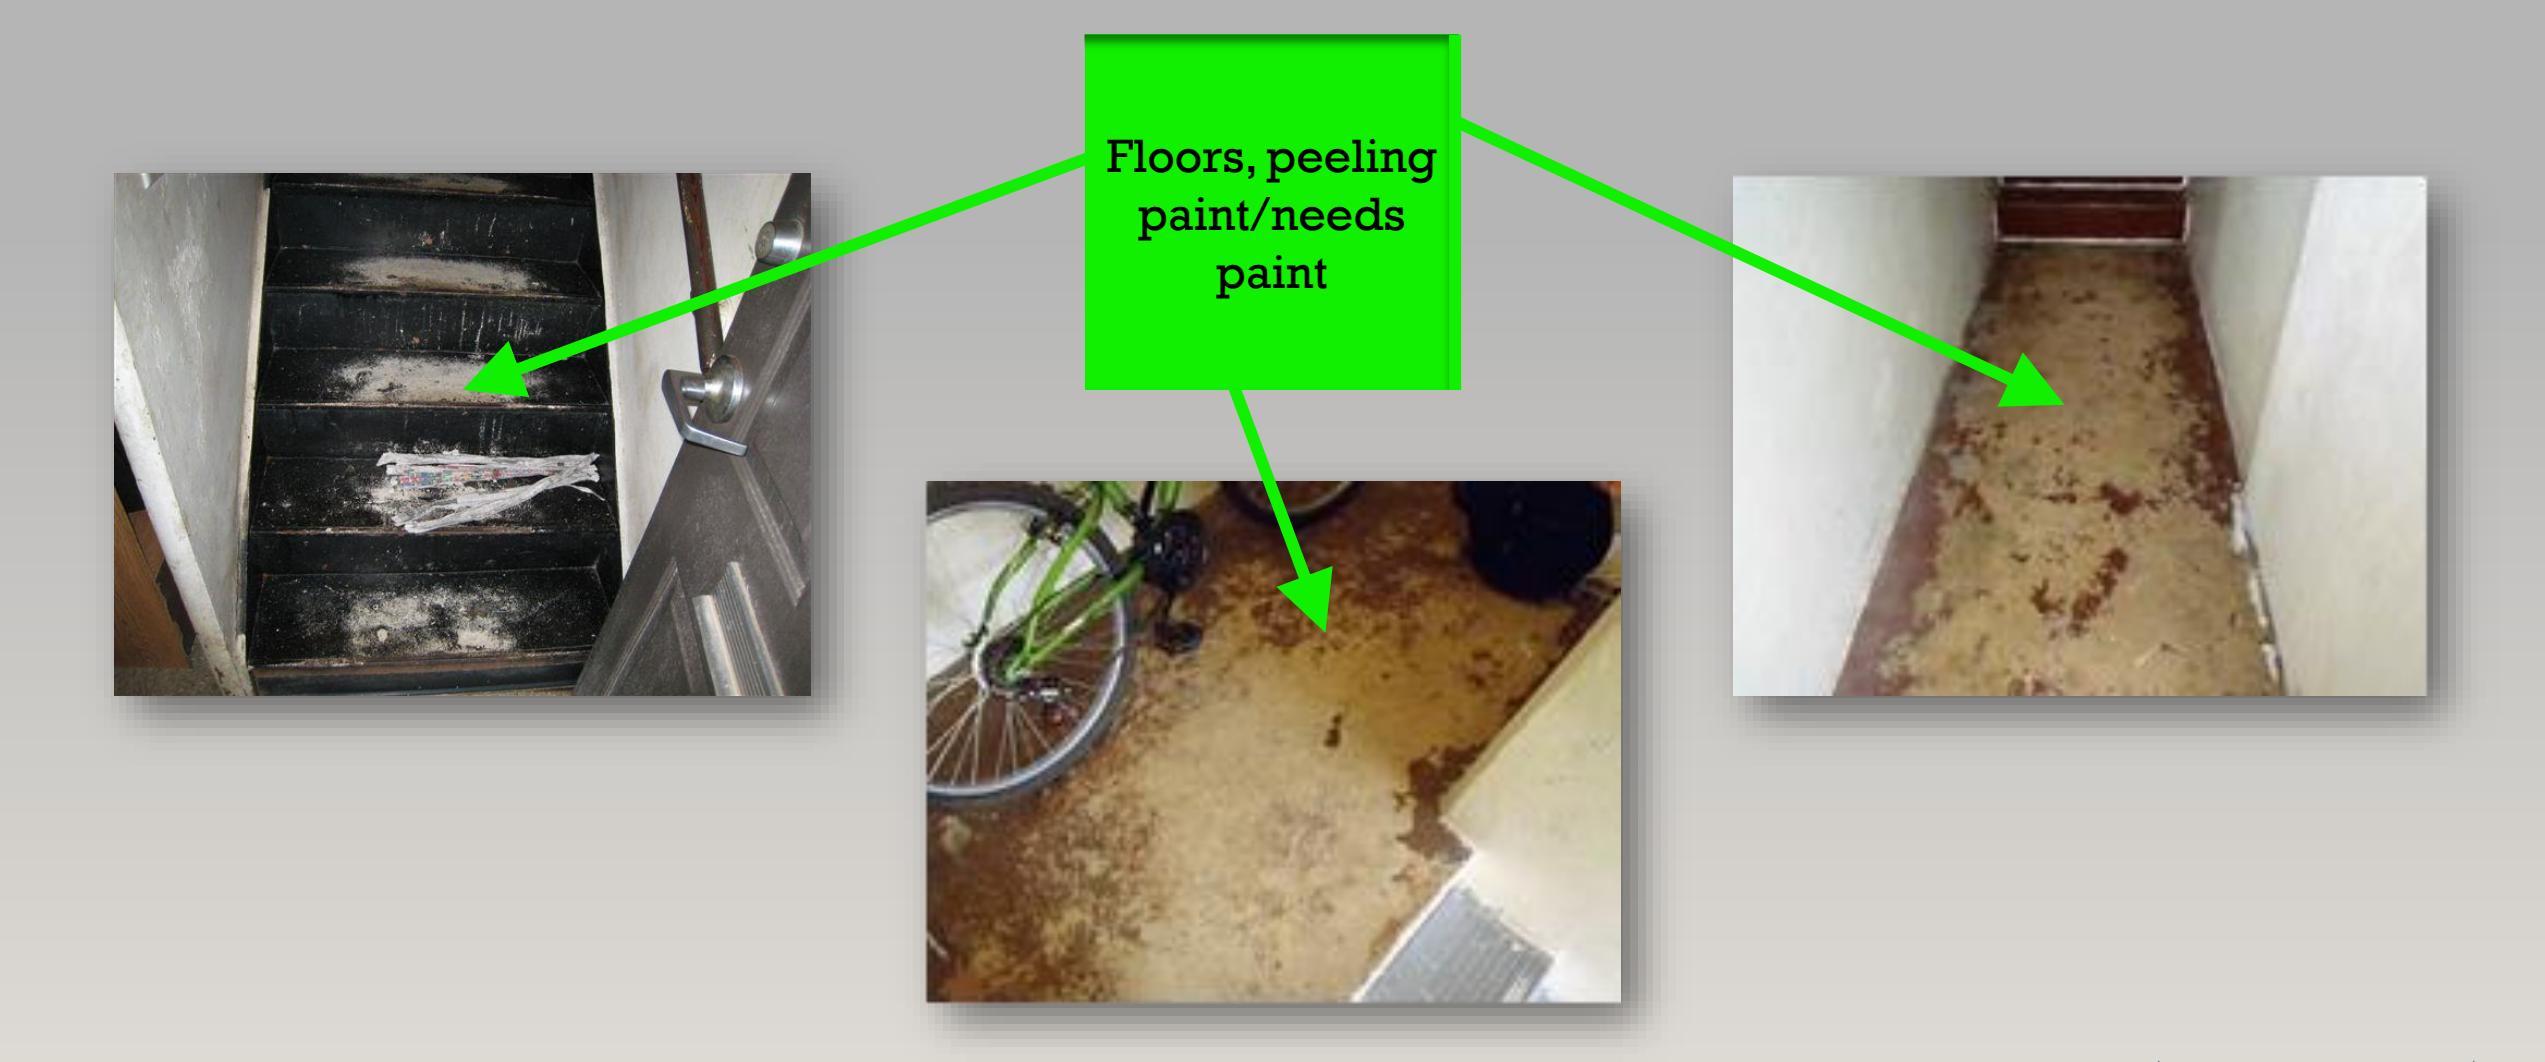
PEELING/NEEDS PAINT (FLOORS – UNIT) PHOTOS

Deficiency: For floors that are painted, you see paint that is peeling, cracking, flaking, or otherwise, deteriorated.

Level 1: The area affected is more than 1 square foot, but less than 4 square feet. Level 2: The area affected is more than 4 square feet. Level 3: N/A

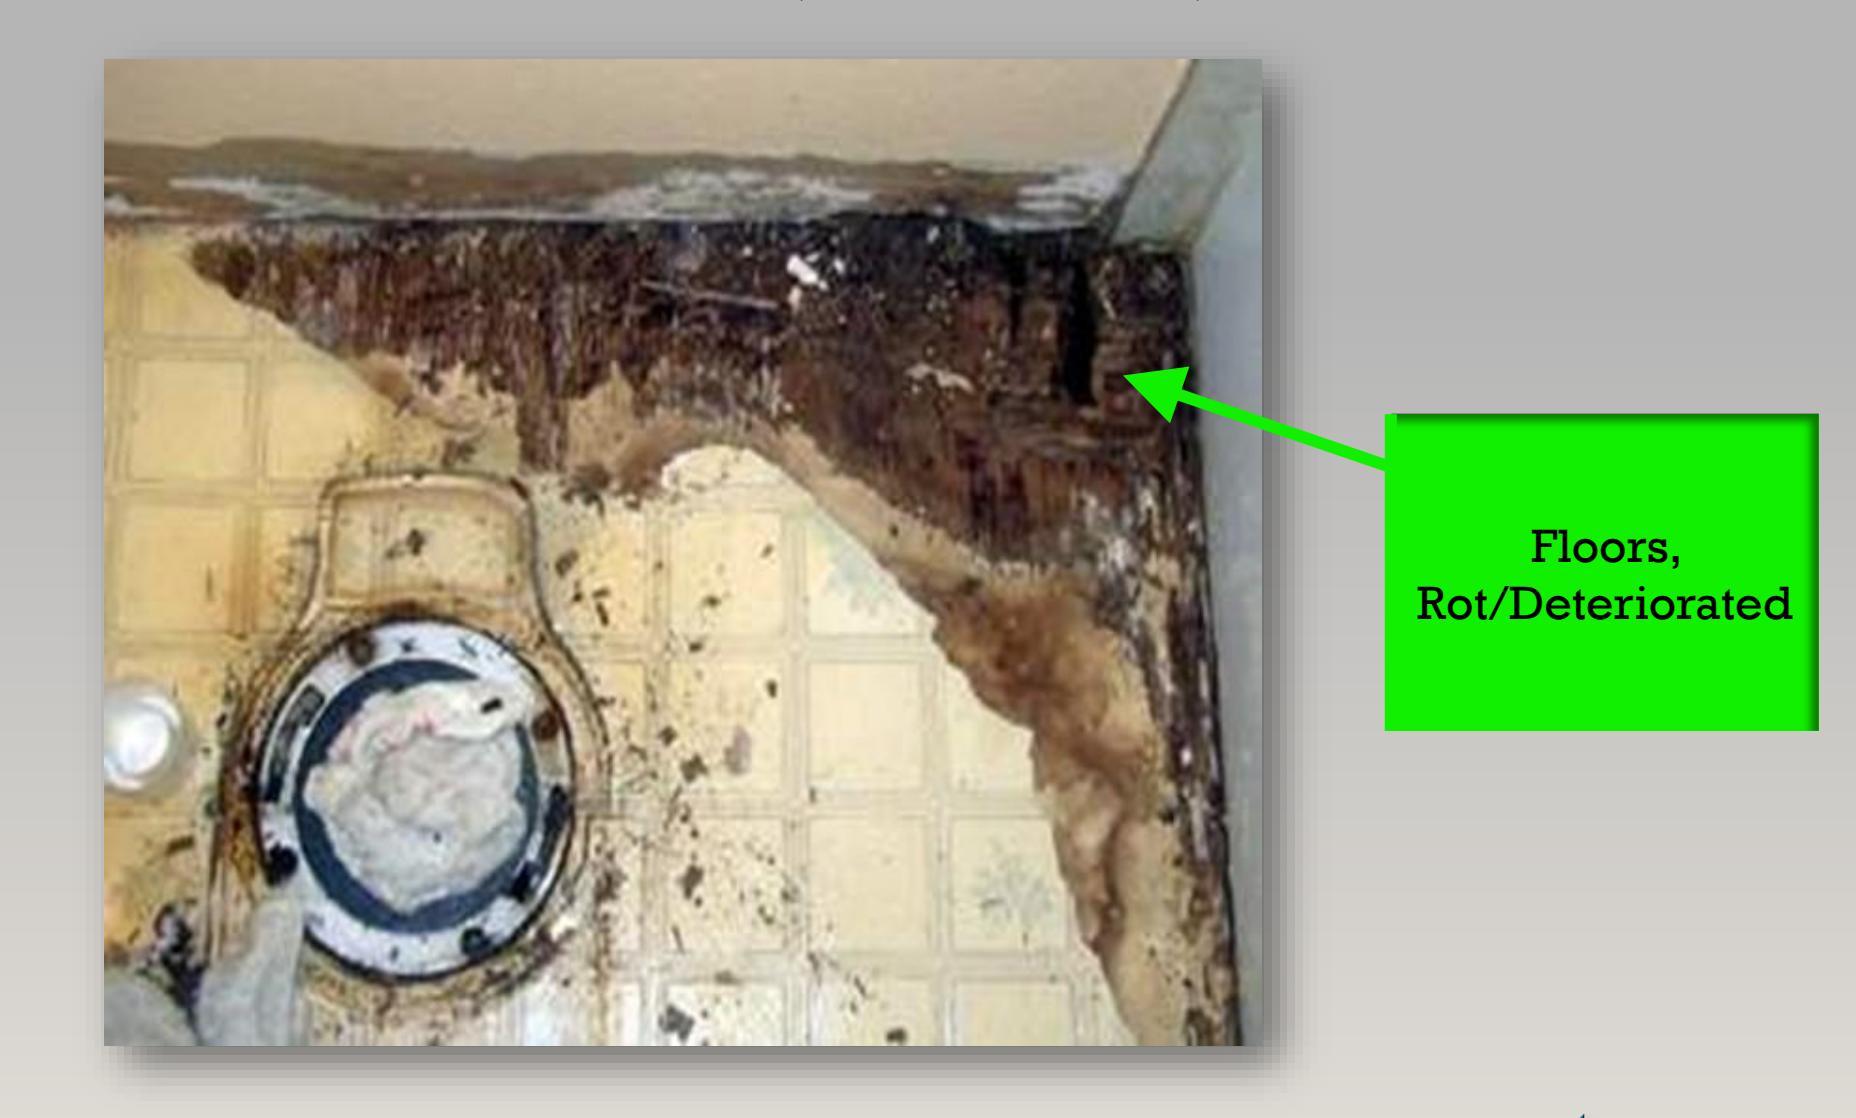
Rot/Deteriorated Subfloor (Floors – Unit) Photos

Deficiency: The subfloor has decayed or is decaying.

Level 2: You see small areas of rot or spongy flooring that is more than 1 square foot, but less than 4 square feet.

Level 3: You see large areas of rot, more than 4 square feet, and applying weight causes noticeable deflection.

If there is any doubt, apply weight to detect noticeable deflection.
 This type of defect typically occurs in kitchens and bathrooms.

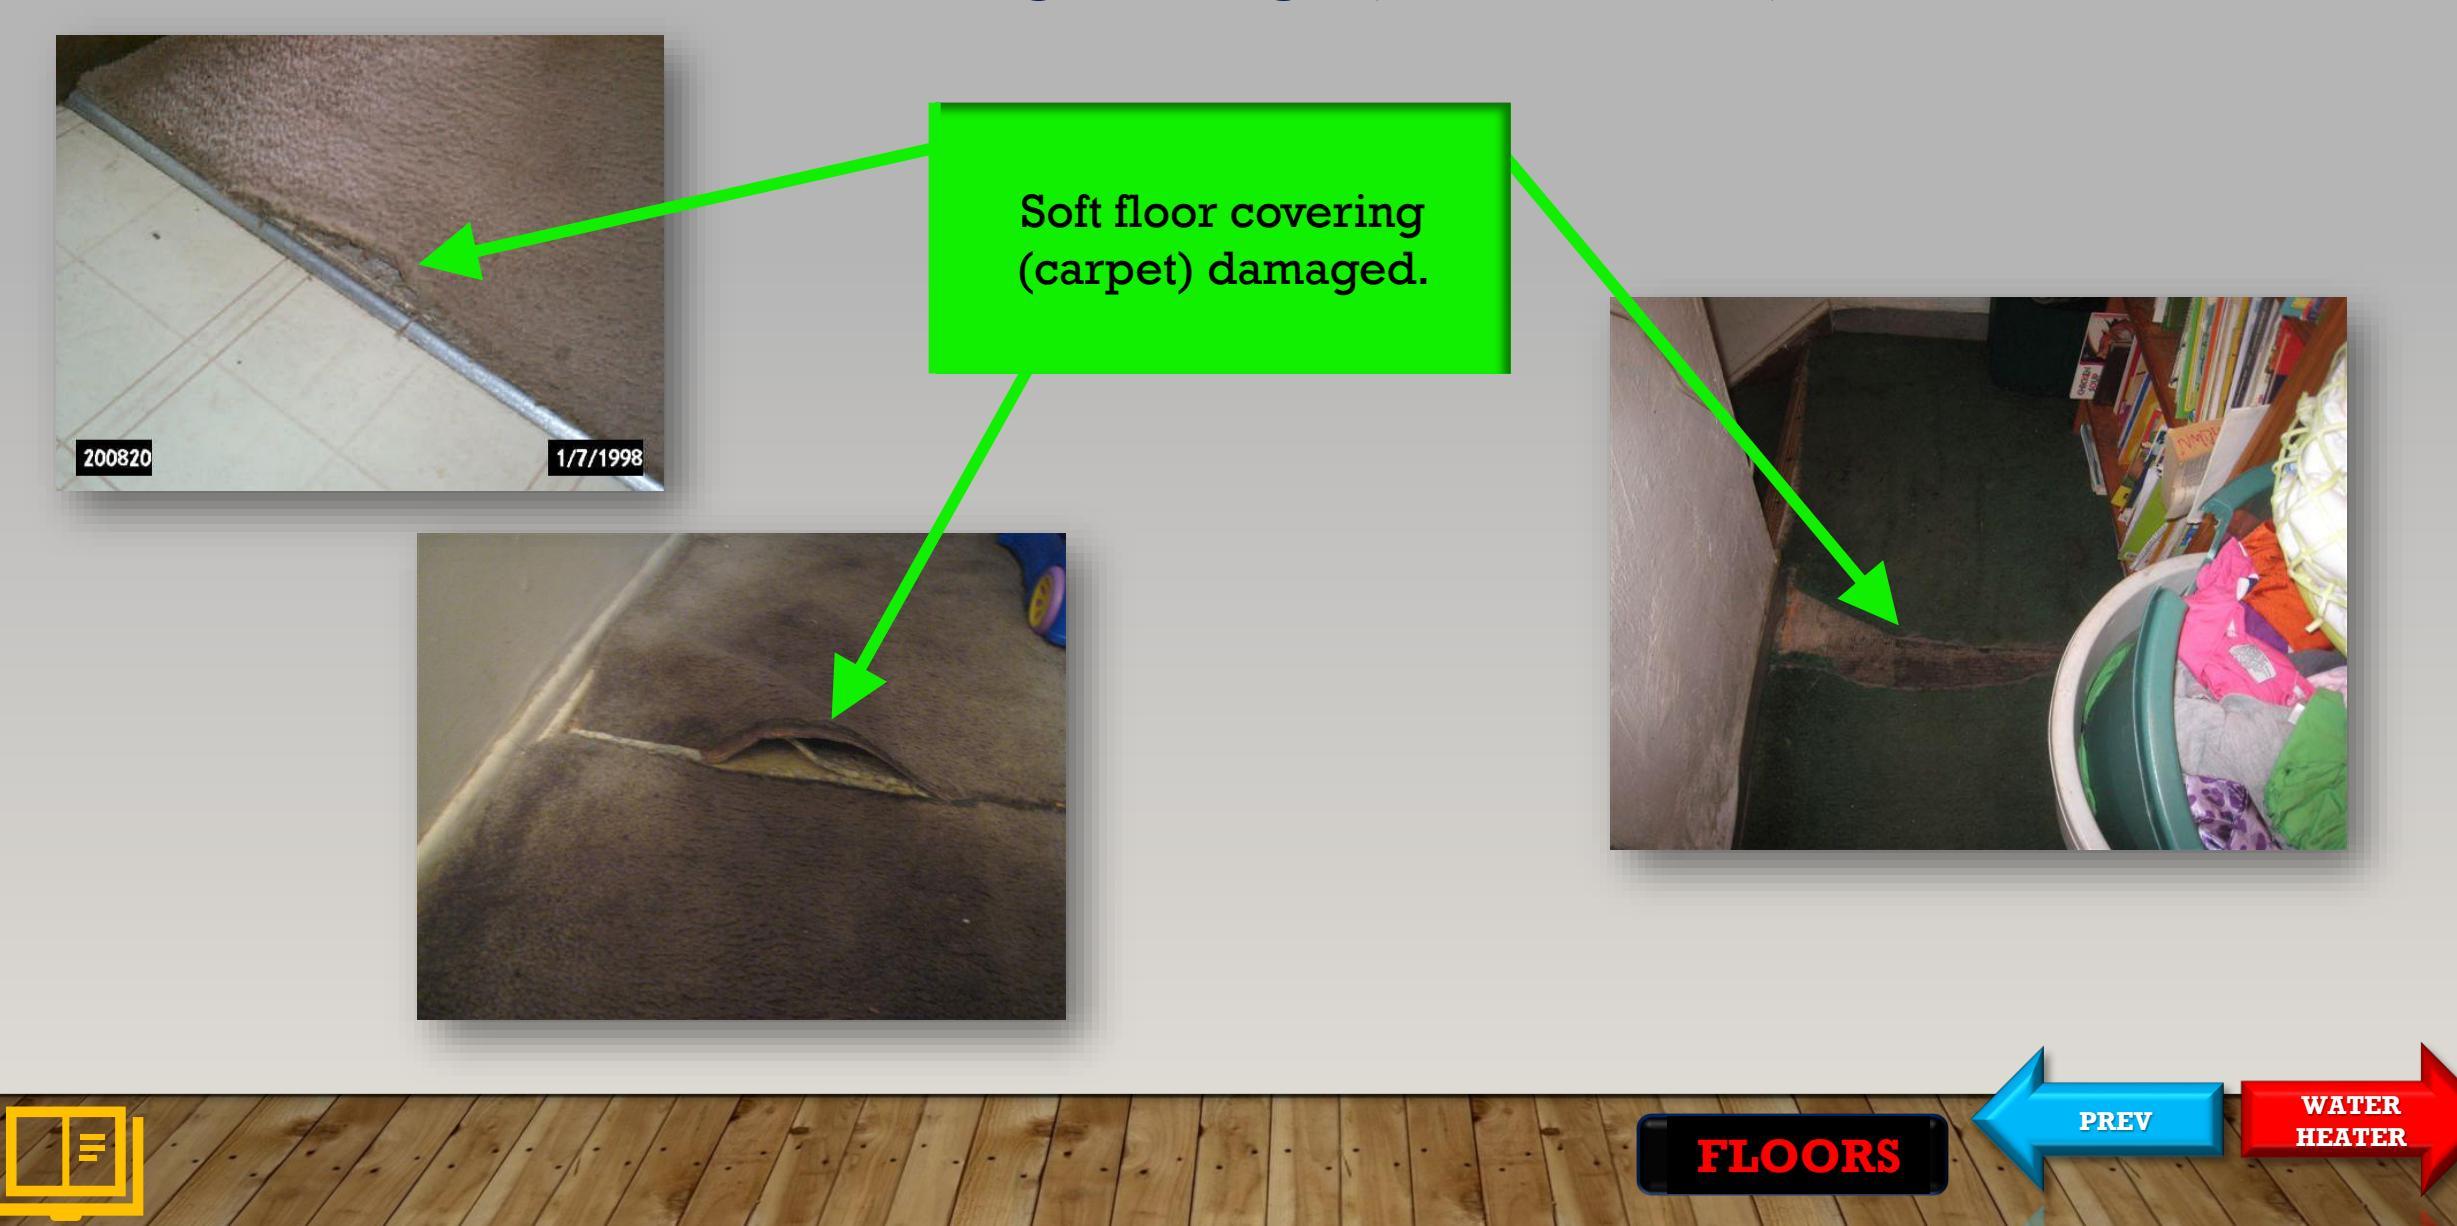
Soft Floor Covering Damage (Floors – Unit) Photos

Deficiency: You see damaged and/or missing soft floor covering.

Level 1: You estimate that only 5% to 10% of any single soft floor covering has stains, surface burns, shallow cuts, small holes, tears, loose areas, or exposed seams. The covering is fully functional, and there is no safety hazard.

Level 2: You estimate that 10% to 50% of any single soft floor covering has burn marks, cuts, tears, holes, or large sections of exposed seams that expose the underlying material. There is no safety hazard.

Level 3: You estimate that more than 50% of any single soft floor covering is damaged. -OR- Damage to the soft floor covering exposes the underlying material.

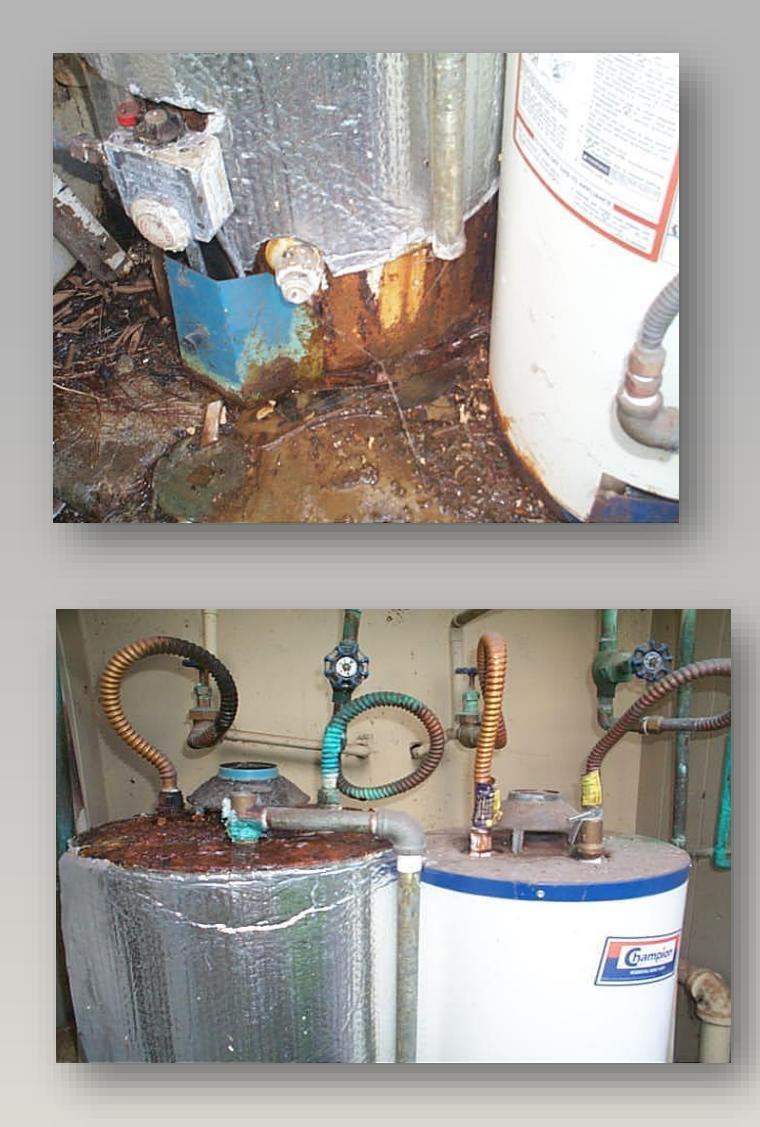
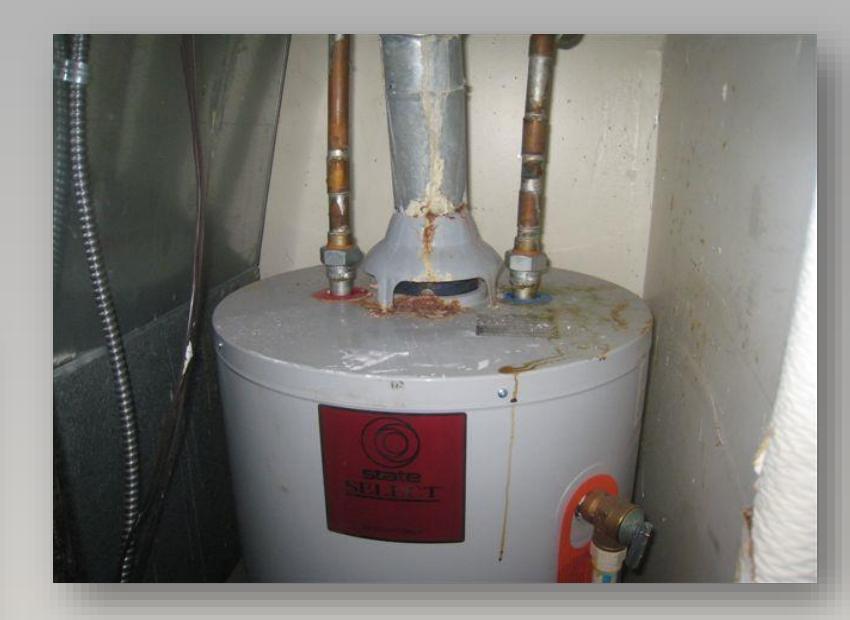
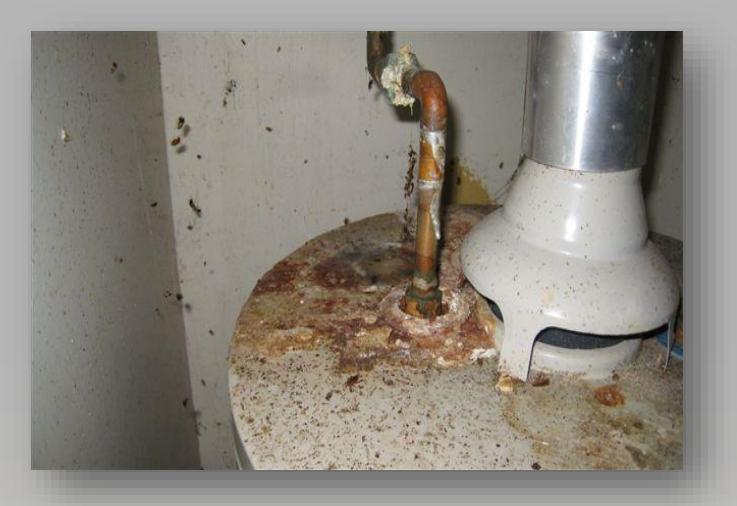
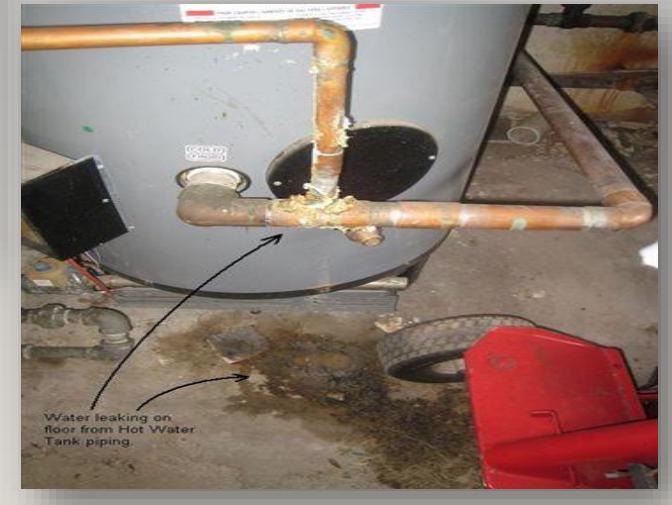
General Rust/Corrosion Photos

Deficiency: The equipment or associated piping/ducting shows evidence of flaking, oxidation, discoloration, pitting, or crevices.

Level 1: You see superficial surface rust.
Level 2: You see significant formations of metal oxides, flaking, discoloration, or a pit or crevice.
Level 3: Because of this condition, the equipment or piping does not function.

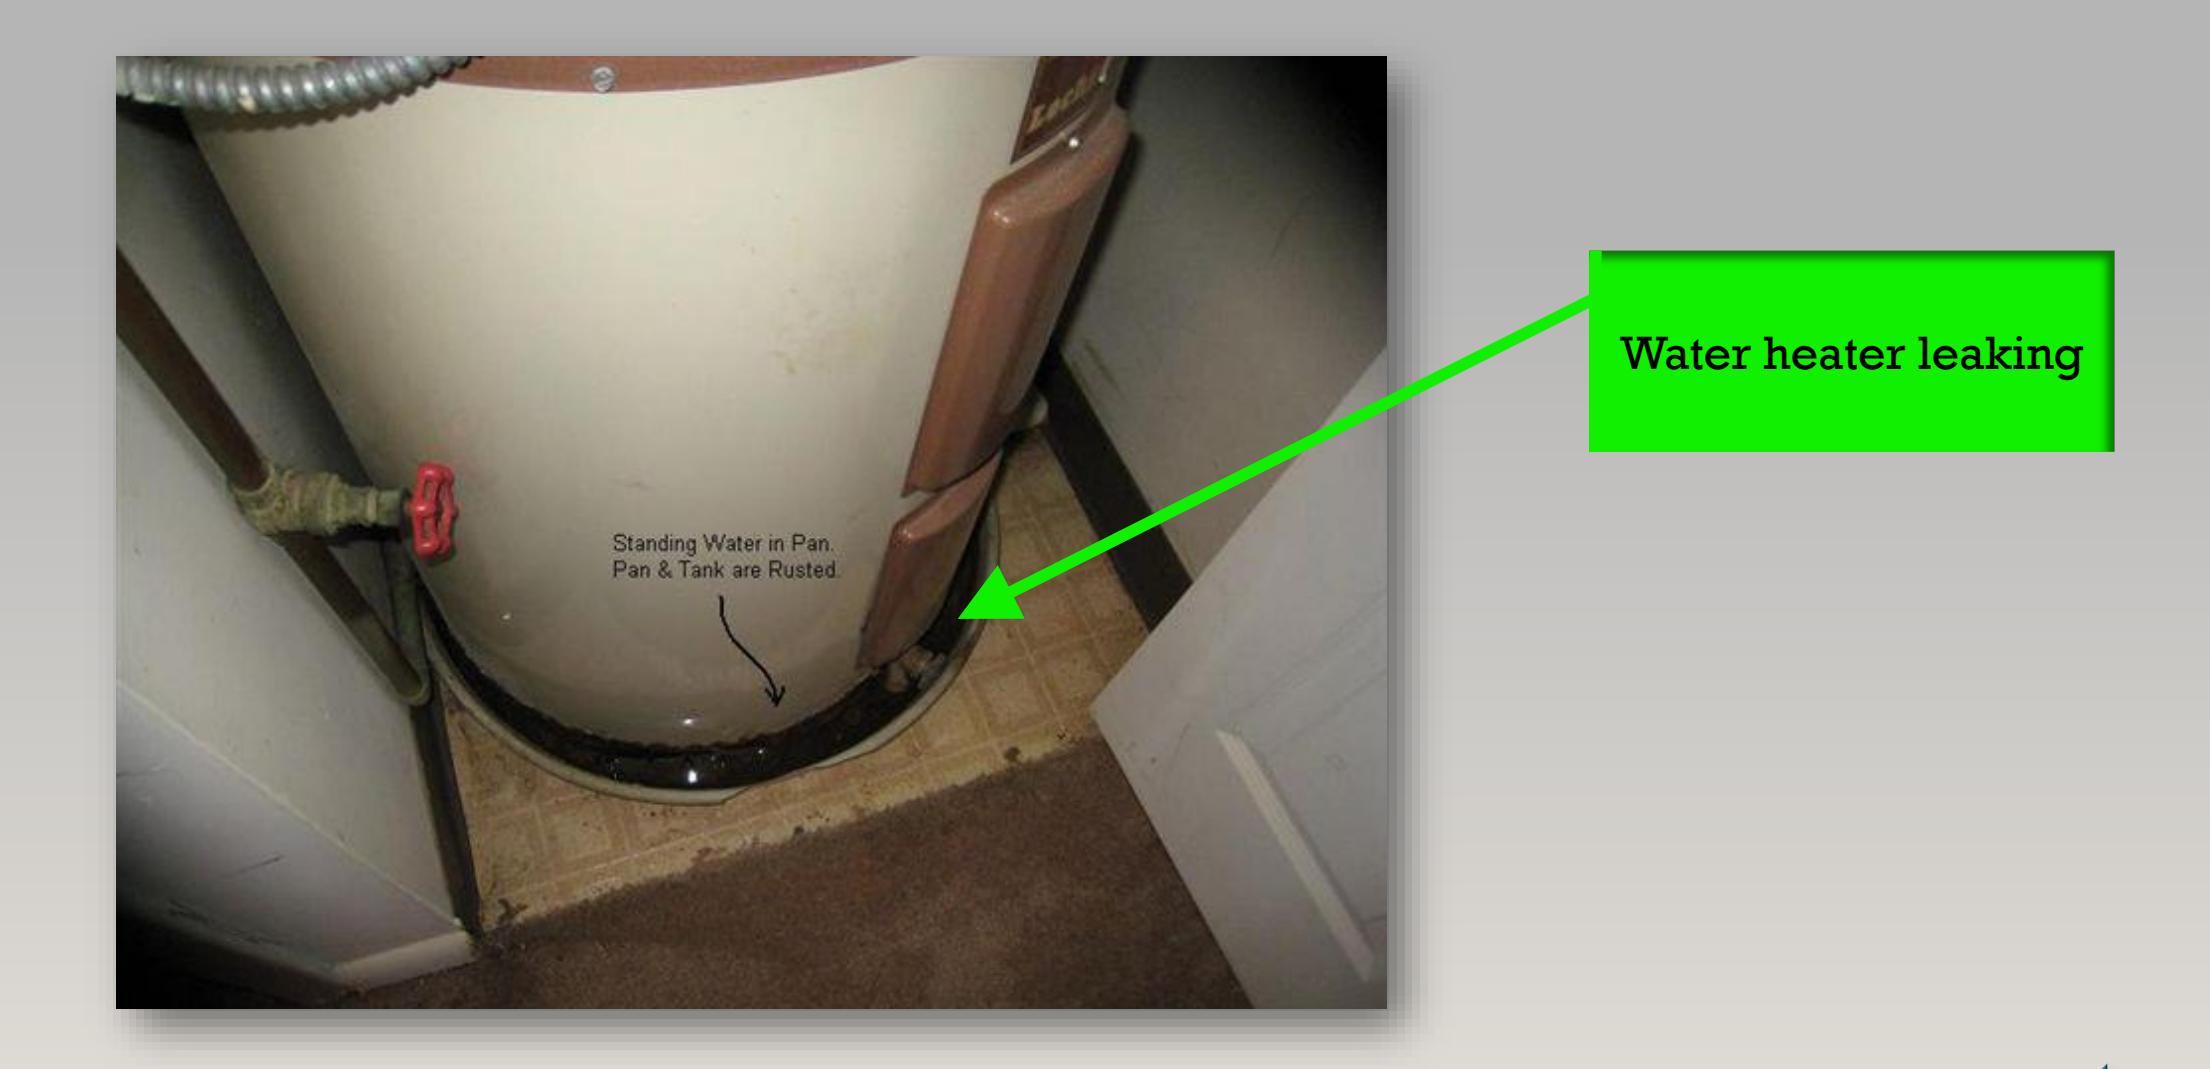
Leaking Valves/Tanks/Pipes (Hot Water Heater – Unit) Photos

Deficiency: You see water leaking from any hot water system component, including valve flanges, stems, bodies, domestic hot water tank, or its piping.

Level 1: N/A Level 2: N/A Level 3: You see water leaking. Comment:

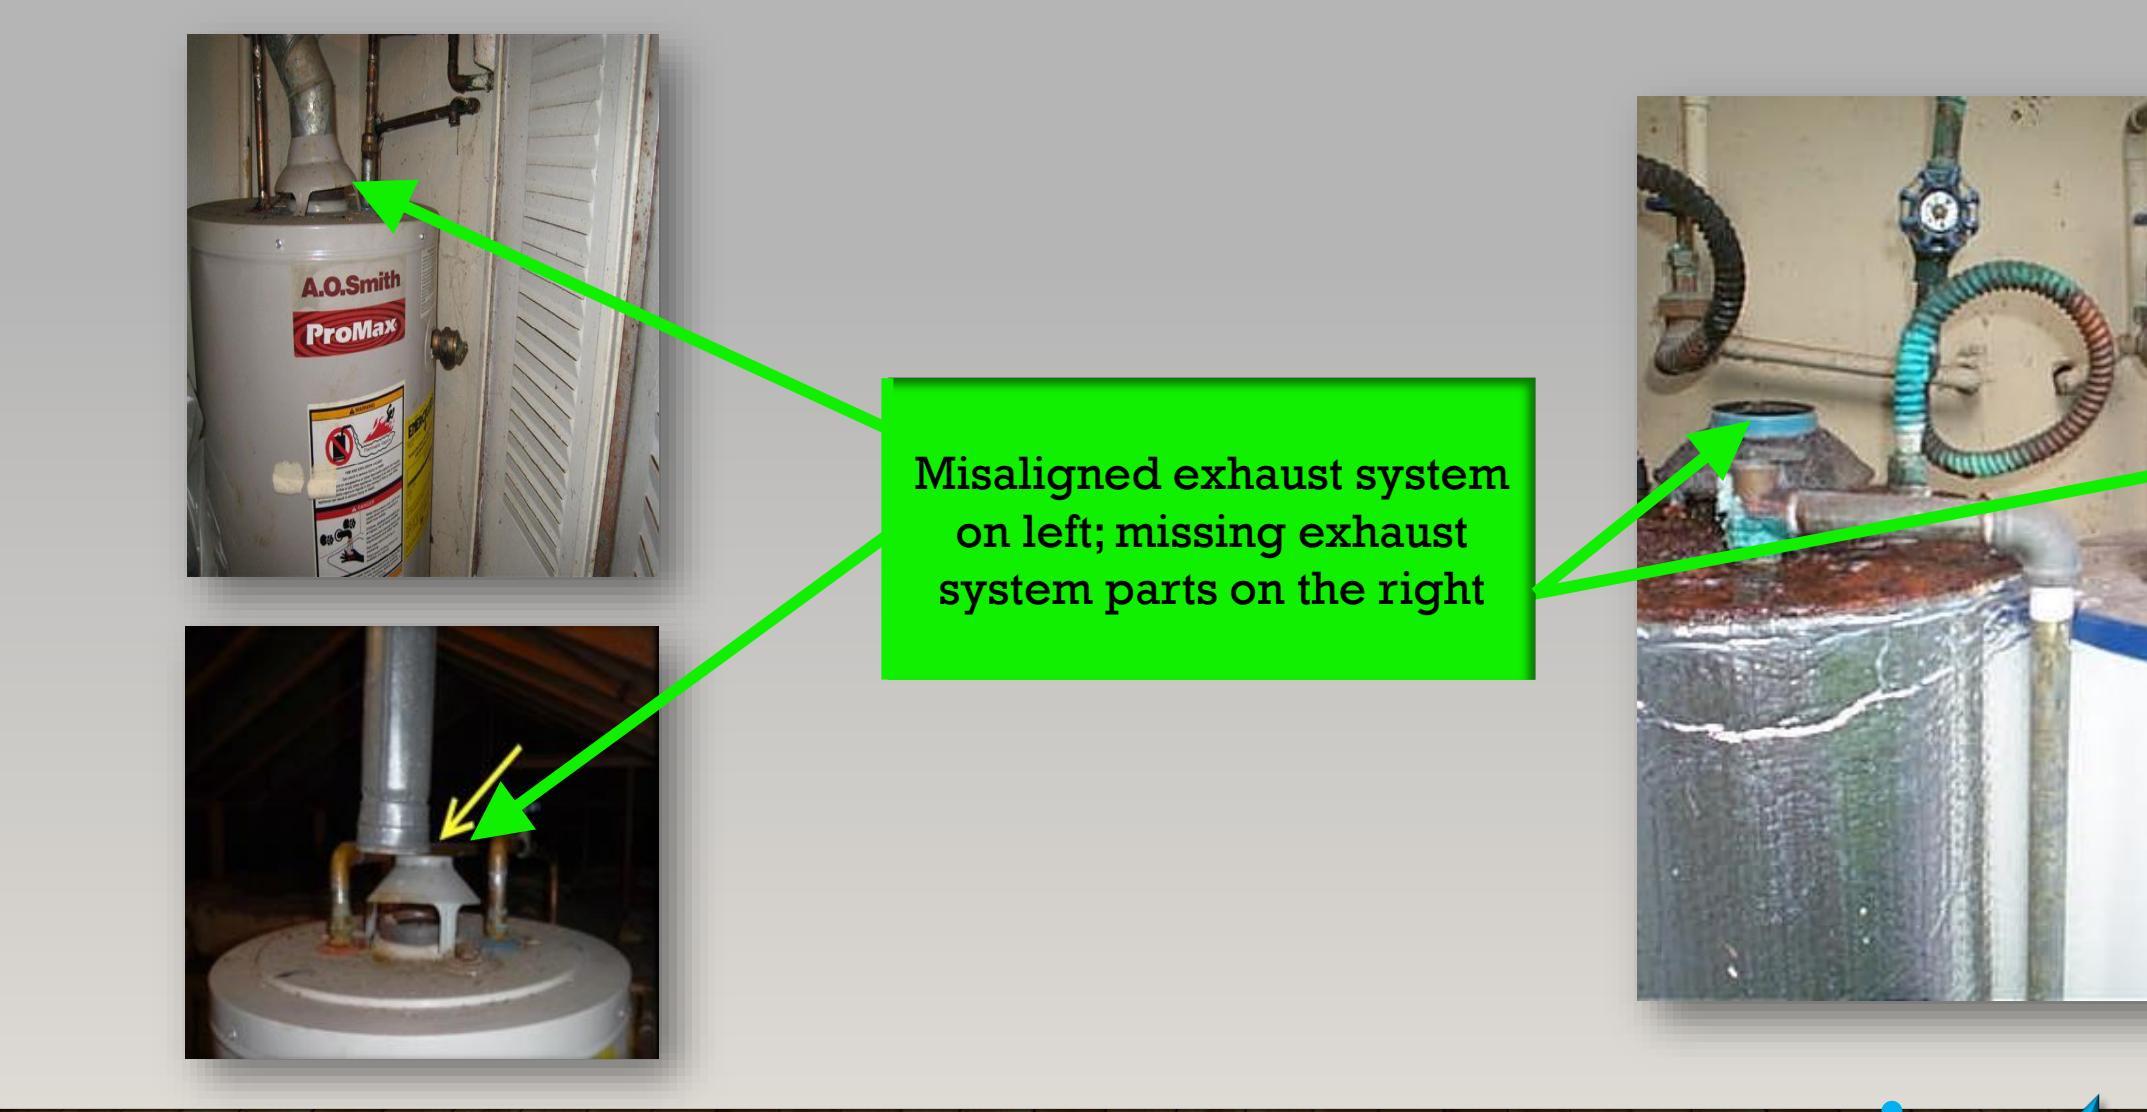
Misaligned Chimney/Ventilation System (Hot Water Heater – Unit) Deficiency: The exhaust system on a gas fired or oil-fired unit is misaligned.

Level 1: N/A Level 2: N/A Level 3: You see any misalignment of an exhaust system on a gas fired or oil-fired unit that may cause improper or dangerous venting of gases.

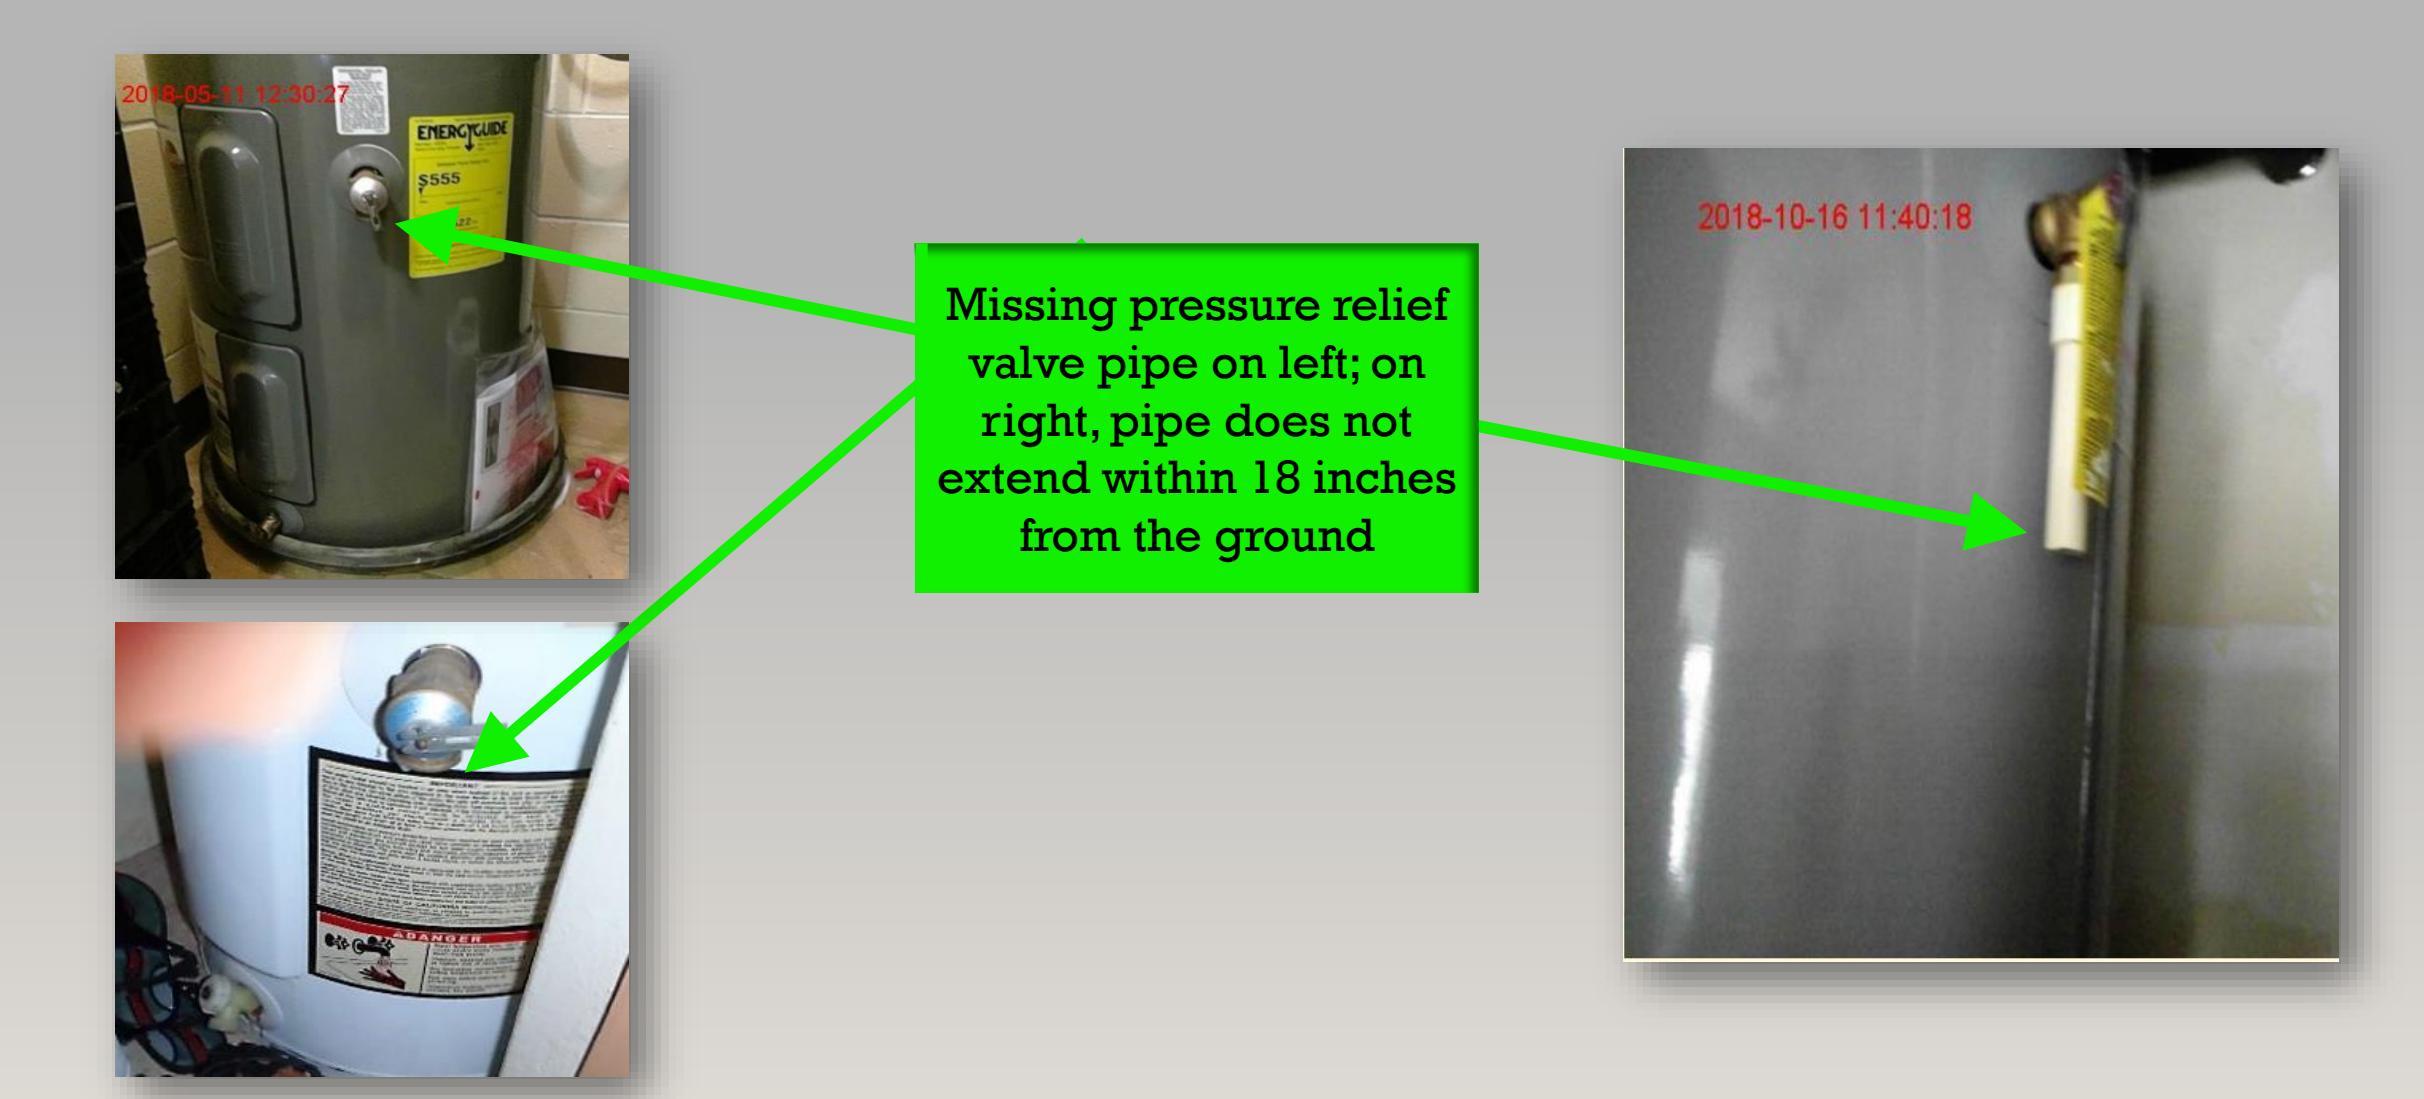
Missing Pressure Relief Valve (Hot Water Heater – Unit) Photos

Deficiency: The pressure relief value on the unit water heating system is missing or does not extend to the floor.

Level 1: N/A Level 2: N/A Level 3: You see that the pressure relief valve on the unit water heating system is either missing or does not extend to the floor.

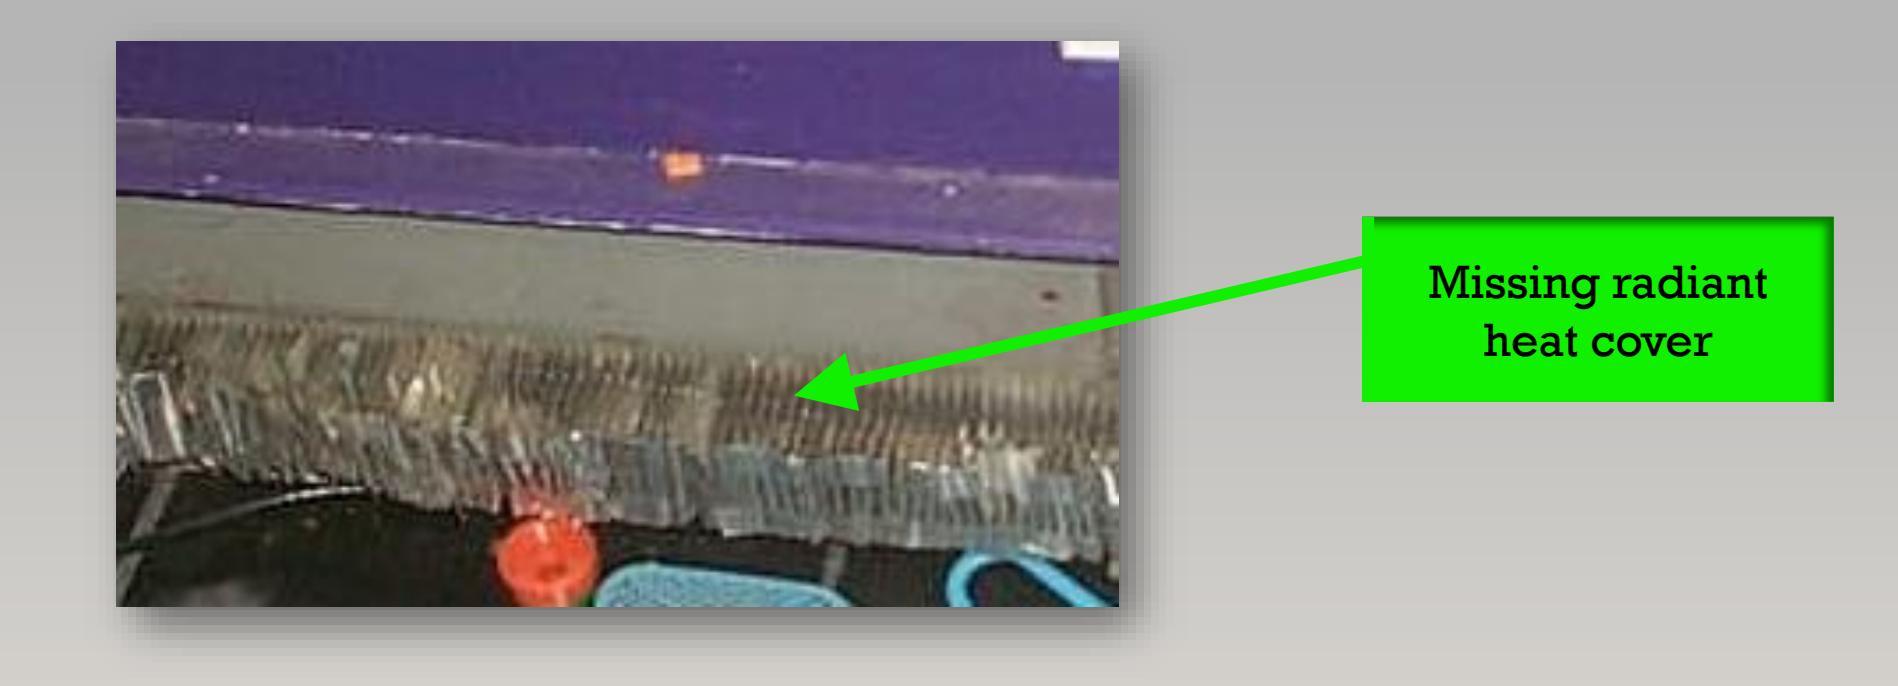
Convection/Radiant Heat System Covers Missing/Damaged (HVAC – Unit) Photos

Deficiency: A cover on the convection/radiant heat system is missing or damaged, which could cause a burn or related injury.

Level 1: N/A Level 2: N/A Level 3: At least 1 cover is missing or substantially damaged, allowing contact with heating/surface elements or associated fans.

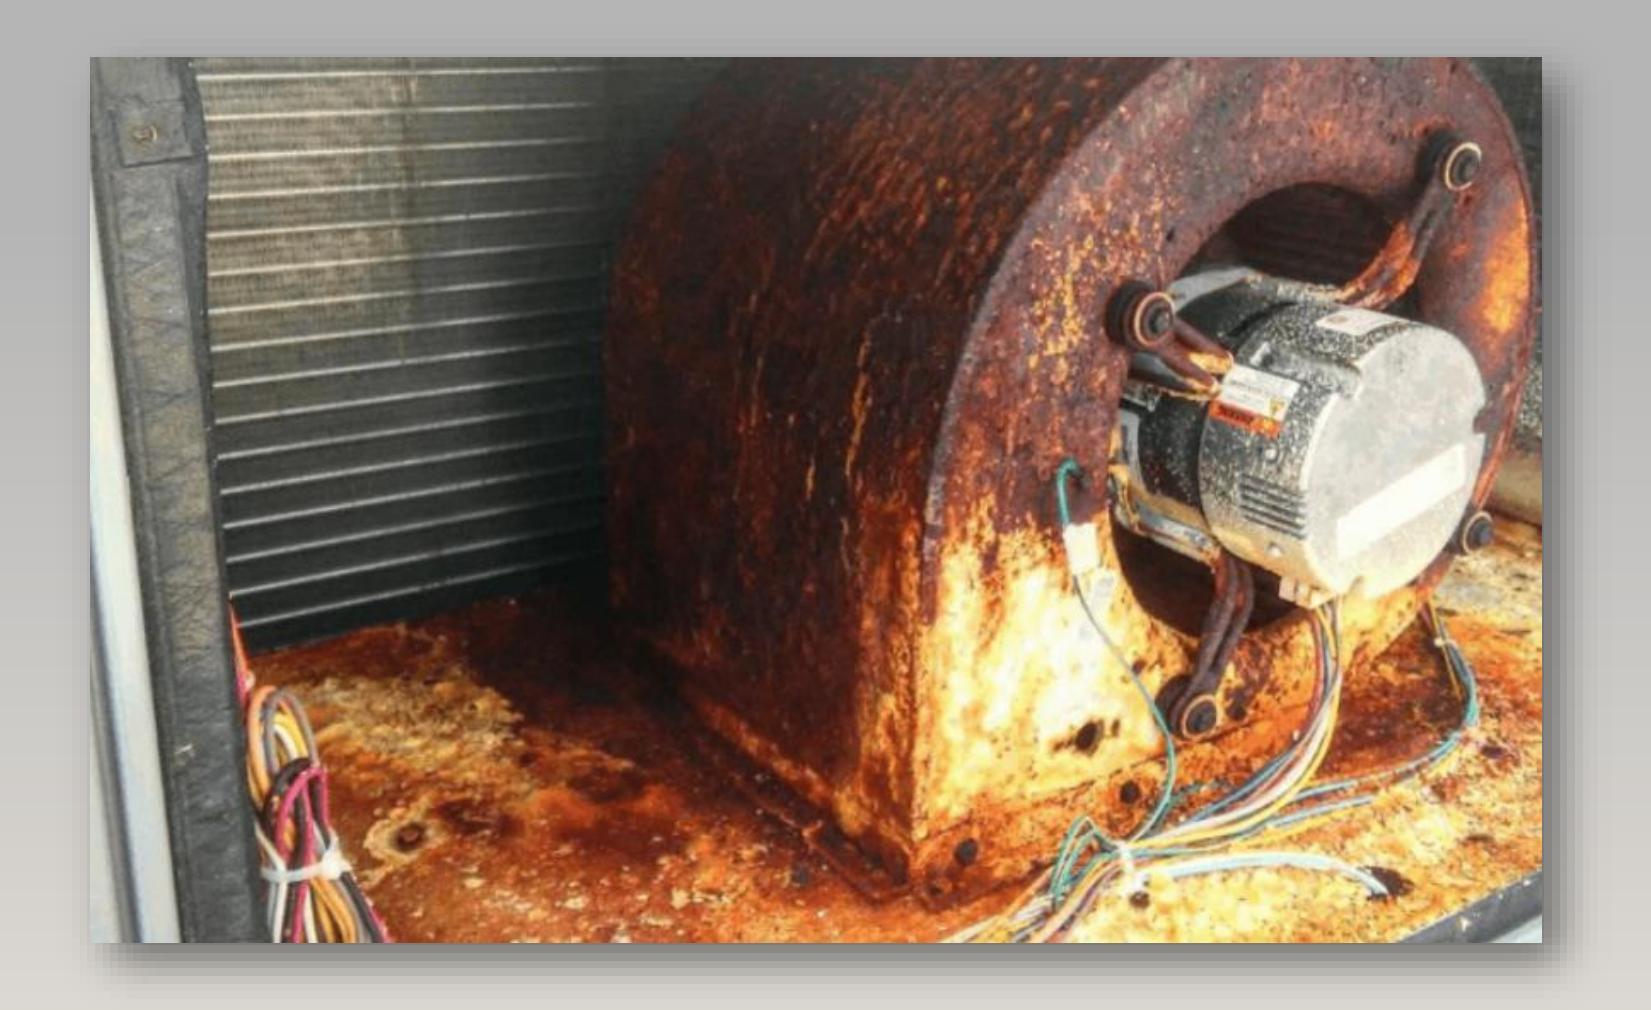
General Rust/Corrosion (HVAC – Unit)

Deficiency: You see a component of the system with deterioration from oxidation or corrosion of system parts. Deterioration is defined as rust and/or formations of metal oxides, flaking, or discoloration, or a pit or crevice.

Level 1: You see deterioration from rust and corrosion on the HVAC units in the dwelling unit. The system still provides enough heating or cooling. Level 2: N/A Level 3: N/A

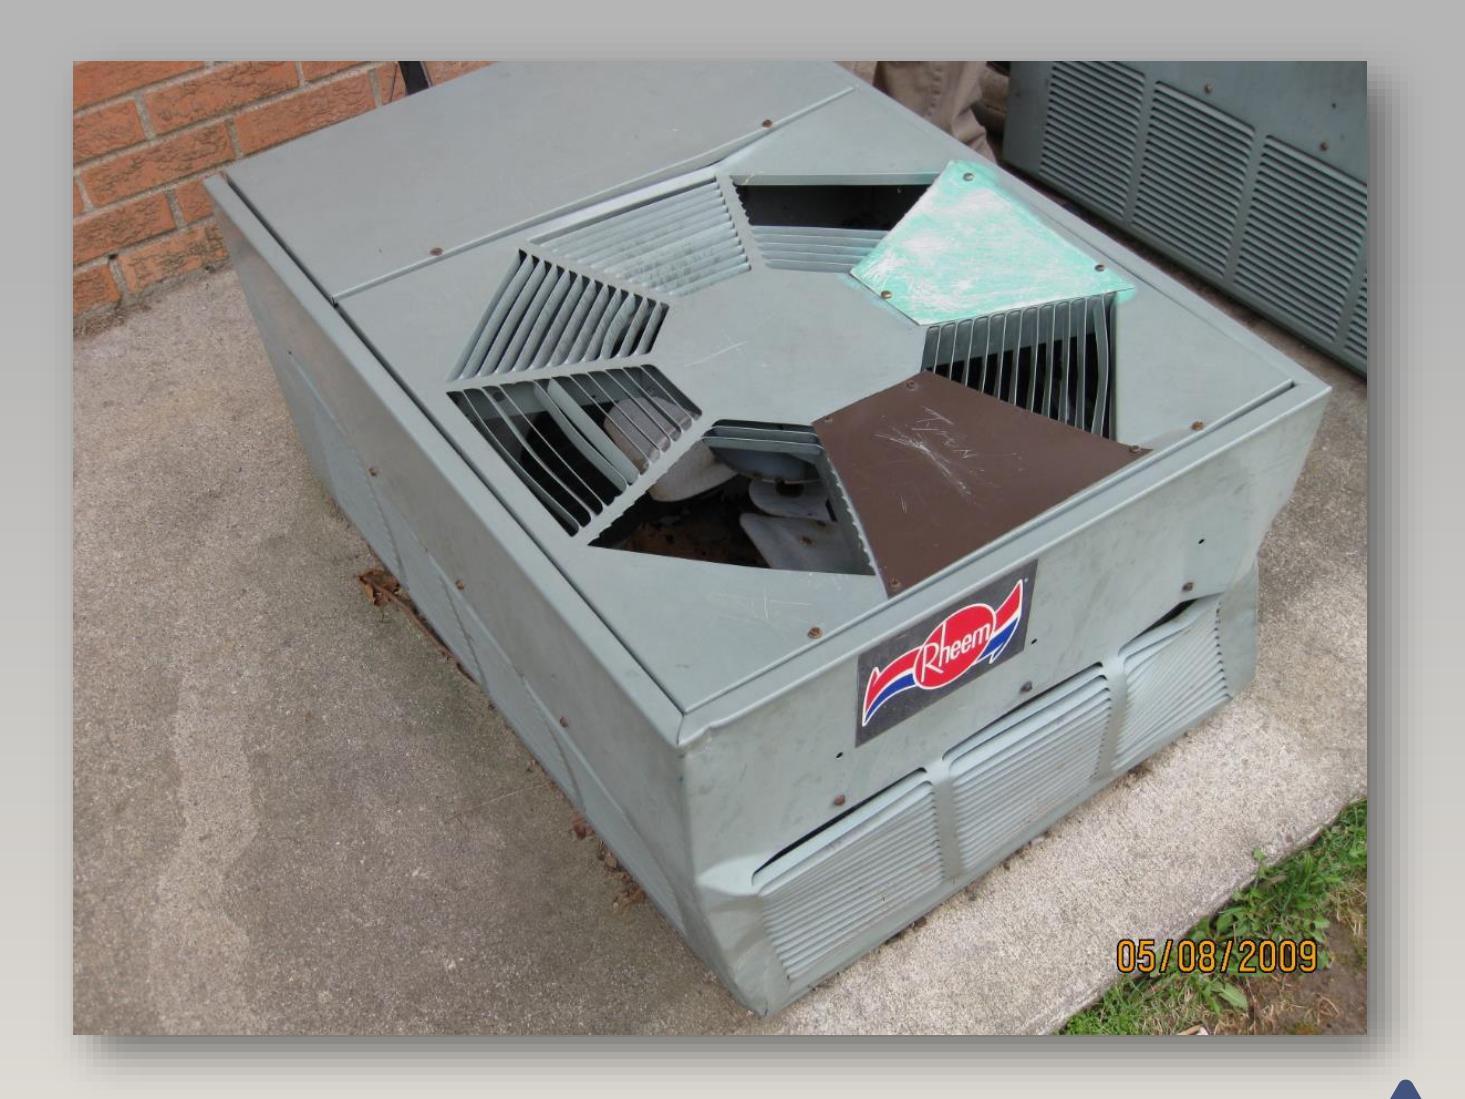
Inoperable (HVAC – Unit) Photos

Deficiency: The heating, cooling, or ventilation system does not function.

Level 1: N/A Level 2: N/A Level 3: The HVAC system does not function; it does not provide the heating or cooling it should. The system does not respond when the controls are engaged.
