PASS TRAINING - DINE & LEARN

How to Inspect a Unit – Part 2

UNIT INSPECTION PART II

DEFICIENCY DEFINITIONS

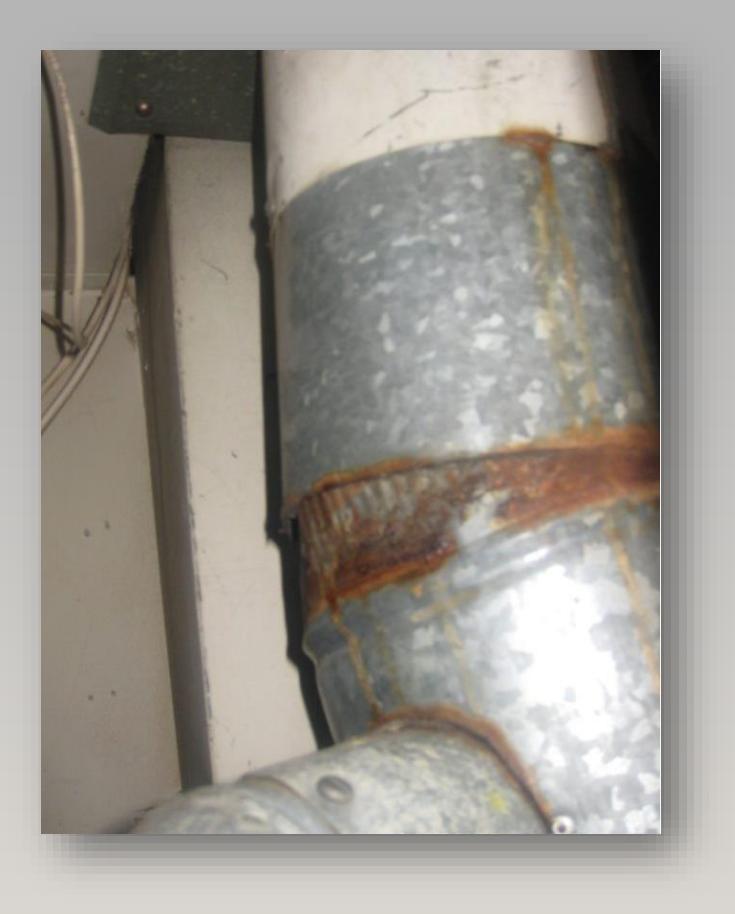
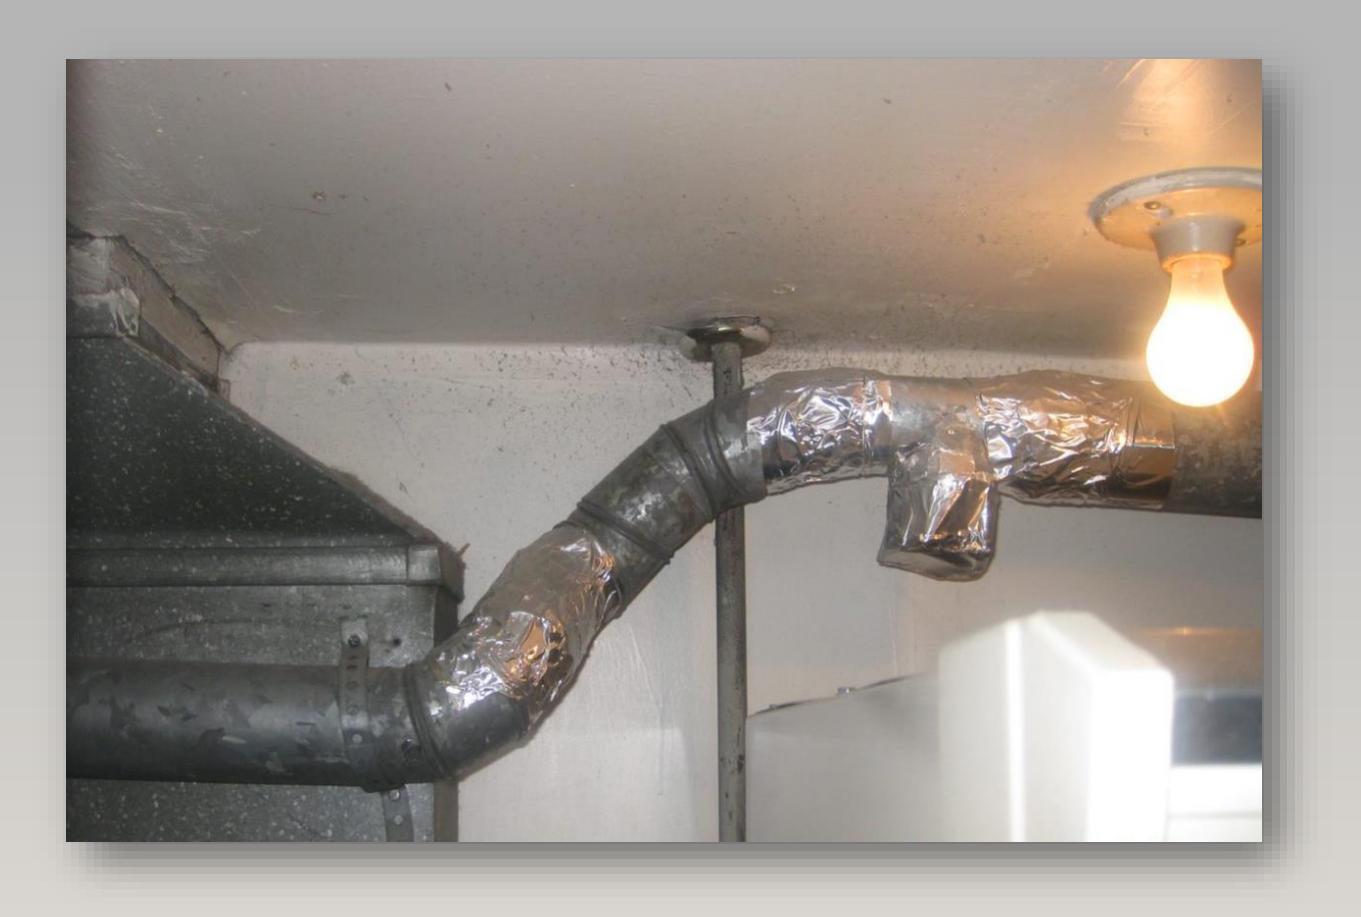
Misaligned Chimney/Ventilation System (HVAC – Unit) Photos

Deficiency: The exhaust system on either a gas, oil fired, or coal unit is misaligned.

Level 1: N/A Level 2: N/A Level 3: You see any misalignment of an exhaust system on a gas fired, oil fired or coal unit that may cause improper or dangerous venting of gases.

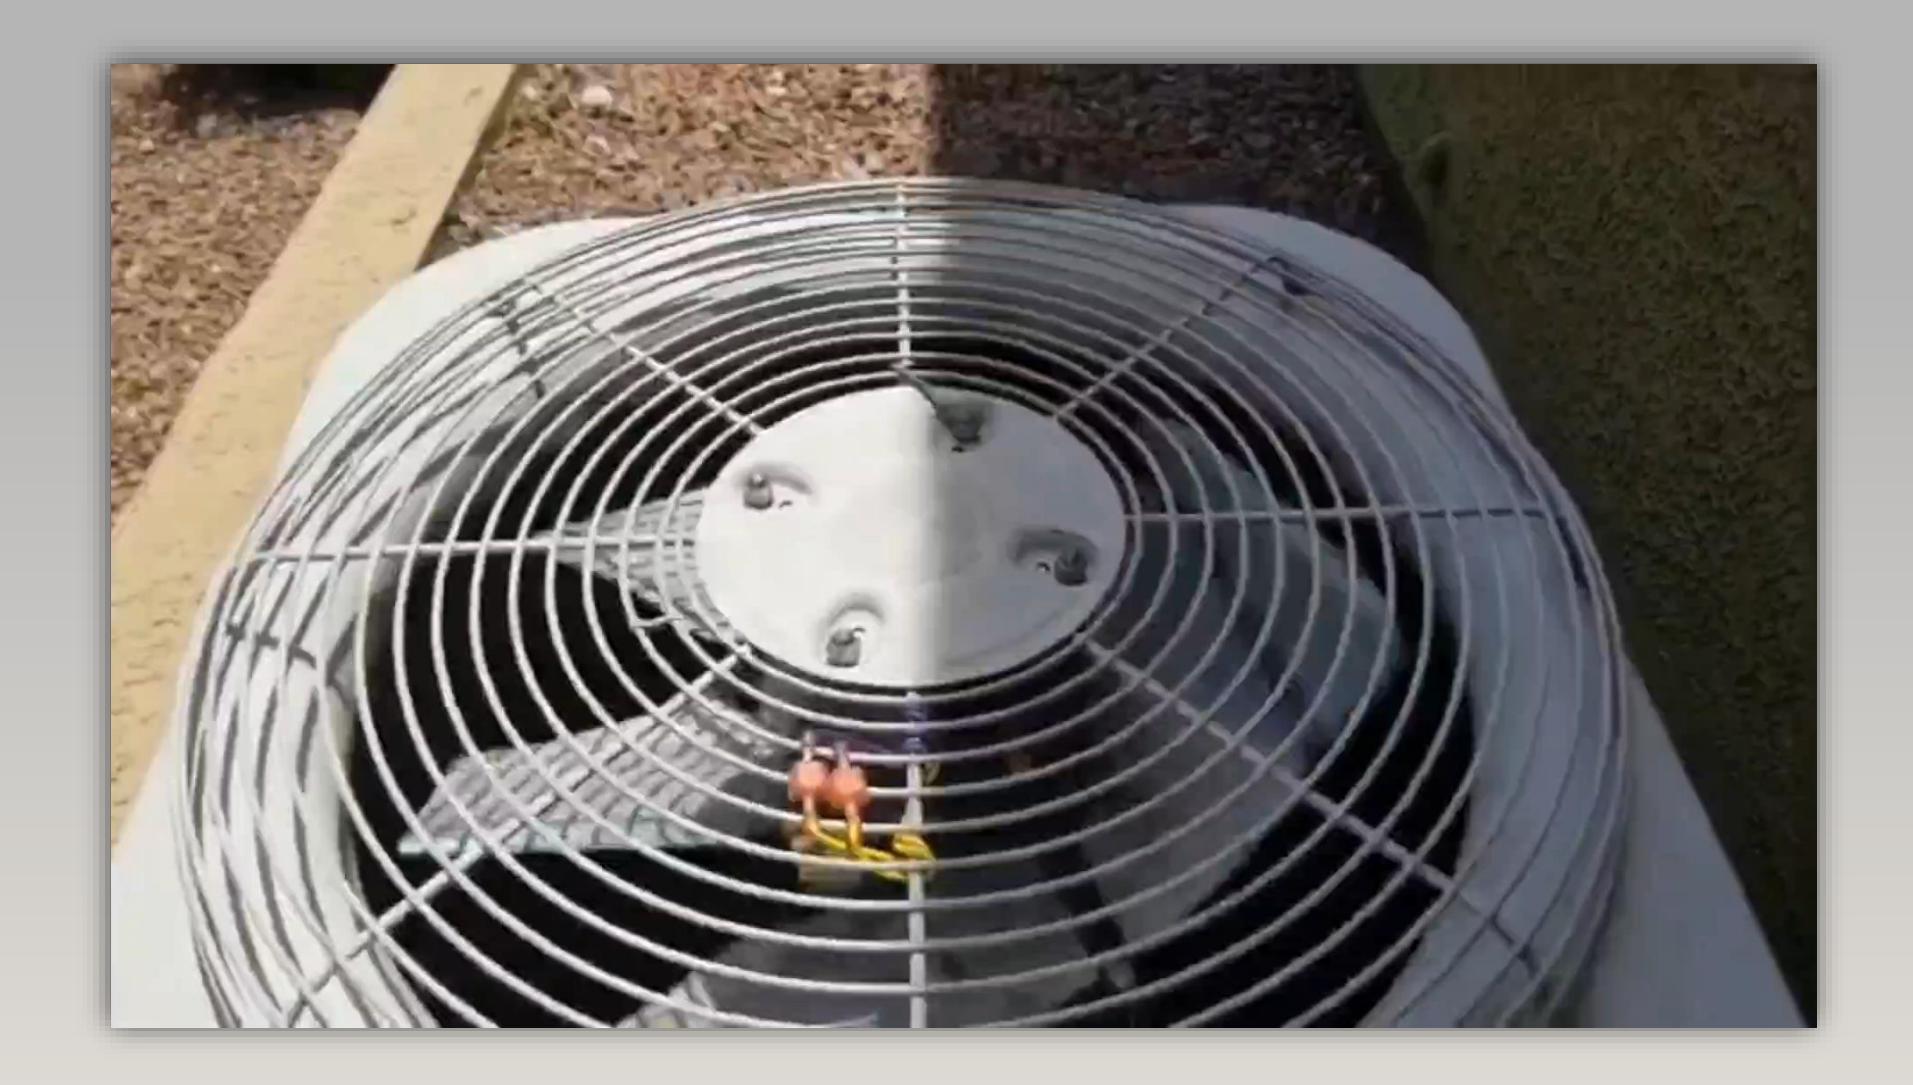
Noisy/Vibrating/Leaking (HVAC – Unit) Photos

Deficiency: The HVAC distribution components, including fans, are the source of unusual vibrations, leaks, or abnormal noise. Examples may include, but are not limited to, screeching, squealing, banging, shaking, etc.

Level 1: The HVAC system shows signs of abnormal vibrations, other noise, or leaks when engaged. The system still provides enough heating or cooling to maintain a minimum temperature range in the major living areas. Level 2: N/A Level 3: N/A
